MSC-07230

APOLLO 16 MISSION REPORT

MANNED SPACECRAFT CENTER

AUGUST 1972

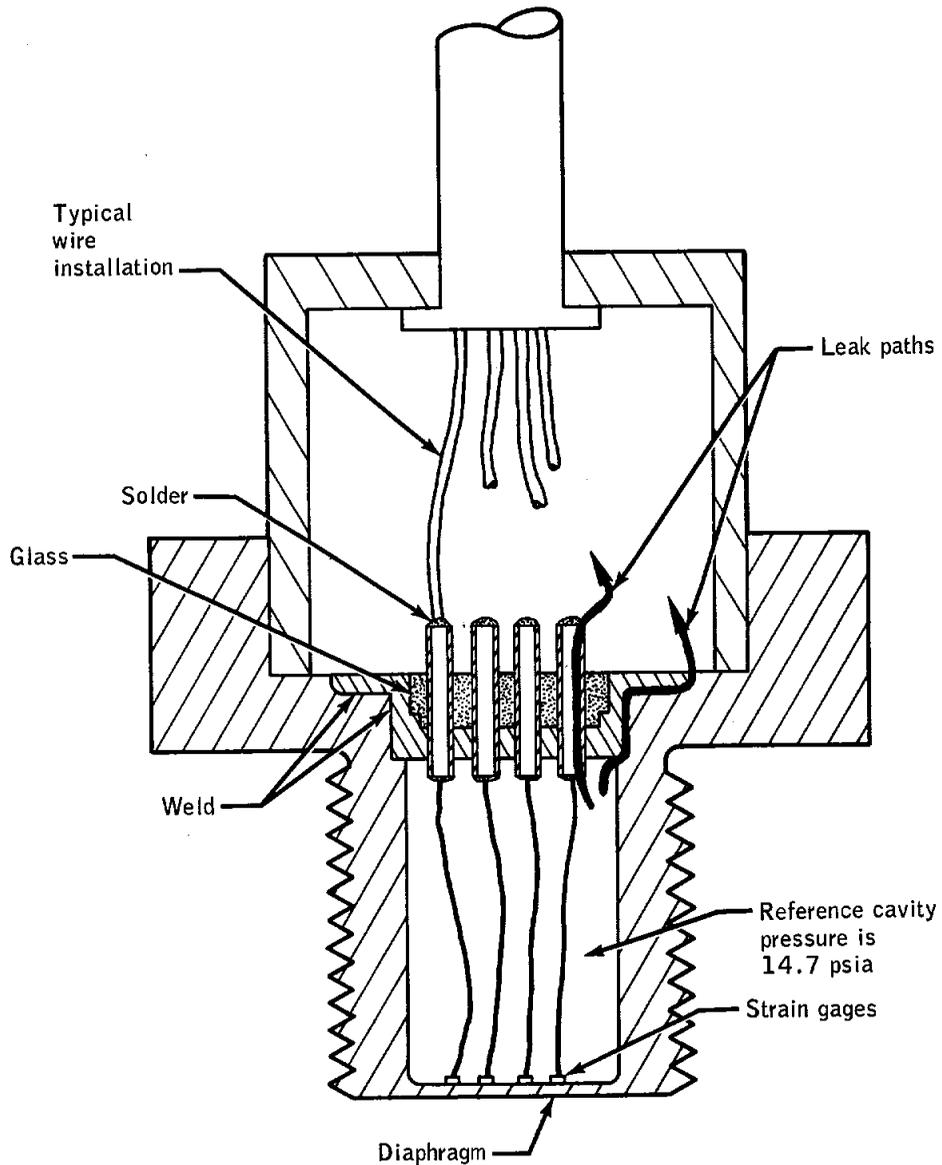
Figure 14-3.- Service propulsion system pressure transducer failure.

Previous experience with this type of transducer showed that the reference cavity can leak through the feed-through tubes in the header and at

the header-to-case weld (fig. 14-3). During altitude chamber tests for Apollo 16 and during the Apollo 12 mission, a similar transducer showed the same type of failure. The Apollo 16 transducer (replaced after the altitude chamber tests) had not had a vacuum check since 1965 to verify that the reference cavity was leak tight. The altitude chamber test is adequate to verify the integrity of this type of pressure transducer.

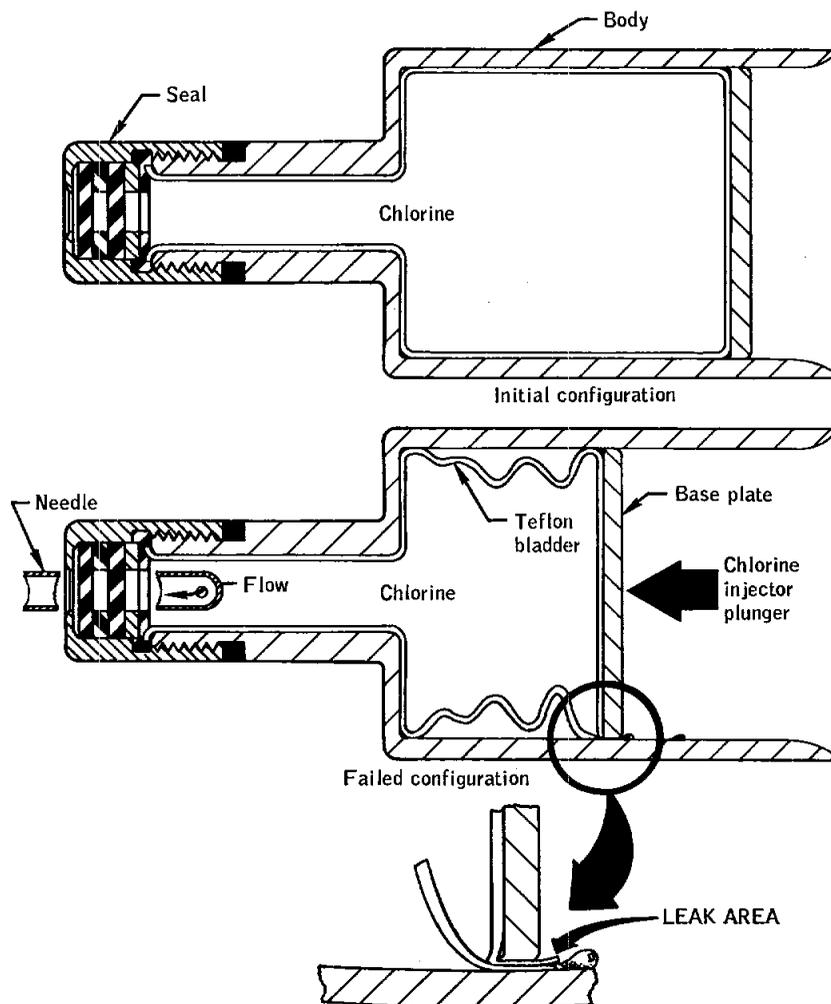
Figure 14-9.- Chlorine ampule failure.

Upon further examination by the crew, the chlorine ampule appeared to be broken (leaking) and the inner bladder was visible after having been extruded past the base plate. Inner bladder extrusion has been observed before but has not been associated with leaks. Figure 14-9 shows typically how the Teflon bladder can be forced past the injector base plate. The body sidewall is not sufficiently rigid to prevent the bladder from extruding around the base plate and being creased, which would be conducive to leaks. Subsequent chlorine injections were satisfactory. The specific ampule which caused the problem was later jettisoned with the lunar module and was not available for postflight inspection.

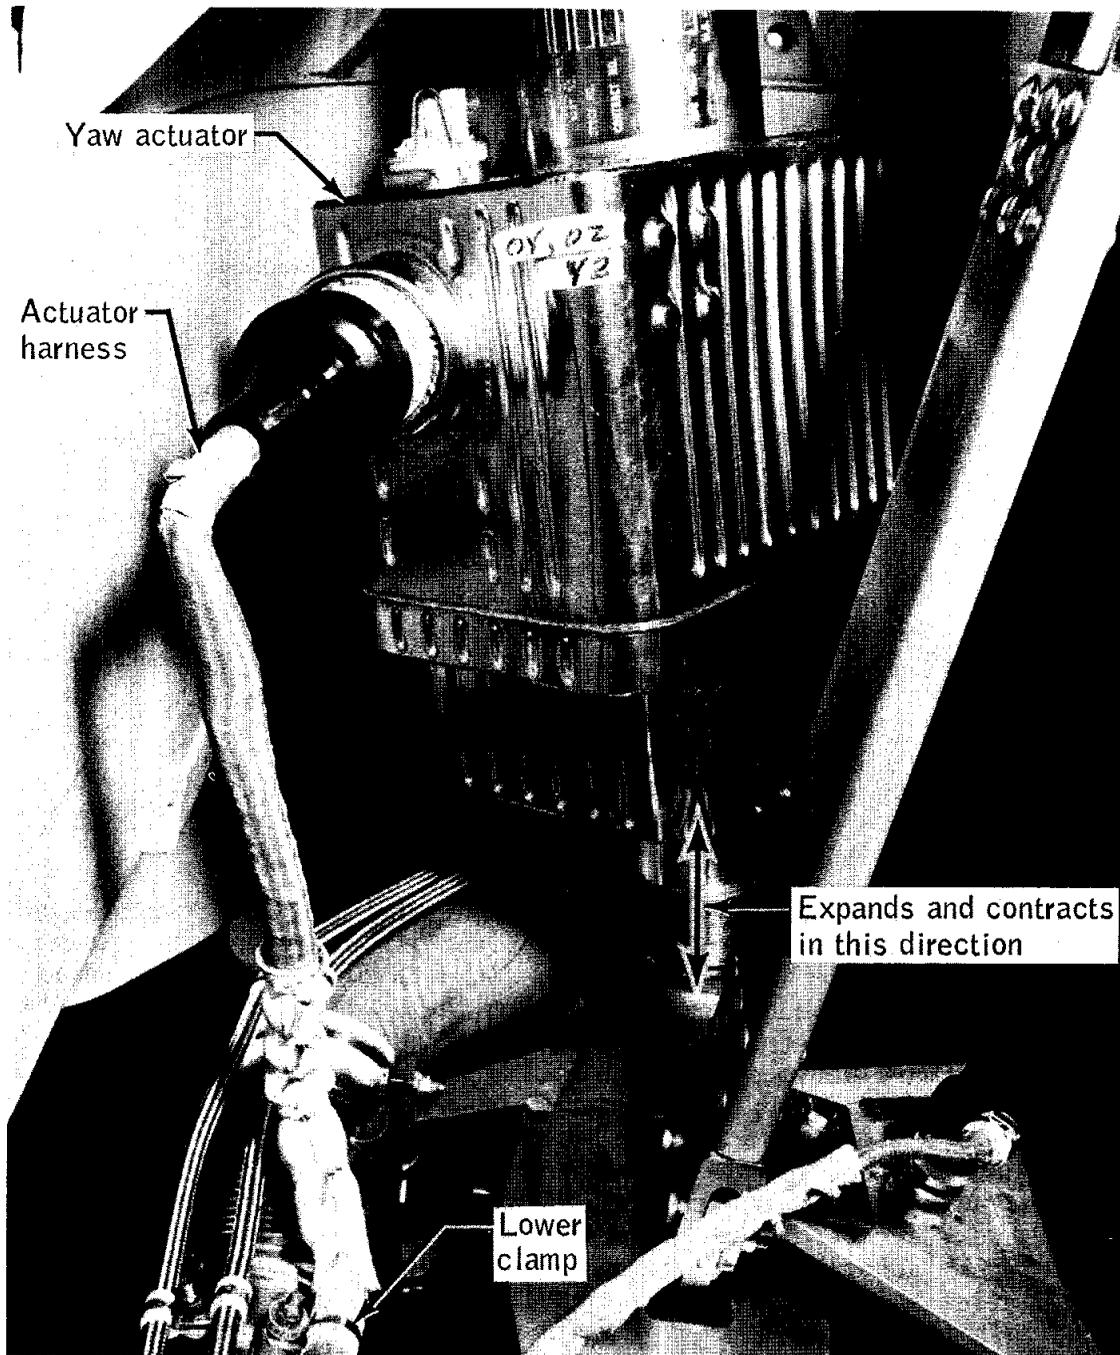
Figure 14-12.- Yaw actuator assembly and interconnecting wiring.

The cause of the failure was an open in the rate feedback loop of the secondary yaw servo system. Postflight testing of command module wiring and connectors and bench testing of the thrust vector servo assembly did not reveal any abnormalities. Therefore, the failure must have occurred in the service module wiring or connectors. Possible pin corrosion on the engine gimbal actuator wiring harness connectors or broken wires in the yaw gimbal wiring loop are the most probable causes of the flight problem. A broken wire would result from inadequate strain relief (see fig. 14-12) due to cable flexing. Wiring harnesses to the actuator assembly on three other vehicles were reviewed and found to move when the engine was gimballed. Motion of the actuator produced a strain on the harness at the lower clamp. The position of this clamp was changed for the remaining vehicles to provide strain relief.

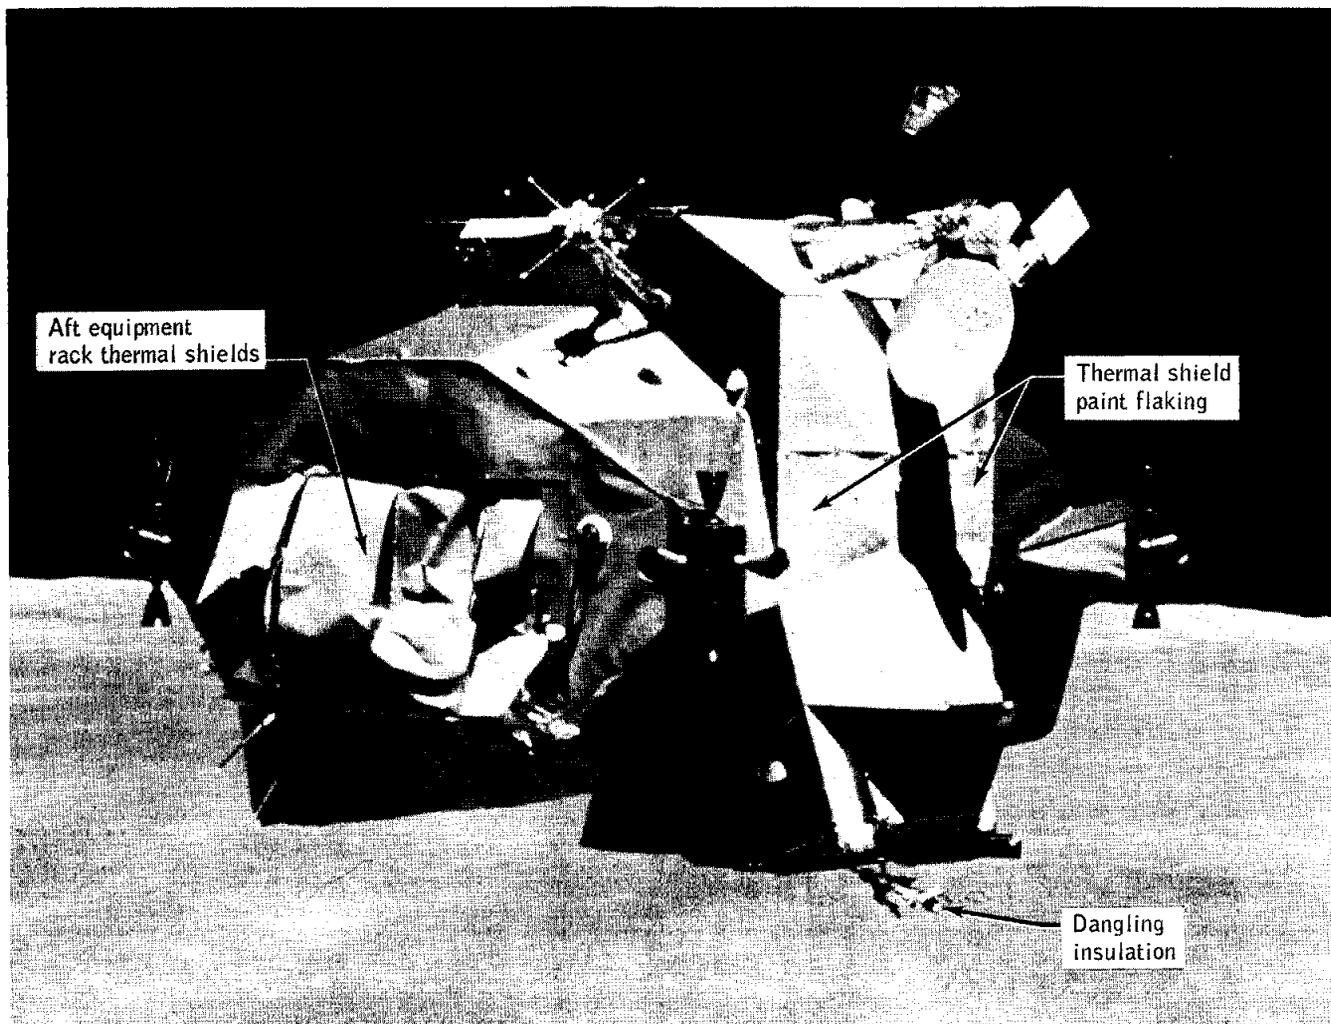
Figure 14-26.- Paint flaking and damaged thermal shield panels.

The most probable cause of the failure was ascent engine exhaust entering the cavity behind these thermal shields. A cross section of the lower edge of the shields is shown in figure 14-27. Analysis shows that the thermal shield which extends below the support tube allows a pressure buildup on the closure shield which exceeds its capability. Once the closure shield failed, the exhaust entered the cavity behind the shield, resulting in a pressure buildup exceeding the capability of the vertical thermal shields. The detailed flight configuration in this area was not tested.

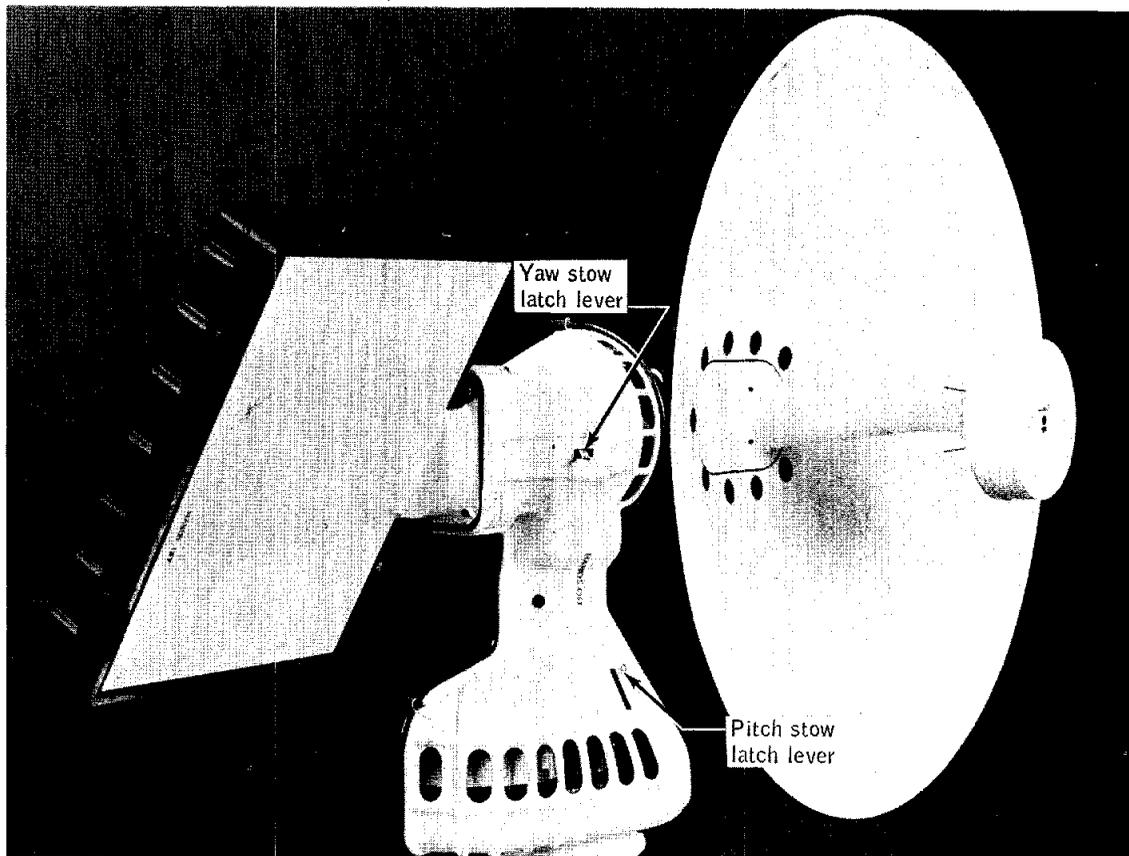
Figure 14-29.- Lunar module S-band steerable antenna.

The S-band steerable antenna (fig. 14-29) would not move in the yaw axis during initial activation. Several unsuccessful attempts were made to operate the unit using both the manual slew and auto track modes. Photographs and inflight test data show that the problem was caused by failure of the mechanical stow latch to release.
