MSC-01855

APOLLO 12 MISSION REPORT

HOUSTON, TEXAS
MARCH 1970

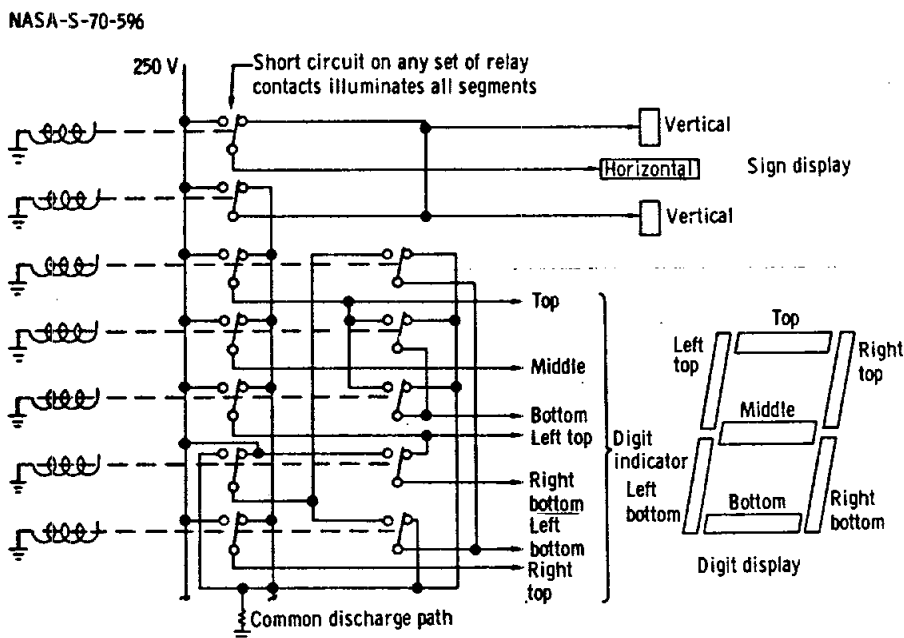
The crew reported several intermittent, all-"8's" displays on the main display and keyboard assembly approximately 1-1/2 hours before launch, but no display malfunction occurred in flight. The display segments are illuminated by applying 250 V ac through the contacts of miniature relays, as shown in figure 14-1. When a segment is off, it is grounded through a resistor and the normally closed contacts of a relay to avoid residual illumination. The normally closed contacts of all relays are tied together; consequently, a short across the contacts of any one relay will apply the voltage to all segments of each display. The effect of the short in conjunction with the common discharge path is shown in figure 14-1 for a typical character and one sign. A short across the relay contacts will affect only the display function of the unit.

Figure 14-1. - Simplified schematic diagram of relay matrix.

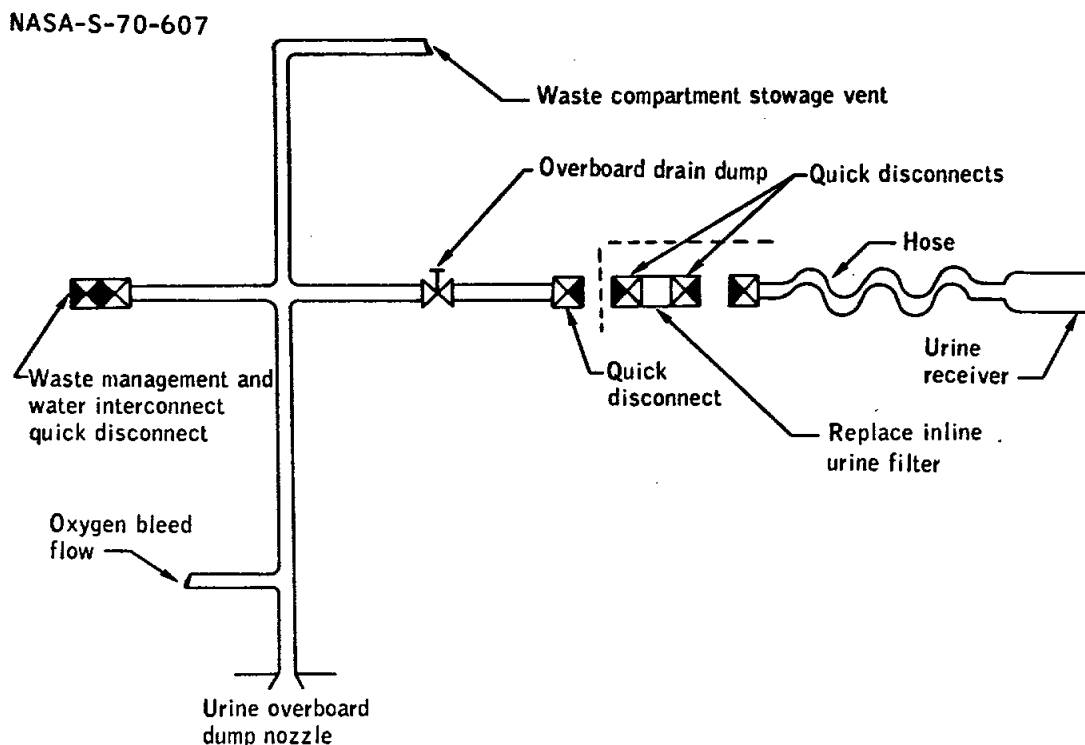
By about 215 hours, the crew reported that both urine filters had clogged and that the urine overboard dump system was being operated without a filter. The inline filter (fig. 14-12) clogged the day after the Commander and the Lunar Module Pilot returned to the command module from the lunar surface activity (day 7). The filter was then replaced by a spare unit which also clogged 2 days later. The urine dumping system operated satisfactorily without a filter for the remainder of the mission (approximately 30 hours).

Figure 14-12.- Urine dump system flow schematic.

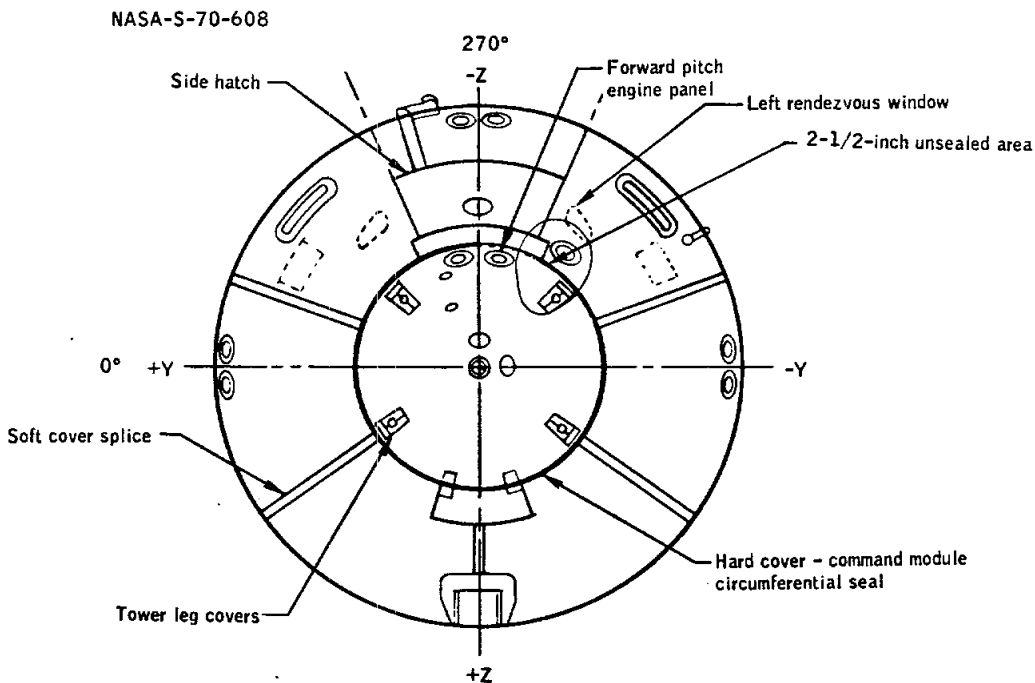
The hatch, left-hand side, and both rendezvous windows of the command module had considerable amounts of contamination appearing as vertical streaks on the exterior surfaces. Before flight, gaps in the boost protective cover were noted in the hard-to-soft transition region over the left rendezvous window (fig. 14-13). A procedure requires that these gaps be sealed with a composition sealant on final installation of the boost protective cover; however, some gaps were not sealed. The crew reported that during the heavy rain just prior to launch they saw water on the exterior window surfaces and also observed water flowing over the windows at tower jettison. The water rivulets acted as collection sites for the exhaust residue during escape motor firing. After the water evaporated, the residue deposits remained on the surfaces of the windows.

Figure 14-13.- Boost protective cover view looking aft.

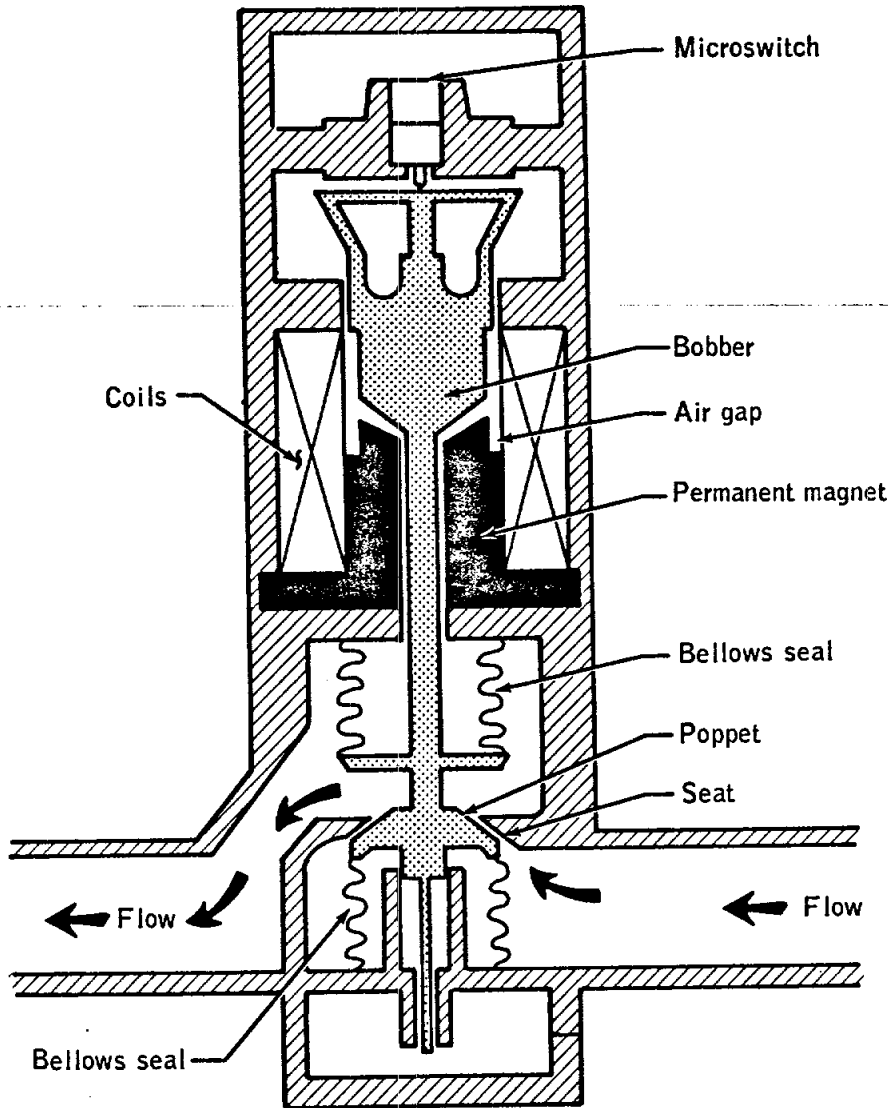
When the oxidizer isolation valve was disassembled after flight, the inlet-side bellows had been deformed enough to prevent the valve from staying in the closed position. The bellows in the system 1 propellant

Figure 14-16.- Cross sectional view of reaction control system isolation valve.

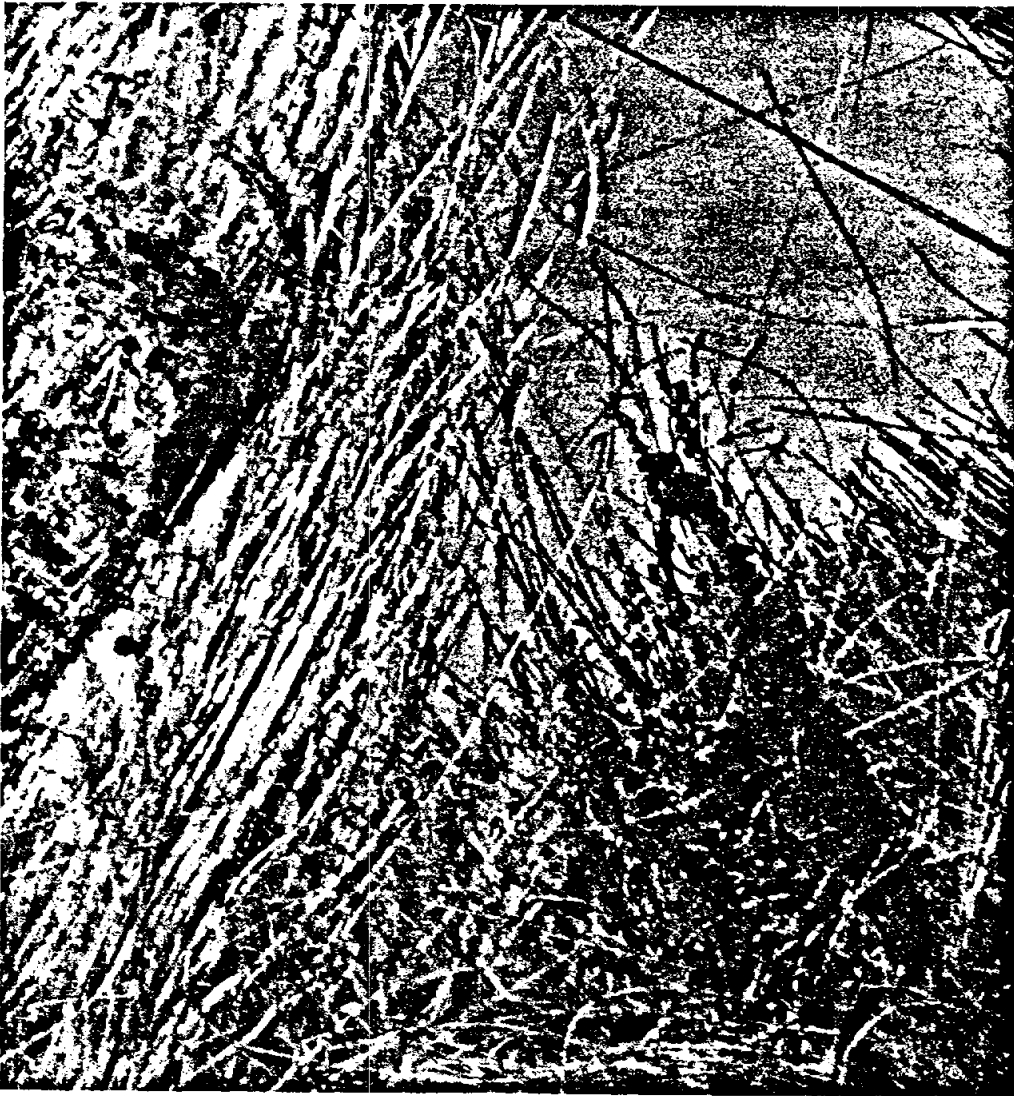
Figure 14-19.- Deposit on end of heat shield lanyard.

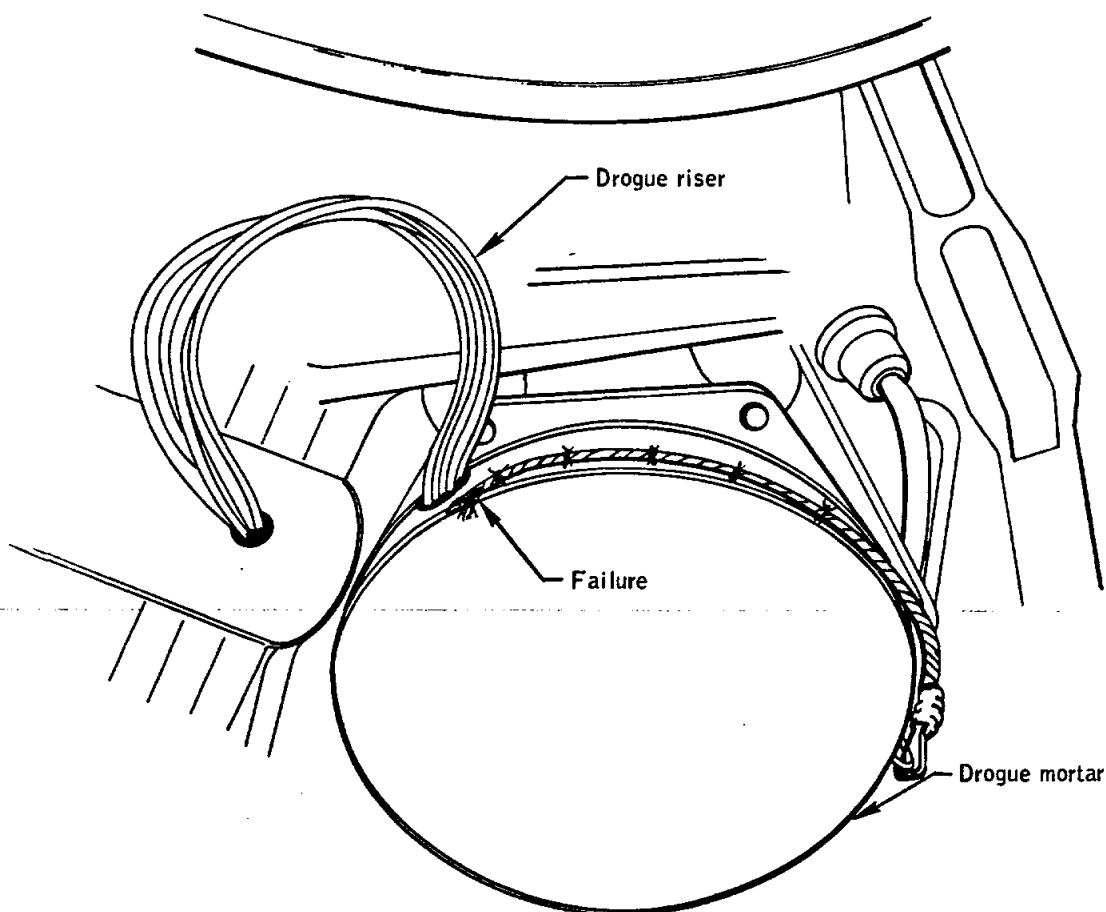
Figure 14-20.- Failed lanyard at right-hand drogue mortar.

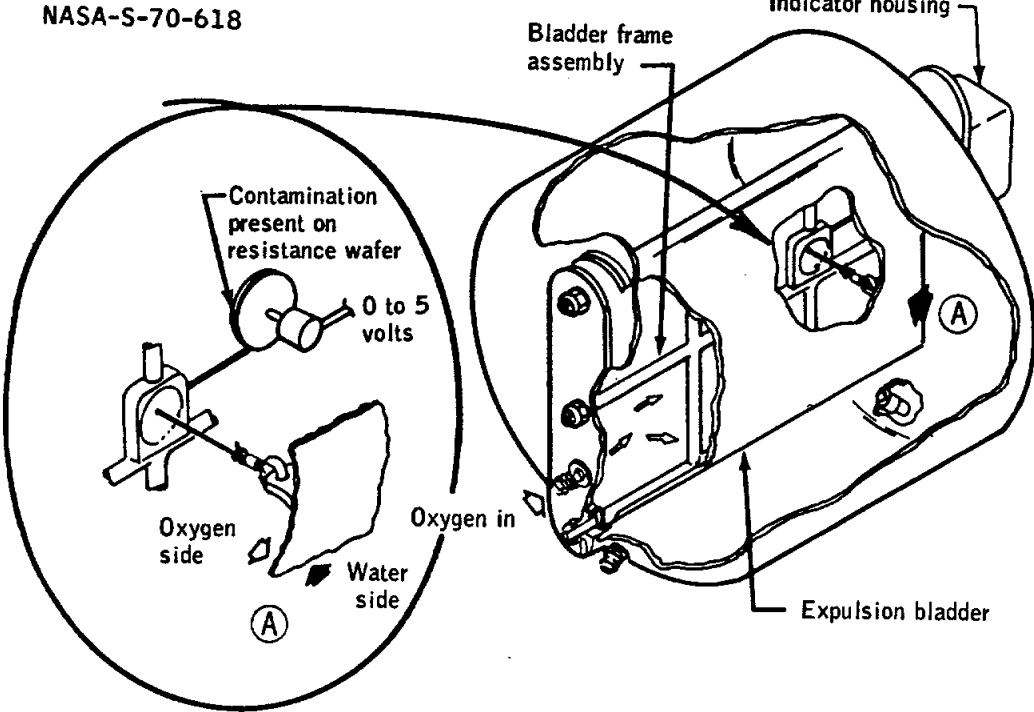
Tests of the potentiometer reproduced the output fluctuations for wiper positions equal to approximately zero quantity (zero volts) and full quantity (5 volts). The potentiometer was disassembled and appeared clean and free of contamination except for a slight stain on the end surfaces of the resistance wafer (fig. 14-24) corresponding to wiper positions for the 0 and 5 volts. The film was removed with a water-moistened swab, but the quantity of contaminate was too small to be identified.

Figure 14-23.- Area of failure in erratic potable water transducer.

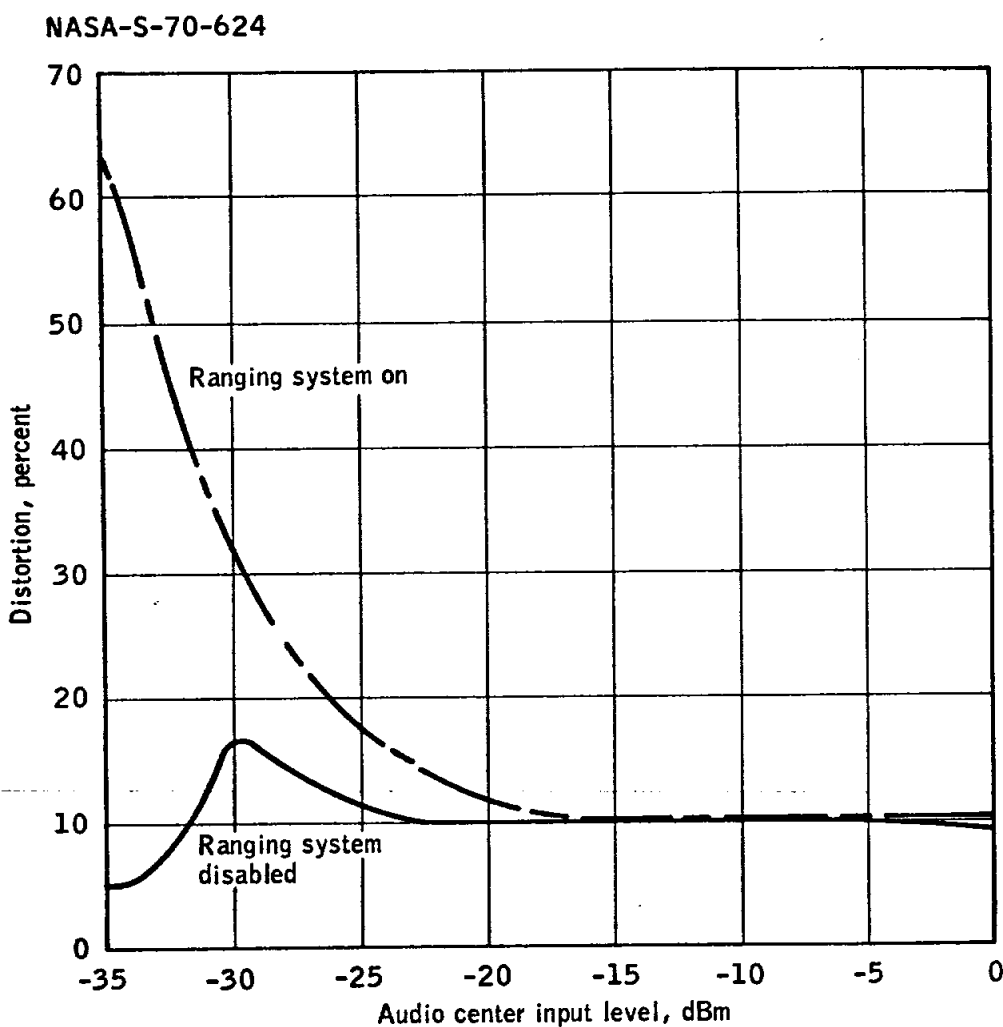
reduced level can then cause a voice-operated dropout of the voice operated transmitter. Such dropout did not occur at this time, because the Command Module Pilot was using the push-to-talk mode. Figure 14-29 shows the percent distortion of the lunar module received signal versus the command module audio center input, both with and without ranging. The curve shows that, in the ranging mode as the input level to the audio center decreases, distortion of the received signal increases significantly. This distortion cannot be directly related to intelligibility, but it does indicate that system performance is degraded by the low input levels.

Figure 14-29.- Lunar module received VHF audio distortion.

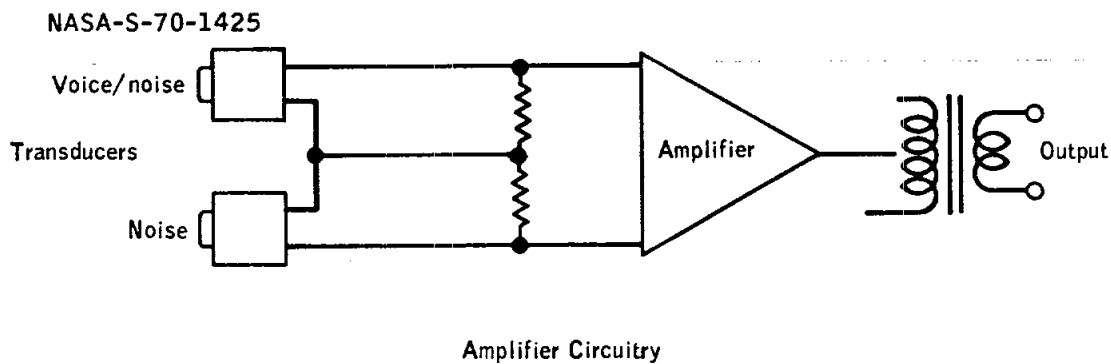
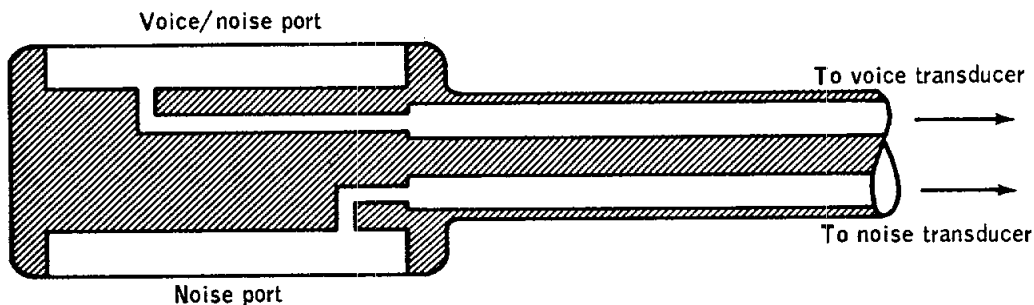
The headset microphone was designed to provide noise cancelling through mechanical spacing of the voice-capture and noise-cancelling ports (fig. 14-30). The output of the microphone amplifier is the amplified difference between the voice and noise transducer outputs. Therefore, with improper microphone placement, voice transmissions also enter the noise port, partially cancel transmissions entering the voice port, and thereby reduce the overall voice output level.

Figure 14-30.- Headset microphone voice/noise ports and amplifier circuitry.

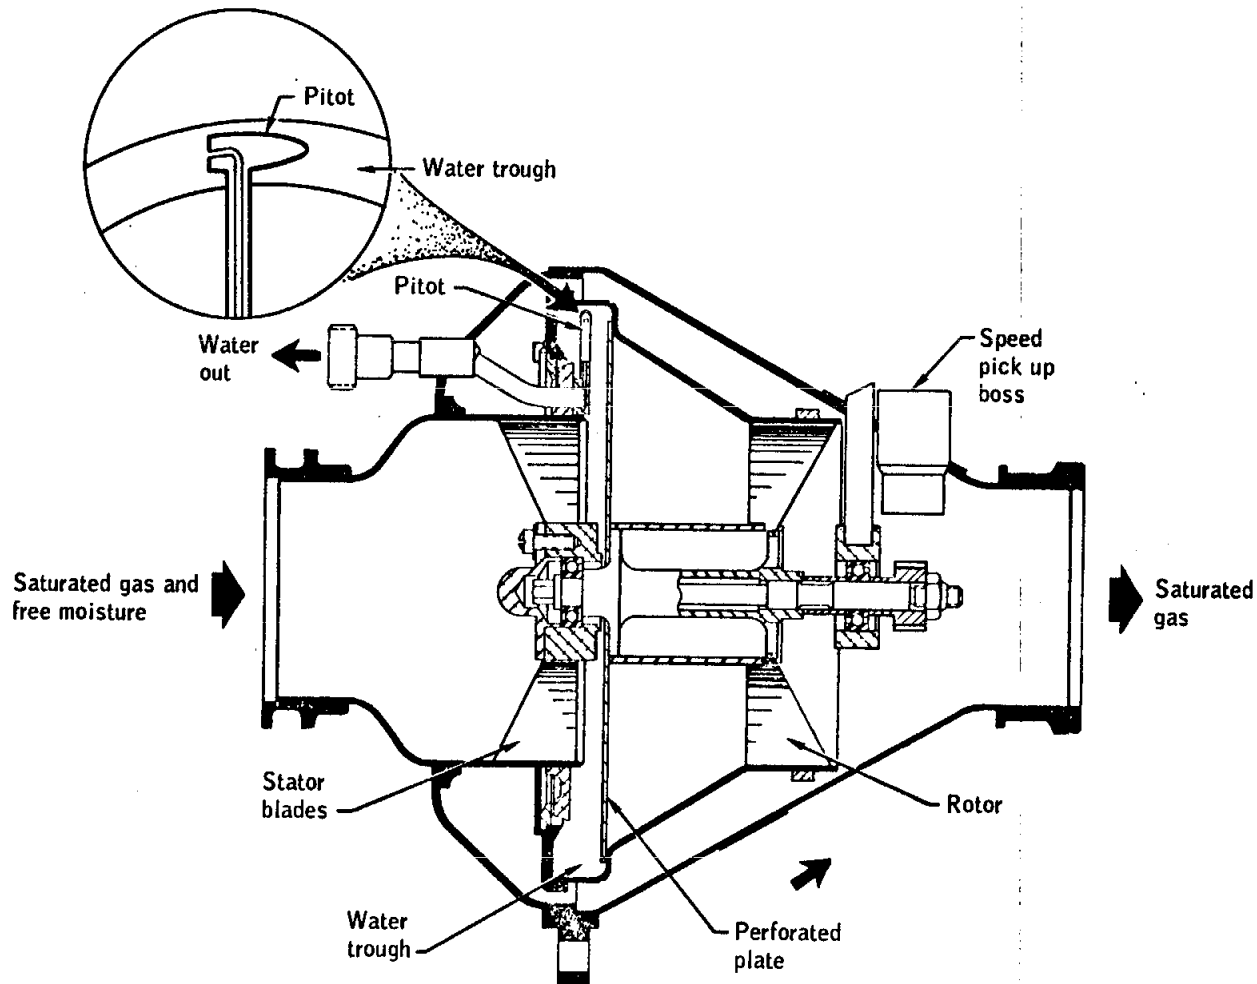
The water separator speed indication was above the upper limit (in excess of 3600 revolutions per minute) for about 50 percent of the mission. Since the water separator is a gas-driven centrifugal pump, this high speed indicates a higher than normal gas flow through the separator. Tests have shown that, at separator speeds in excess of 3700 revolutions per minute, water splashing occurs at the pitot tube (fig. 14-31) allowing water to bypass the separator.

Figure 14-31.- Water separator and pitot configuration.

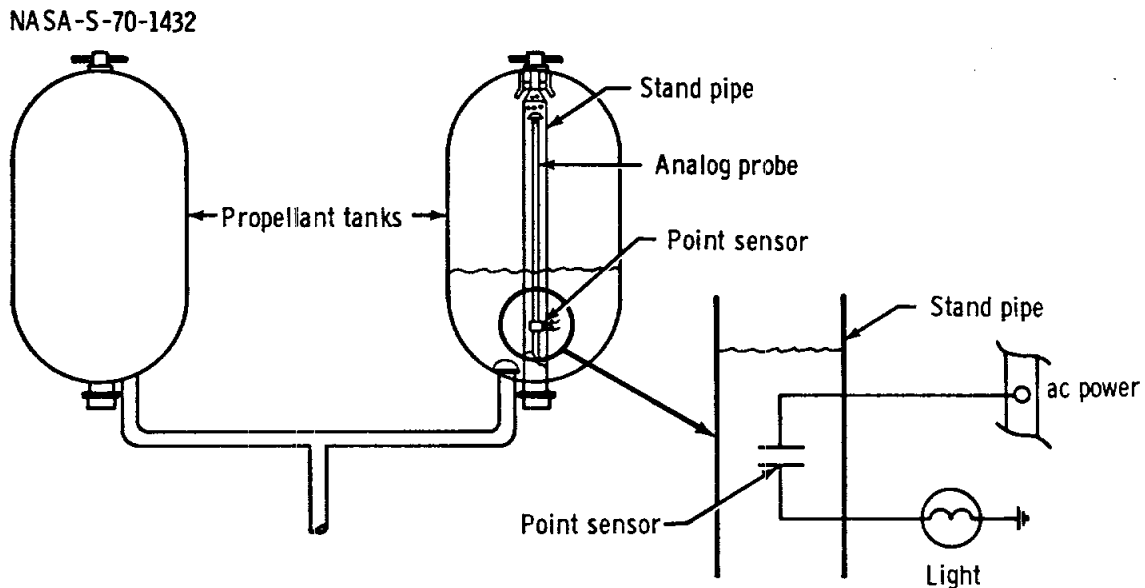
The low-level light for descent propulsion propellant quantities illuminated about 25 seconds early. The low-level light is activated and remains latched on when any one of the four low-level point sensors (one in each propellant tank) is uncovered (fig. 14-37).

Figure 14-37. - Descent propellant tank low-level sensor schematic.
