APOLLO 10 MISSION REPORT

MANNED SPACECRAFT CENTER

AUGUST 1969

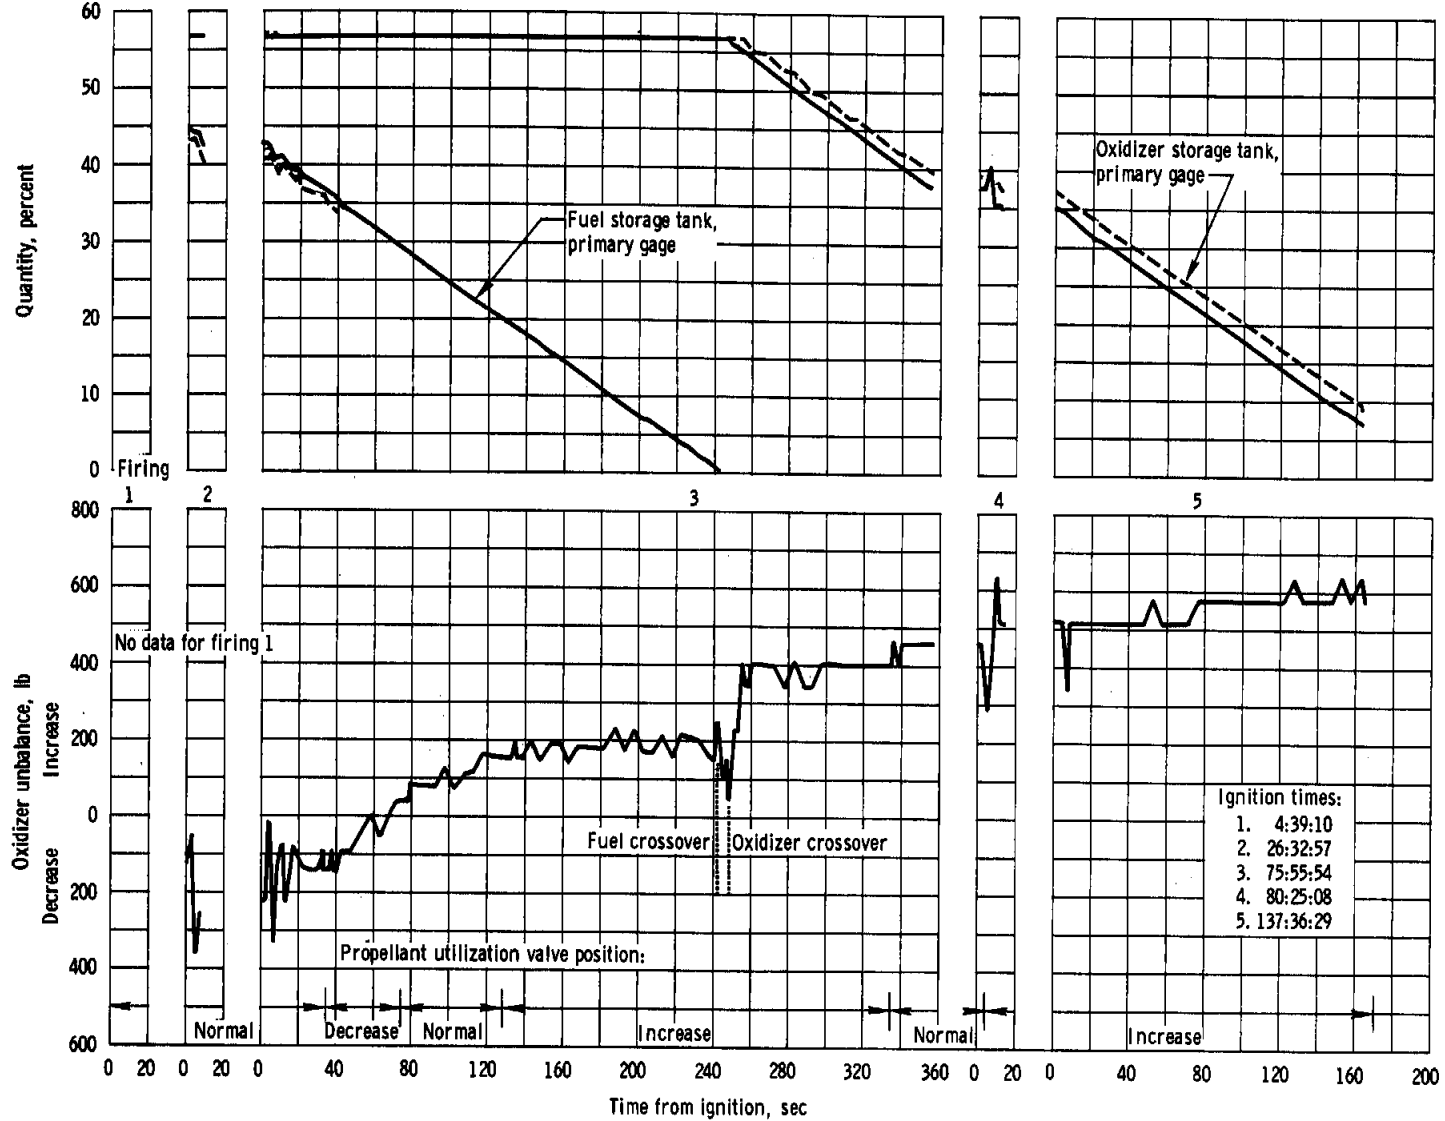
Figure 7.8-1. - Gaging system quantities and propellant unbalance.

At the end of the fifth firing, the crew reported displayed quantity readings of 9.2 percent for oxidizer and 6.7 percent for fuel, with the unbalance meter off-scale (greater than 600 pounds) on the increase side. These values indicate that the unbalance continually increased from the end of the third firing, even though the valve was in the increase position for almost the full duration of the fifth firing.

Based on the telemetered gaging data and predicted effects of the propellant utilization valve positions, mixture ratios of about 1.52 for the normal valve position were derived, compared with an expected ratio of 1.58. The expected ratio was lower than for most engines to account for results from the actual engine acceptance test. Nonetheless, the flight mixture ratio was approximately 4-percent lower than the expected value at the normal position of the propellant utilization valve. The reason for the downward shift in mixture ratio is unexplained, but an analysis for the engine to be used on the next flight shows more than adequate margin with a shift of this magnitude. However, the propellant utilization valve operated normally and provided the expected mixture ratio changes as indicated by the changes in oxygen interface pressure and verified by computer simulations.
