MSC-07230

APOLLO 16 MISSION REPORT

MANNED SPACECRAFT CENTER

AUGUST 1972

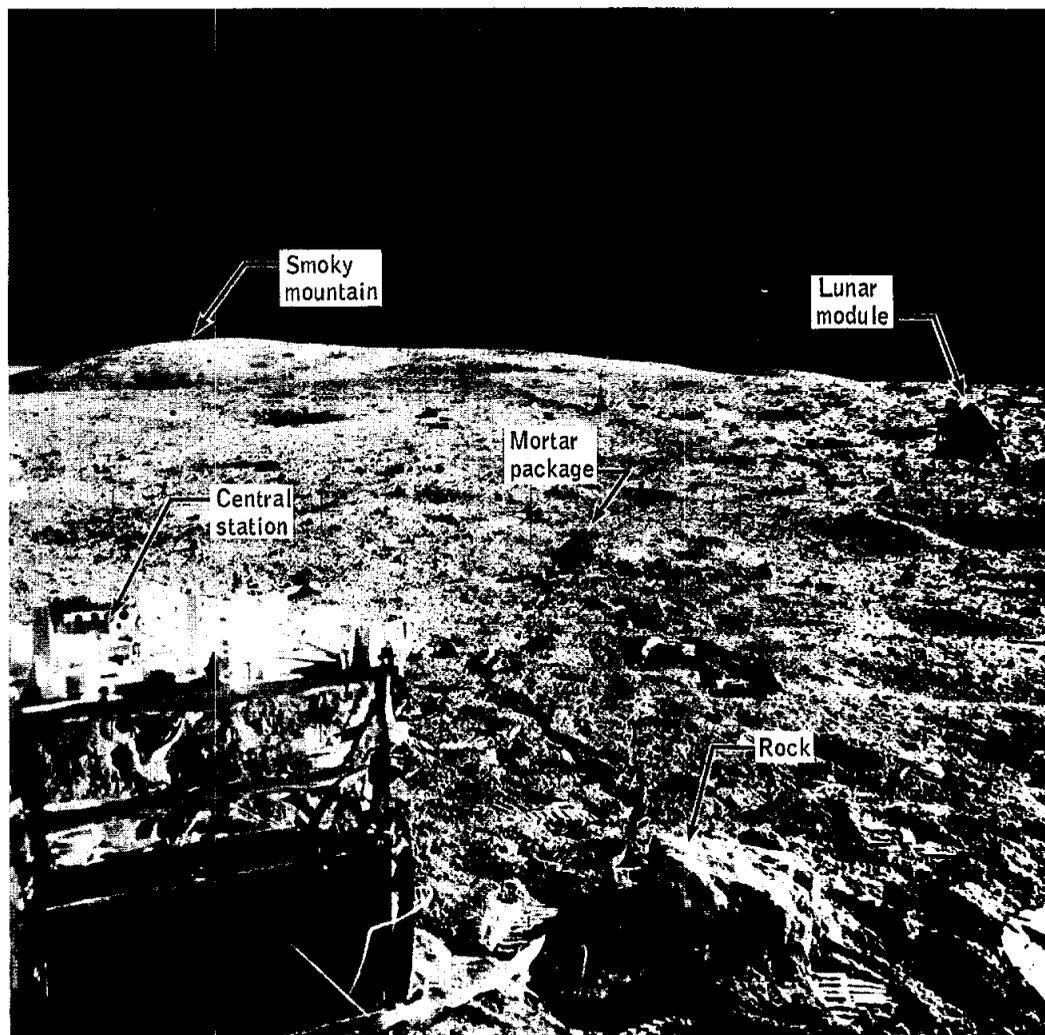
Figure 4-4.- Apollo lunar surface experiments package central station

The site selected for emplacement of the Apollo lunar surface experiments package was approximately 95 meters southwest of the lunar module. As shown in figure 4-4, the deployment site is highly cratered and rock strewn but this was unavoidable because this is the general character of the terrain. While the Lunar Module Pilot was carrying the experiments package to the deployment site, subpackage 2 fell off the carry bar. The subpackage became detached because the latch pin had not locked. Lunar dirt in the subpackage socket had prevented the flanged end of the carry

bar from sliding all the way into place so that the pin could lock. As a result, the package was free to rotate and vertical oscillations caused the detachment. The Lunar Module Pilot knocked the dirt out of the socket and re-attached the package. Dropping of the package caused no operational degradation.

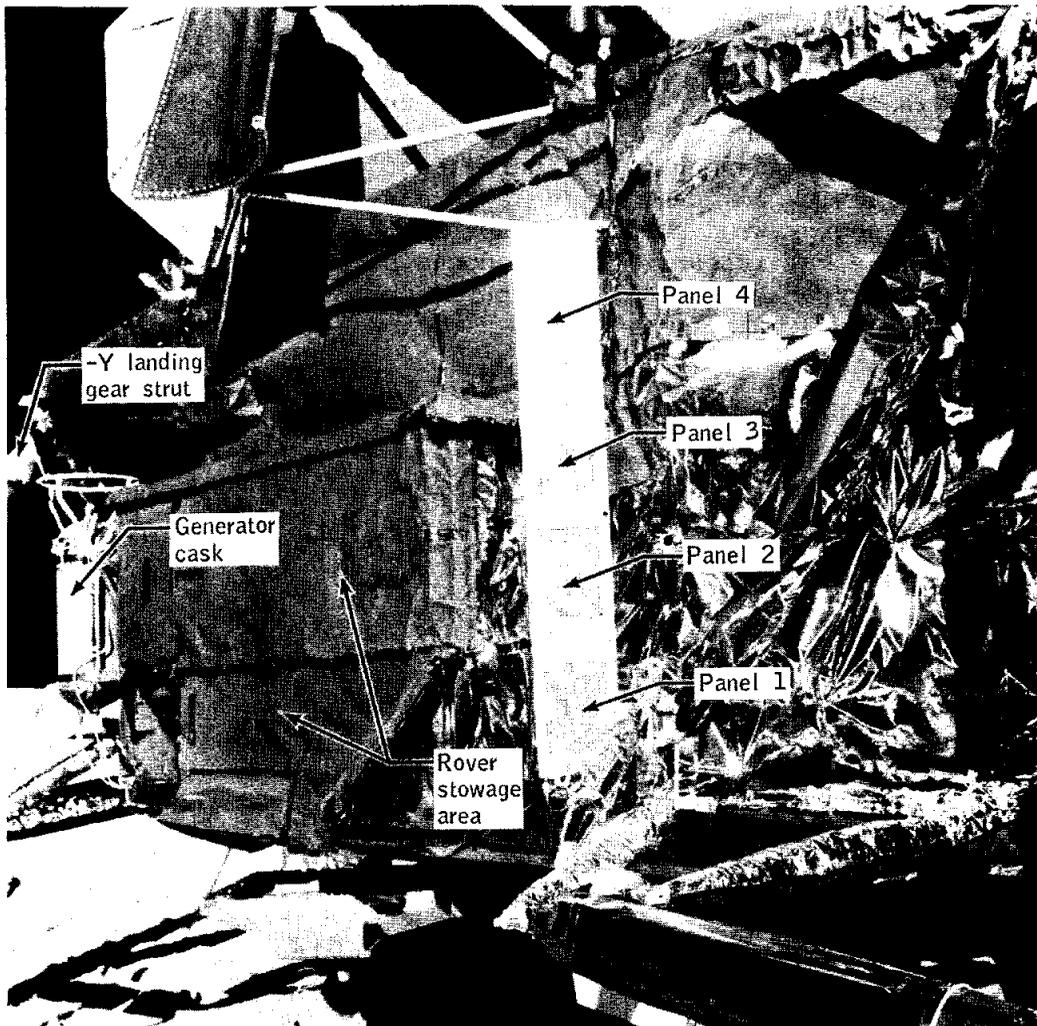
Figure 4-11.- Cosmic ray detector experiment.

The panel array of the cosmic ray detector experiment (S-152) was exposed in its initial configuration upon jettisoning of the spacecraft-launch vehicle adapter panels. The hidden surface of panel 4 was partly exposed by the Commander early in the first extravehicular activity (fig. 4-11). The planned area of exposure for detecting particles at the lunar surface could not be obtained because the experiment mechanism jammed as described in section 14.4.4. The detector panel array was retrieved at

the end of the third extravehicular activity, folded in the proper configuration for transearth coast data collection, and returned for analysis. It was difficult to separate the panel assembly from the main frame at the end of the third extravehicular activity because of thermal expansion of the Teflon slides.

The plastic in all panels of the experiment was degraded by heating above the design limit of 54°C , at which temperature degradation begins. The high temperature was most likely caused by a film accumulating on the thermal control surface, in addition to lunar dust. Analysis of the film has not been completed.

As a result of the incomplete exposure of panel 4, the portion of the experiment designed to measure neutron flux was degraded, as were those designed to measure solar wind gas, and search for radon (Rn^{222}) and argon (Ar^{40}).

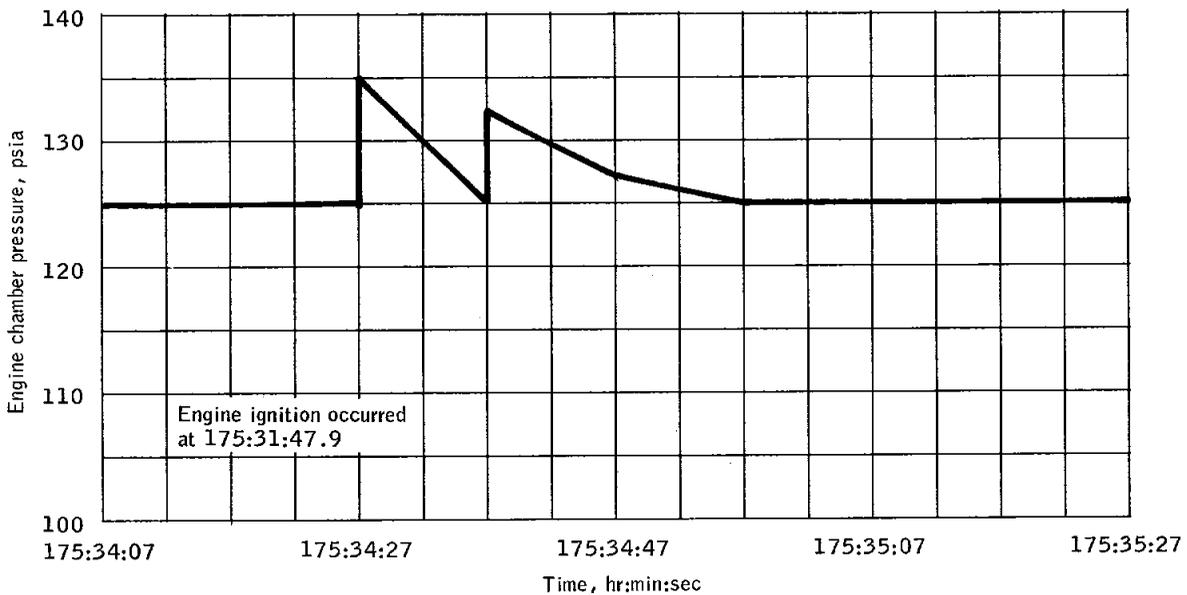
Figure 7-3.- Ascent propulsion system pressure fluctuations.

Two upward shifts in the engine chamber pressure were recorded during the ascent maneuver, as shown in figure 7-3. A review of all other available engine and acceleration data failed to substantiate the increased chamber pressure indication. The crew did not recall feeling additional acceleration or surges during the maneuver. This anomaly is discussed further in section 14.2.8.

Approximately 157 seconds into the lunar orbit insertion firing, the telemetry indication of the ascent propulsion engine chamber pressure reflected an abrupt 10-psi rise followed by a slow decay to its initial value in 10 seconds (fig. 7-3). The phenomenon was repeated 11 seconds after the initial pressure rise.

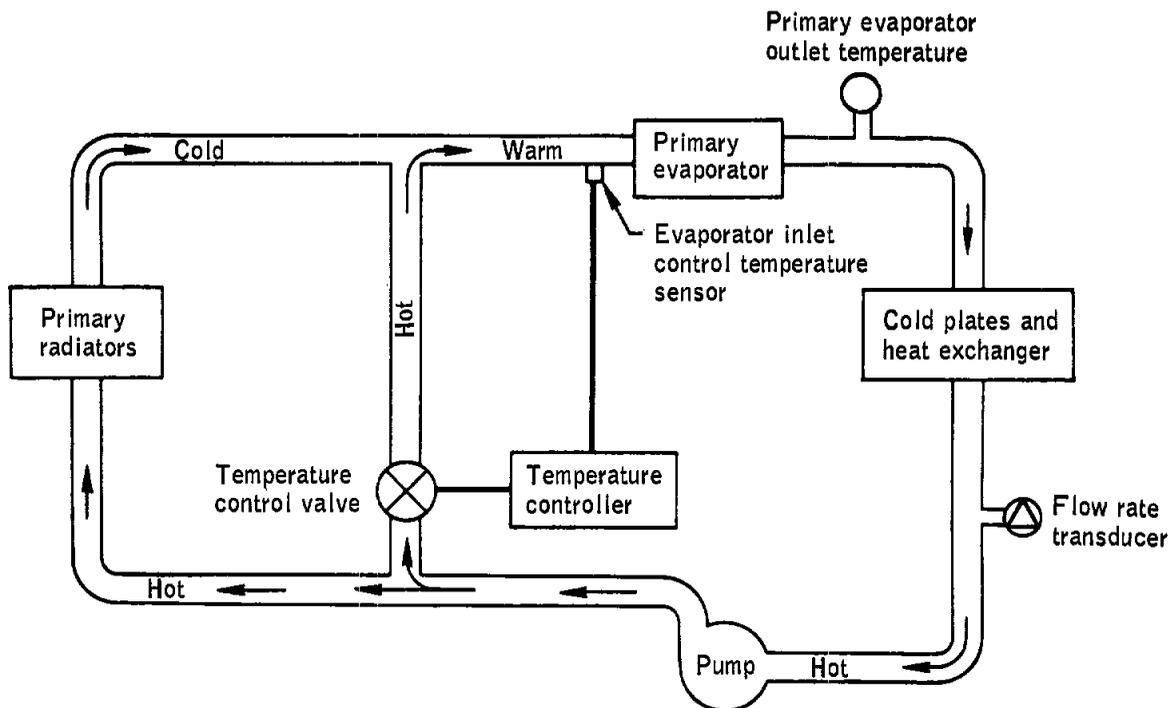
Figure 14-1.- Primary water/glycol coolant loop.

About 3 hours into the mission, the water/glycol temperature control circuit (fig. 14-1) malfunctioned in the automatic mode. The malfunction allowed an excessive amount of hot water/glycol to bypass the radiator causing the mixed water/glycol temperature to exceed the upper control

limit of 48° F. After remaining in this maximum bypass position for 5 minutes, the temperature control valve cycled regularly between maximum and minimum flow to the radiators for about 14 minutes before stopping again at maximum bypass. The control was changed to manual and back to automatic to restart the valve operation and, finally, left in manual at the desired valve position. Variations in the evaporator outlet temperature and total system flow rate for the period are shown in figure 14-2. Control valve operation is evident from the variation of system flow rate. Total flow rate increases as the flow control valve opens since the total system pressure drop decreases.

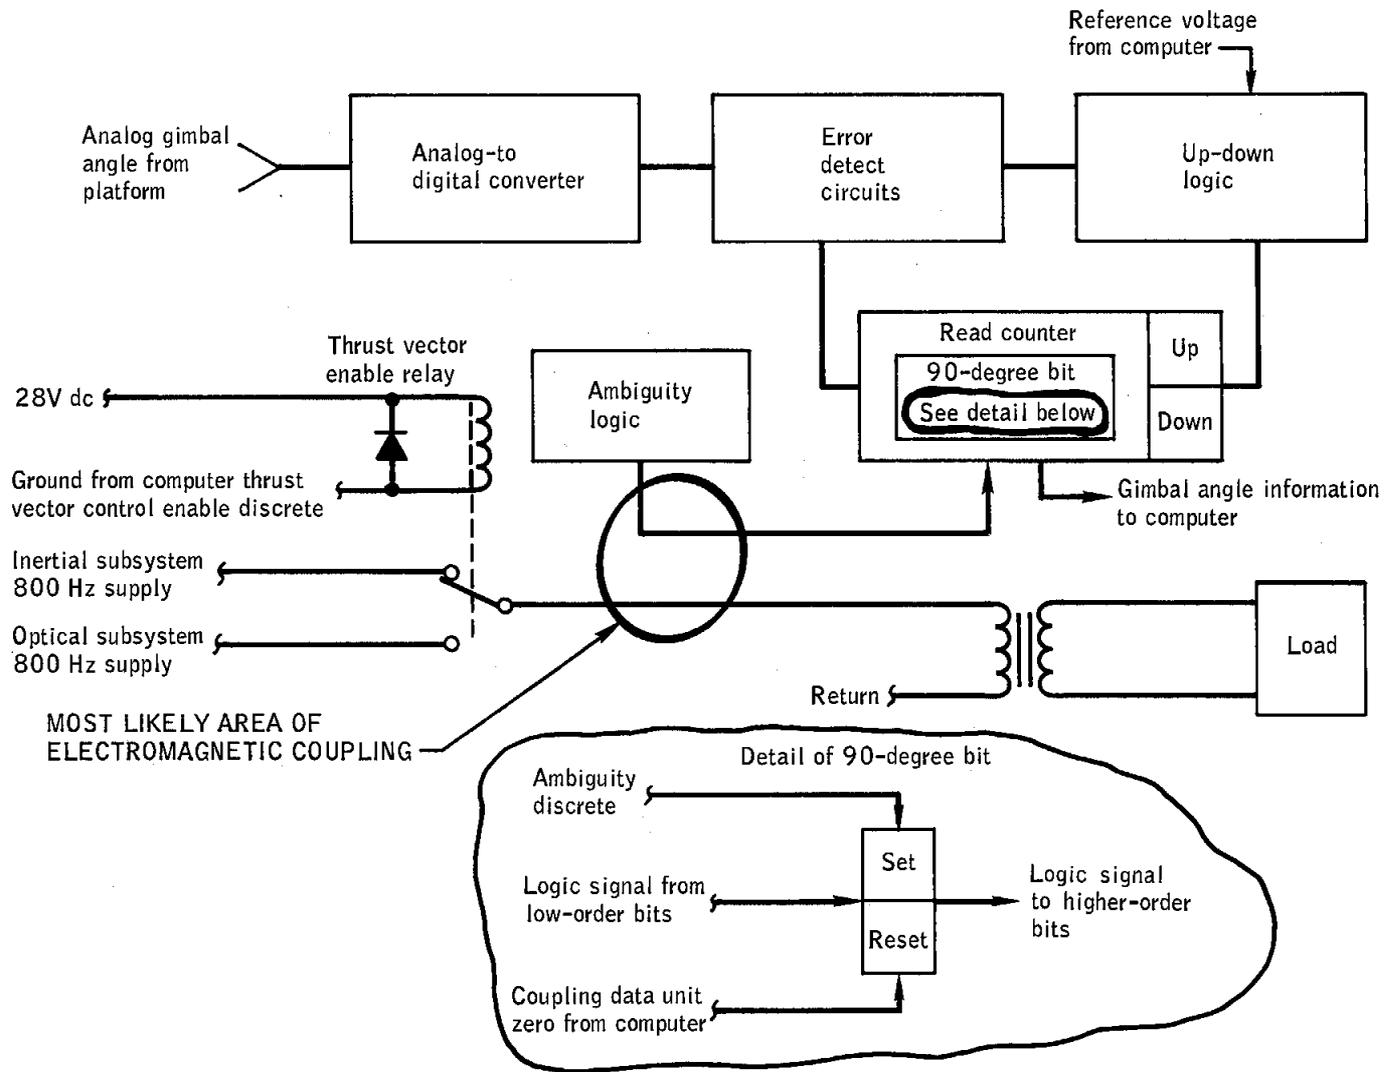
Figure 14-4.- Coupling data unit functional diagram.

Figure 14-4 is a simplified representation of the pertinent circuits in the middle gimbal angle coupling data unit. The purpose of the read counter is to store, in digital form, the platform gimbal angle. If the gimbal angle changes, the analog signal is no longer the same as the digital signal from the read counter and the resulting error signal causes a pulse train to be generated. The pulse train increments or decrements the read counter until it matches the analog gimbal angle. The read counter is a series of flip-flop logic circuits whose only inputs are a pulse train and timing pulses. The 90-degree bit is unique, however, because it can also be set by an ambiguity discrete. The purpose of the ambiguity discrete is to prevent the platform from going to an ambiguous position when the inertial measurement unit is turned on.

The cause of the problem is contact bounce in the thrust vector enable relay (fig. 14-4). The relay switches between two 800-hertz excitation-voltage power sources which are applied to a transformer in the digital-to-analog converter portion of the coupling data unit. A relay without a coil spike suppression diode will transfer between contacts in about 0.5 millisecond with the transients caused by the power interruption and collapsing field of the transformer inconsequential. The addition of the suppression diode across the relay increases the dropout contact transfer time to about 6 milliseconds.

In either condition if the relay contact initially closes the circuit to the transformer (fig. 14-4) at the beginning of either half cycle of the 800-hertz wave form, the current taken by the transformer during the first 3/4 cycle of the 800-hertz excitation voltage will reach 4 to 5 times the steady-state level. If this higher-than-normal current is interrupted by the relay contact reopening, the transformer will feed back a voltage transient as high as 250 volts on the line to the relay. Both of these problems result in circuit-interruption (bounce) durations that would cause high voltage spikes; however, the bounce must occur, as stated previously, at the right time in the 800-hertz waveform.

To prevent caging the platform if the erroneous gimbal lock indication recurred, the crew used an erasable program whenever the thrust vector enable relay was used. This program inhibited the computer from changing the coarse align relay.

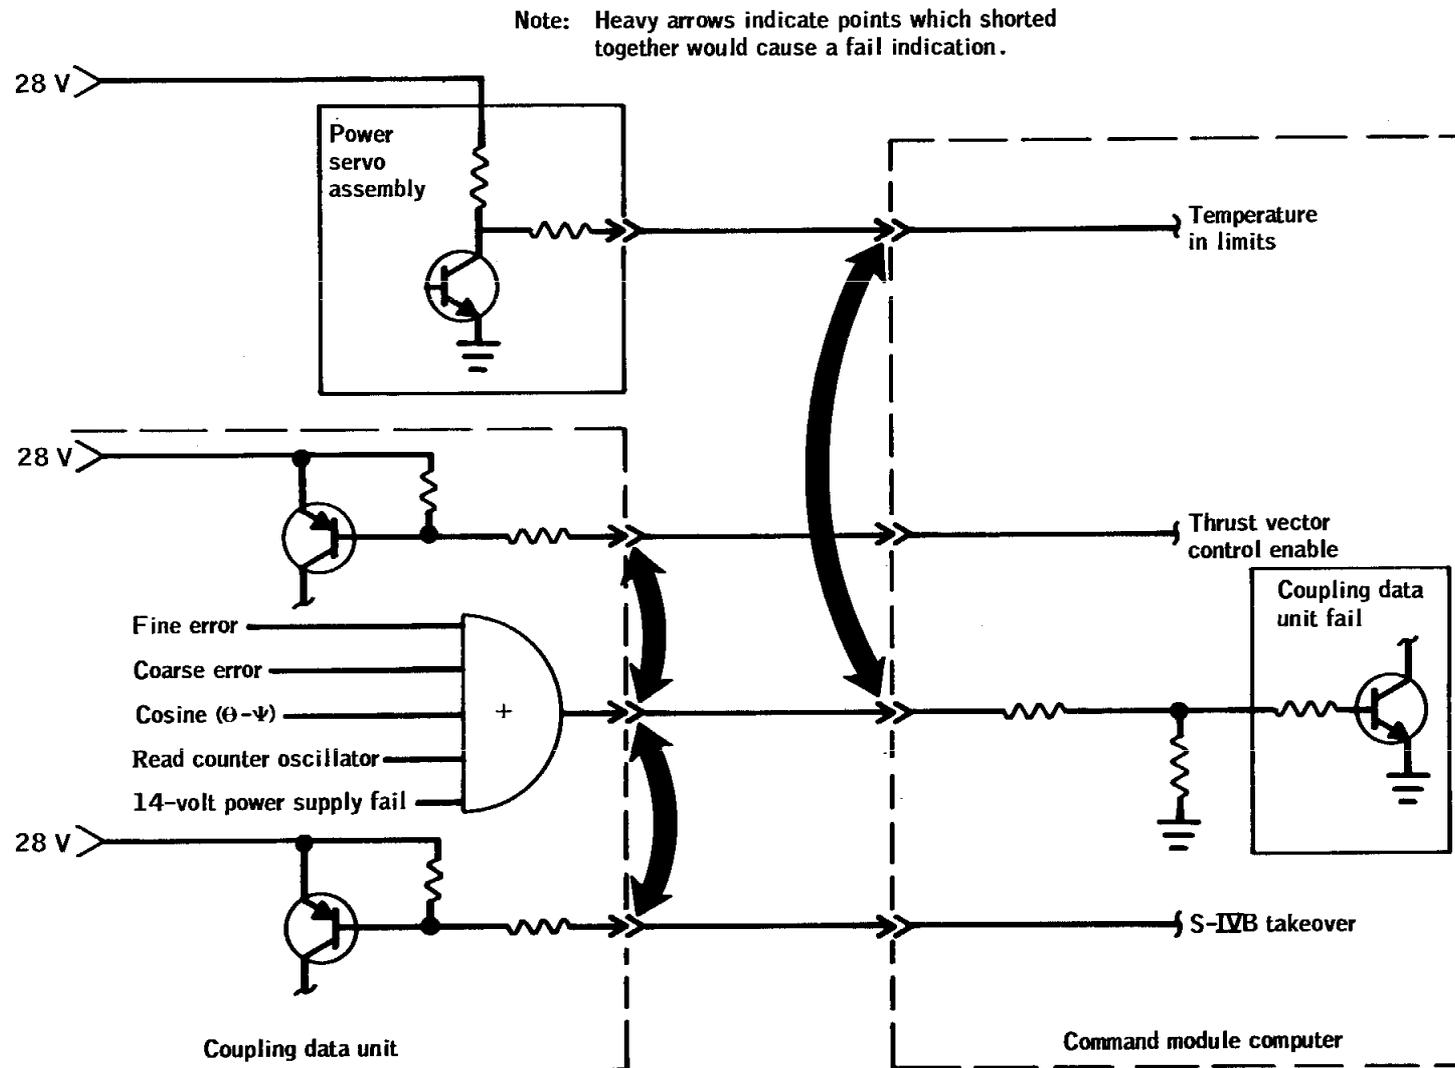
Figure 14-5.- Coupling data unit fail indication.

Data during each occurrence has been reviewed and no abnormalities were observed. If a real failure of the coupling data unit had occurred and lasted as long as 894 seconds, then some data indication should have been observed. For this reason, an intermittent short in the wiring harness or associated connectors shown in figure 14-5 is indicated. However, other possible causes may be an intermittent in the failure detection logic circuits or the input logic to the computer.

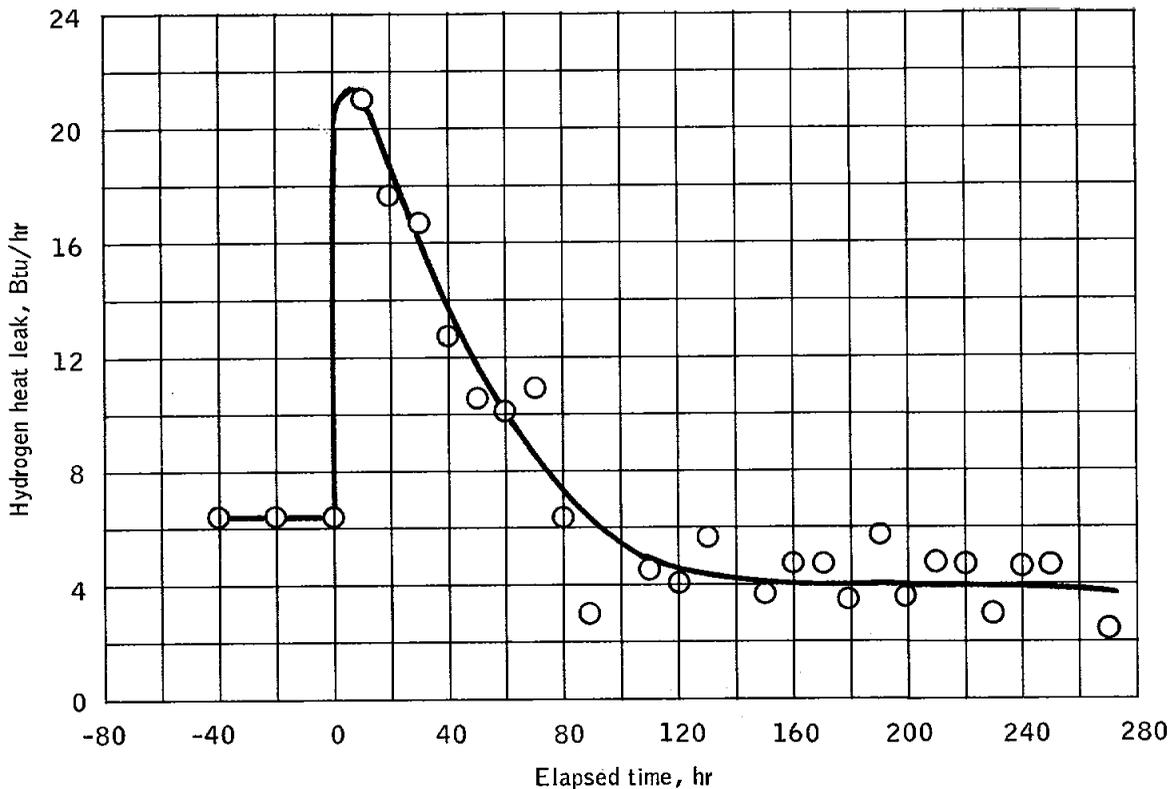
Figure 14-6.- Hydrogen tank heat leak data.

The heat leak into cryogenic hydrogen tank 3 was abnormal during the early hours of the mission. Analysis of the Kennedy Space Center data has shown that the heat leak of this tank was normal prior to lift-off. As shown in figure 14-6, the leak decreased from a high value of 15 to 20 Btu/hour to a normal 2 to 6 Btu/hour by 70 hours and remained normal thereafter. All other parameters were normal.

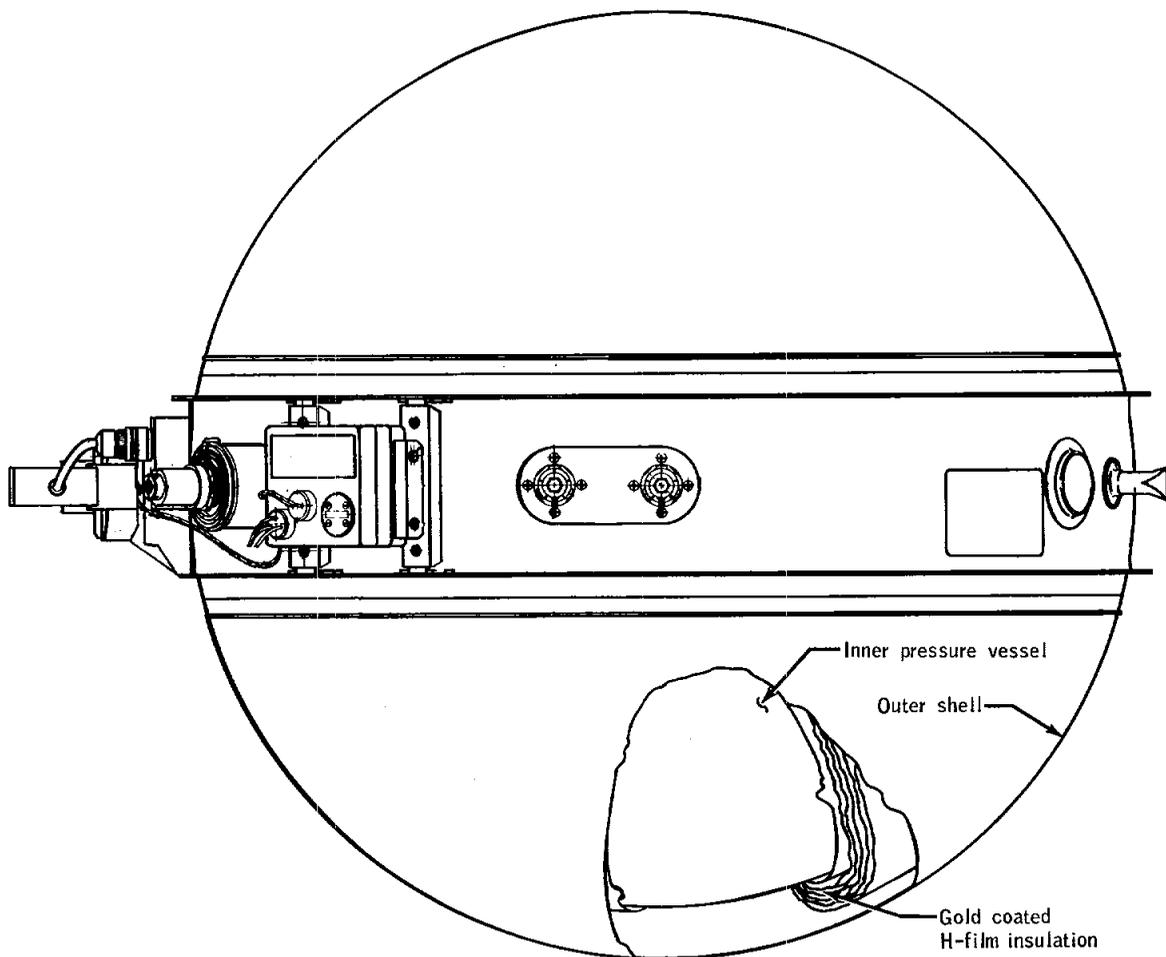
Figure 14-7.- Hydrogen tank.

The insulation for this tank consists of several layers of gold-coated H-film in a vacuum annulus that is formed between the inner pressure vessel and the outer shell (fig. 14-7). The primary insulation system is, however, the vacuum annulus. Degradation of this insulating vacuum will cause a significant increase in the heat leak into the tank as shown in figure 14-8. The analysis indicates that the high initial heat leak resulted from a degradation of this vacuum by approximately one decade (approximately 10^{-6} to 10^{-5} torr). This degradation could have been caused by any of three conditions.

- a. If thermal insulation layers rubbed together during the launch phase vibration, the condition could have caused the release of previously entrapped or absorbed gas molecules into the annulus (hereafter referred to as "insulation scrubbing").
- b. A hydrogen leak from the pressure vessel into the annulus.
- c. An ambient air leak into the annulus during launch.

Condition a.- Insulation scrubbing has been analytically ruled out as a possible cause of the high heat leak. A non-condensable gas such as hydrogen or helium would have produced a constant heat leak since cryopumping would not occur at the observed temperatures. If the gas were condensable, cryopumping would rapidly decrease the pressure at the pressure vessel, preventing the observed heat leak. Nitrogen or oxygen, if originally cryopumped, would have sublimed later in the flight, causing the heat leak to increase to a high level (e.g., 100 Btu/hr at 185 hours), which was not observed.

Condition b.- Hydrogen leak was also eliminated as a possible cause since the leak would have continued throughout the flight and would also have produced a much higher heat leak than was observed.

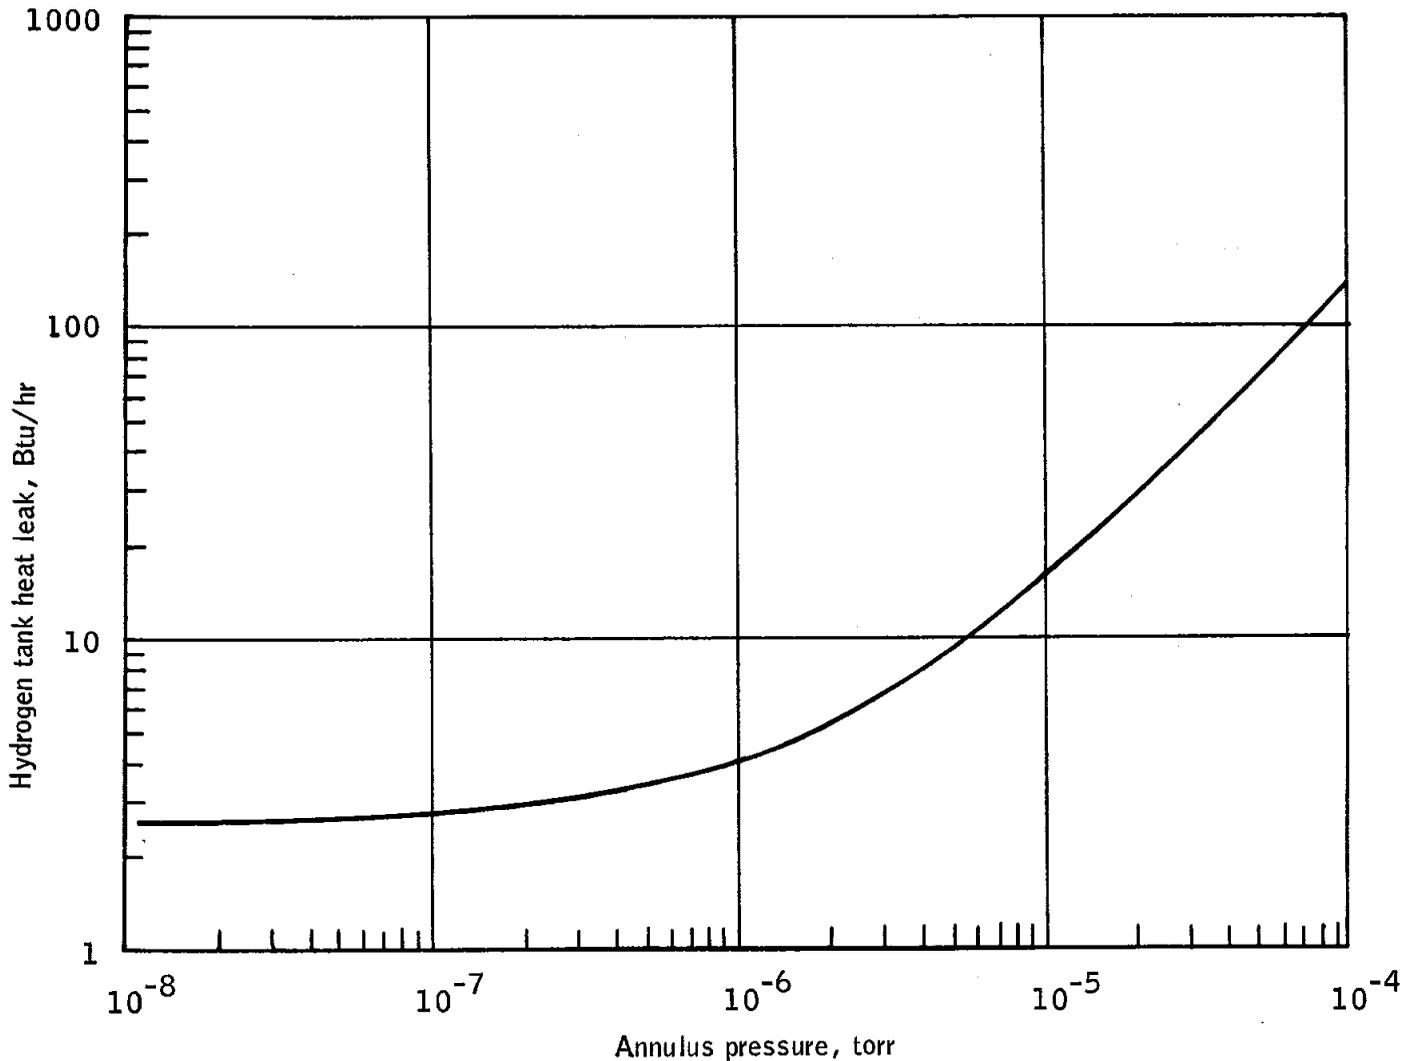
Figure 14-8.- Hydrogen tank heat leak as a function of annulus pressure.

Condition c.- An ambient air leak is the most probable cause of the high heat leak. Figure 14-8 shows that a pressure of 5×10^{-5} torr in the annulus would produce a heat leak of 21 Btu/hr, which is the average observed for the first 10 hours of the flight. The heat leak returned to a normal value of 6 Btu/hr by 80 hours, which corresponds to approximately 2×10^{-6} torr. Assuming that a small hole opened in the outer shell during the launch phase, the annulus pressure would quickly build up to that required to produce the observed heat leak. As the bay pressure continued to decrease and fall below that in the annulus, the annulus pressure would follow the decrease slowly and drop to a final value sufficient to provide the normal heat leak observed by 80 hours. Analysis shows that the area of the opening was at least 2.2×10^{-3} sq cm. For an opening of this size, iterative analysis places the formation of the crack or hole at approximately 2 1/2 minutes into the flight to produce the observed conditions.

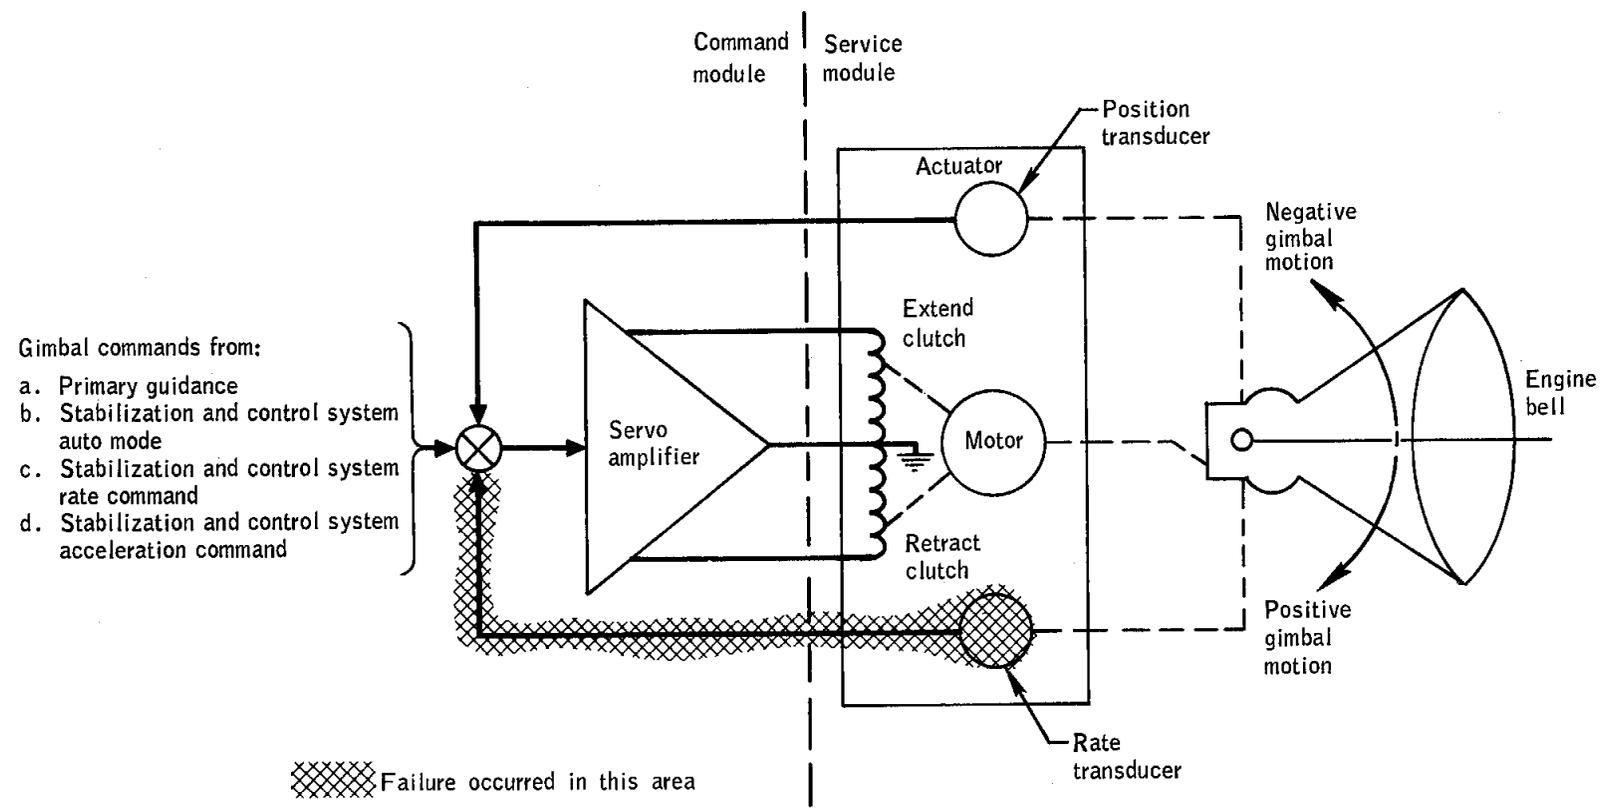
Figure 14-10.- Service propulsion system gimbal servo diagram.

During the pre-ignition checklist for the lunar orbit circularization maneuver, an oscillation was detected in the yaw axis of the secondary servo system for the service propulsion engine gimbal actuator. Figure 14-10 is a functional diagram of the servo loop. The oscillation was present in all modes of operation, but only when the secondary yaw servo loop was used. The oscillation was limited at ± 1.0 degree and at 2.4 hertz with the gimbal correctly following commands to different positions. Figure 14-11 shows one occasion that the oscillation did not occur when repositioning the engine which implies that the failure is electrical in nature.

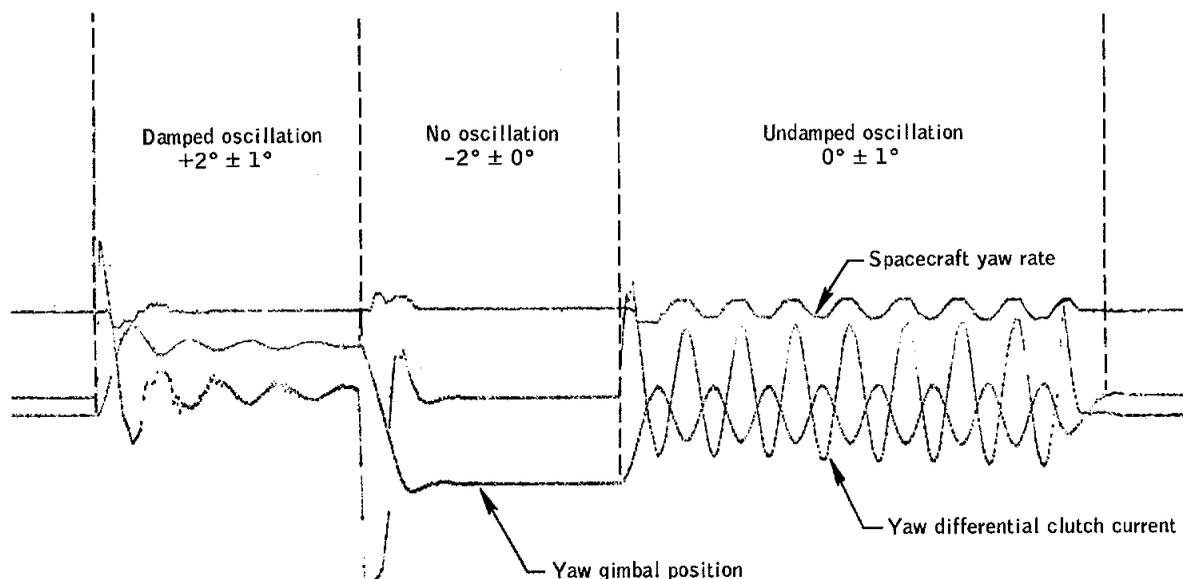
Figure 14-11.- Secondary yaw gimbal drive test
(primary guidance control).

Inflight results were matched by simulations of system performance with an open in the rate feedback loop of the yaw servo system. It was also demonstrated that the oscillations would have damped after ignition because of the side load forces exerted on the engine bell while thrusting. Therefore, the secondary yaw servo system was considered safe to use if the primary servo system were to fail and it became necessary to switch over to the secondary system.

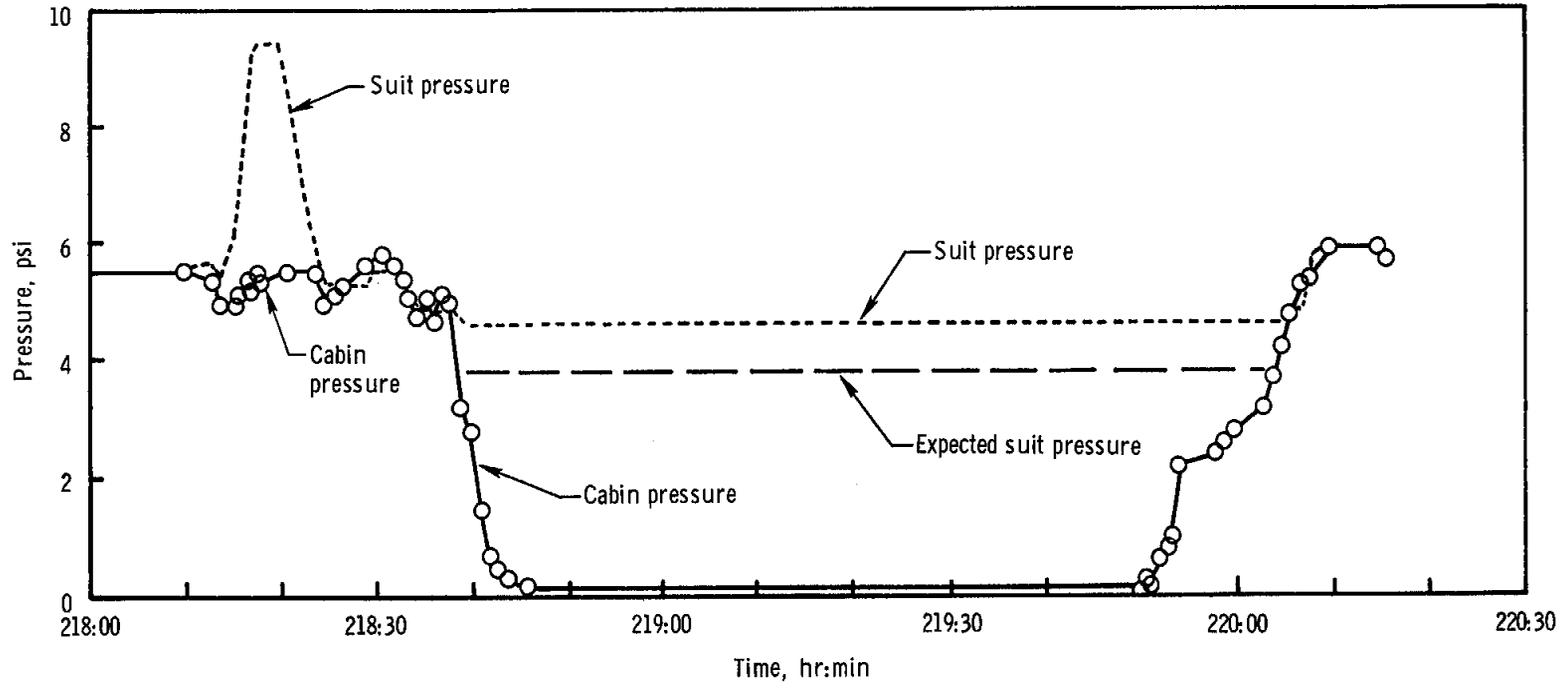
Figure 14-13.- Suit loop pressure data.

Prior to the reduced cabin pressure operations, the suit transducer performed acceptably and read within 0.1 psi of the cabin pressure transducer with the suit loop open to cabin. After cabin repressurization, the suit transducer again appeared to read correctly above 4.6 psia.

The suit pressure transducer was removed from the command module during postflight testing and a reduced-pressure test and calibration check

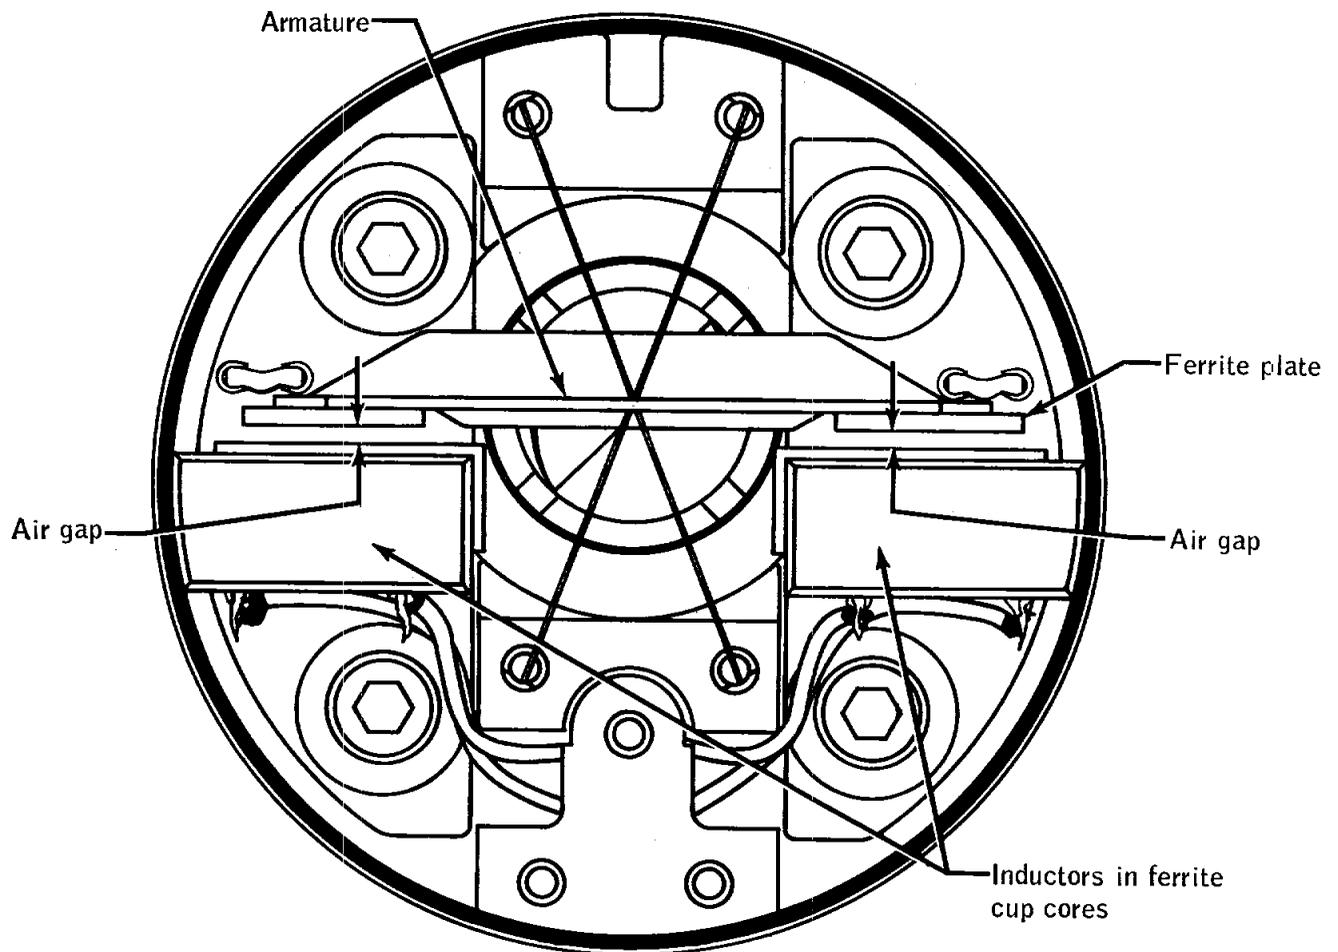
Figure 14-14.- Suit pressure transducer.

were conducted. The results were within tolerance. Teardown analysis revealed three particles of calcium aluminum silicate (lunar origin) ranging from 500 to 2000 microns in size in the sense cavity. If one of the lunar particles had been caught in the air gap (see fig. 14-14) of the variable reluctance element, the armature would transmit an incorrect signal. Normal readings were obtained when the cabin was repressurized and a suit pressure in excess of 4.6 psia was obtained. This could have freed any particle that might have been lodged in the air gap.

The corrective action for Apollo 17 and later spacecraft will be to add a 5-micron filter in the suit pressure sense line to protect the suit pressure transducer.

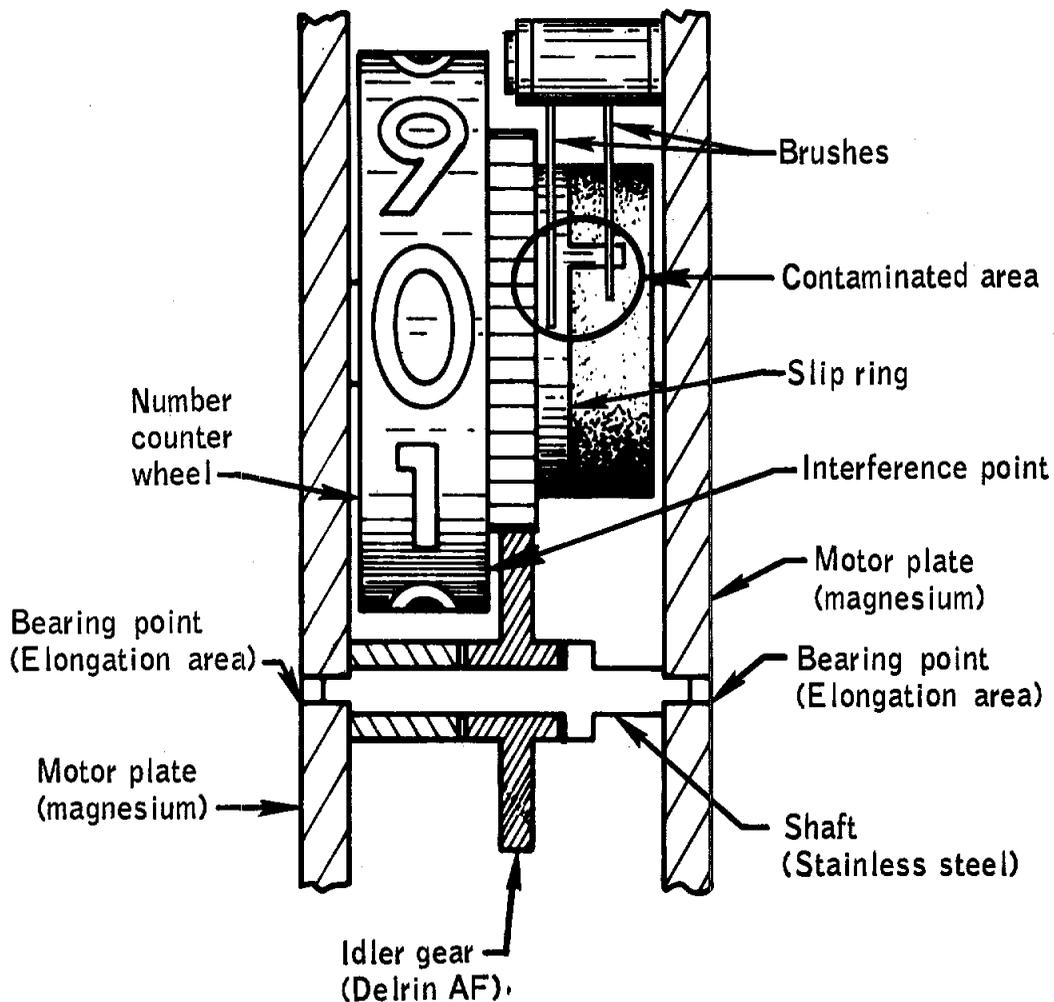
Figure 14-15.- Digital event timer seconds counter.

Inspection of the digital event timer showed that the bearing points in the magnesium motor plates had been elongated. The idler gear is free to rotate on the shaft (fig. 14-15); however, the design permits the stainless steel shaft to also rotate which would account for the wear in the motor plates. The elongated bearing points permitted the idler gear to rub against the number wheel. This interference rubbed paint off the number wheel and the paint particles prevented the slip rings and brushes from making good contact which affected proper counting of the seconds wheel.

The bearing points also elongated on the Apollo 15 digital event timer. The idler gear shaft can be prevented from rotating by staking at the bearing point in the motor plates. For Skylab, corrective action will be to secure the shafts of digital event timers, that require opening of the case for other rework. For Apollo 17, the units will be visually inspected for signs of wear.

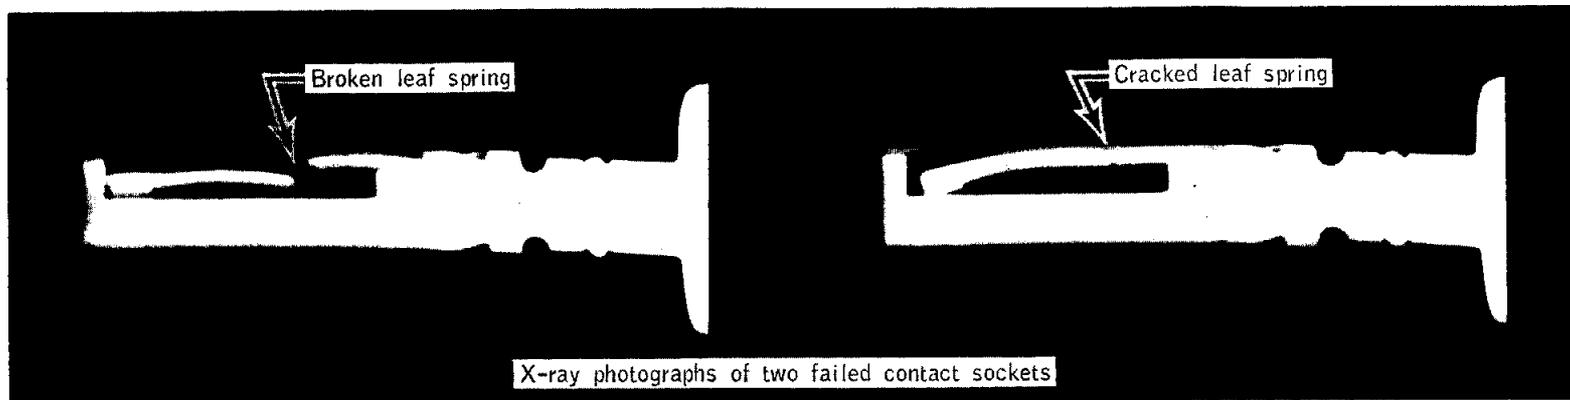
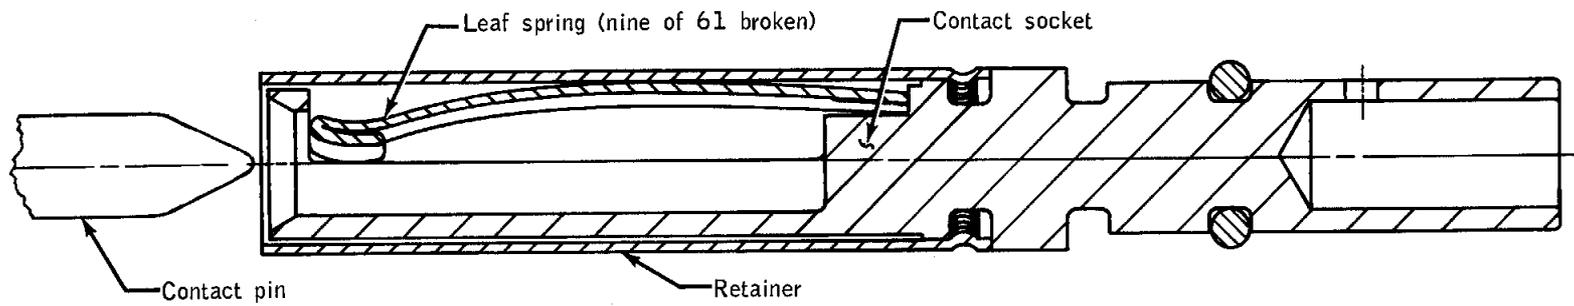
Figure 14-16.- Contact and leaf spring arrangement of optical unit connector.

The optical unit assembly was thoroughly soaked during recovery by salt water which caused extensive corrosion. The unit was cleaned, however, and tested. The intermittent flight condition was reproduced by wiggling the scanning telescope wiring harness in the optical unit assembly. An examination of the female connector on this harness revealed 9 of 61 contact springs (fig. 14-16) were cracked or broken. Also, several contact springs were found broken in a 91-pin connector in the optical unit assembly. The cause of the broken springs is being investigated.

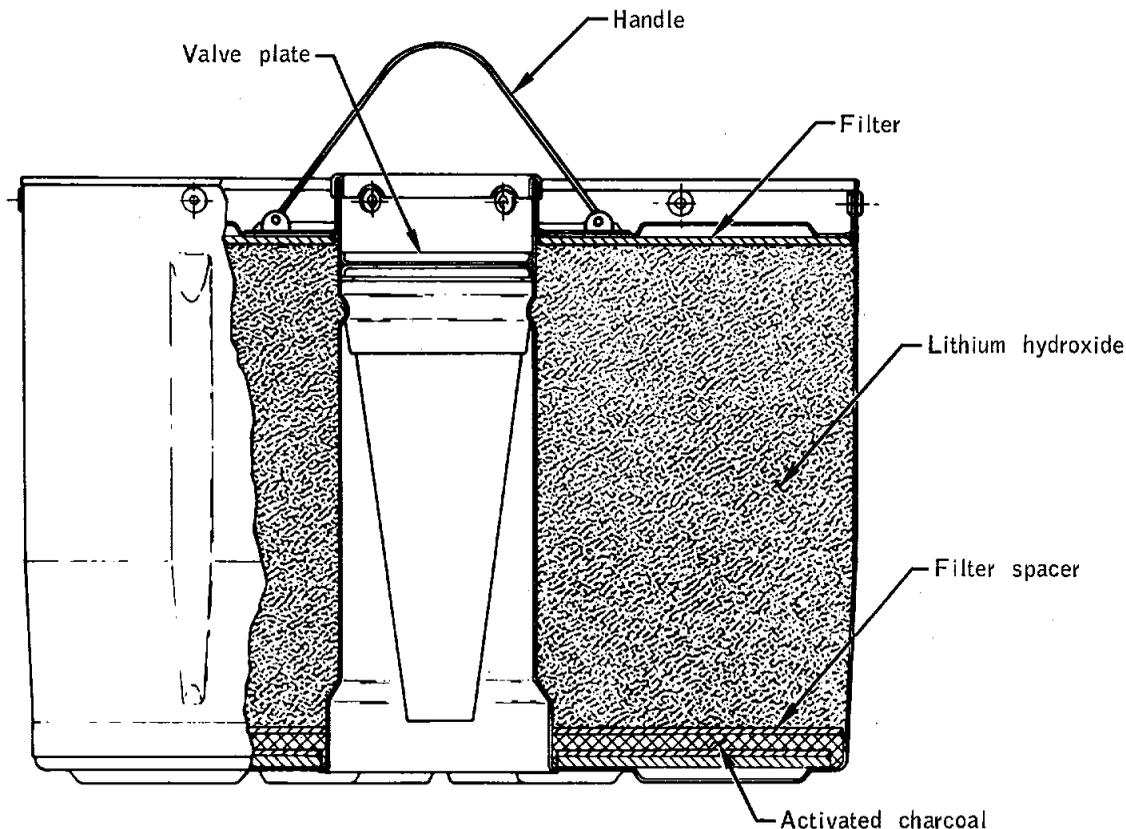
Figure 14-17.- Lithium hydroxide canister.

Although canister 10 was jettisoned with the lunar module, canister 12 was returned for inspection and analysis. Figure 14-17 shows a cross-section of the lithium hydroxide canister. The lithium hydroxide swells while it is being used, and to account for this swelling, the units are fit checked in the spacecraft with 0.030-inch shims on all sides. Additionally, the pull force required to remove the canister is checked with the shims in place. An analysis performed on five separate layers of the chemical bed indicated that approximately 32 percent of the lithium hydroxide had been used. In addition, the analysis showed the moisture content to be approximately 21 percent compared to a range of 5 to 10 percent found in canisters used during the solo period on previous flights.

A dimensional analysis showed both sides of the environmental control unit canister receptacle to be within specification, although postflight removal forces using the canisters indicated a tighter fit in side B (53-lb pull) than side A (22-lb pull). The preflight pull force for this canister was 18 pounds. Normally, pull forces for these canisters are 10 pounds or less.

The combination of the adverse environment and the initially tighter-fitting canister apparently accounted for the removal difficulty.

To prevent recurrence of this problem during the Apollo 17 mission, the prelaunch insertion and removal force specification during fit checks at the Kennedy Space Center will be changed from 30 pounds to 8 pounds for the canisters to be used during the solo activities. The maximum allowable force on the remaining canisters will be reduced to 15 pounds. In addition, flight procedures will be changed to insure that the suit flow control valves are positioned to cabin flow for solo operation.
