MSC-07230

APOLLO 16 MISSION REPORT

MANNED SPACECRAFT CENTER

AUGUST 1972

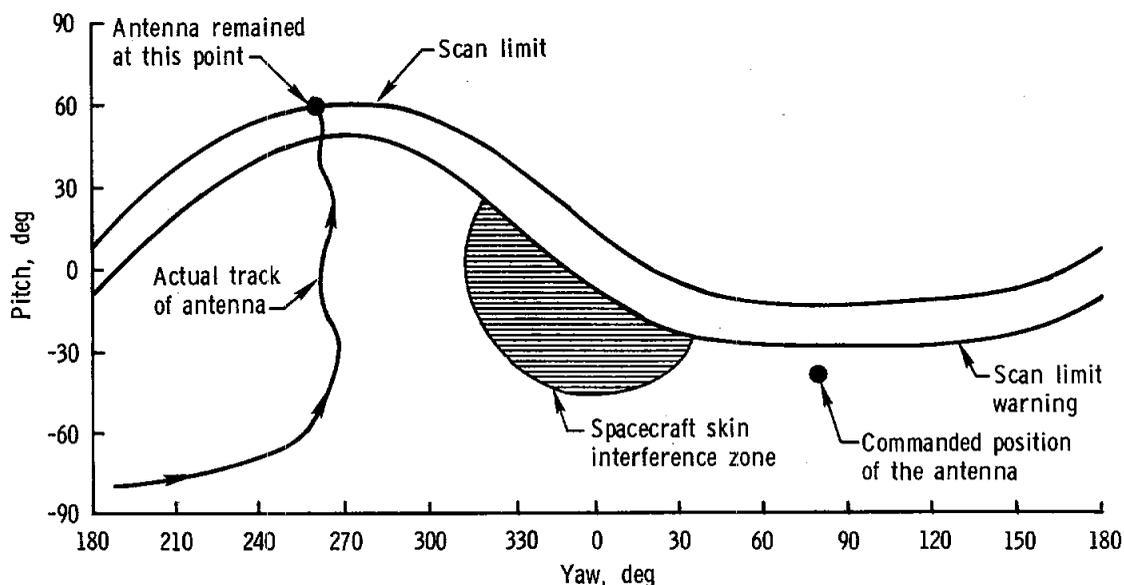
Figure 14-18.- High gain antenna scan limit.

the spacecraft were being maintained by ground-commanded switching between the high-gain antenna and omnidirectional antenna D. The initial indication of a problem occurred at about 234:04 when the high-gain antenna reached the scan limit and failed to drive to the position set on the manual controls. Figure 14-18 shows the path taken by the antenna prior to the anomaly, where it stopped, and the position to which it should have driven. The antenna remained at the position indicated until the crew awakened about 1 1/2 hours later and cycled the high gain antenna track mode switch from "reacquisition" to "manual" and then back to "reacquisition".

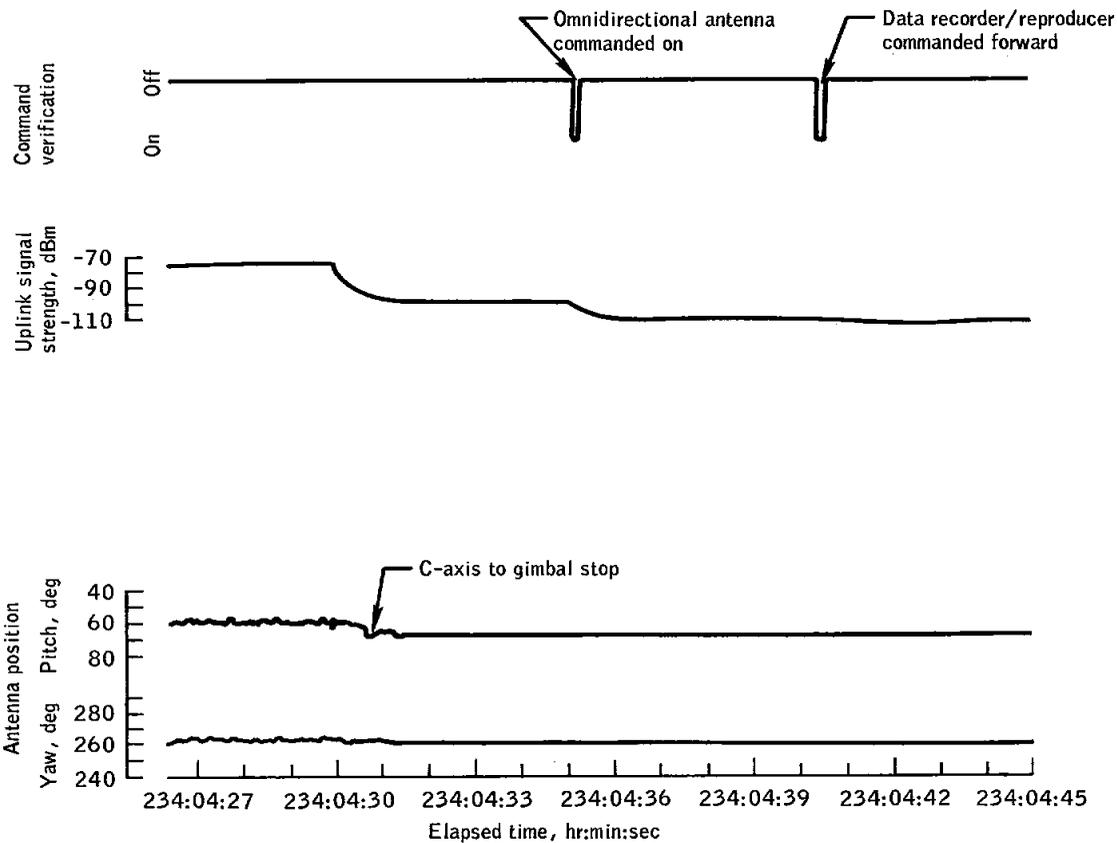
Figure 14-19.- High-gain antenna data at beginning of anomalous period.

Figure 14-19 shows the pitch and yaw positions and signal strengths in the time frame of the problem. This figure indicates normal high gain antenna operation up to and immediately following entry into the scan-limit region. The step decrease in both uplink and downlink signal strength was due to switching from narrow to wide beam. Such a beam switch results when the logic latchup circuit 2 latches (fig. 14-20). Logic latchup circuit 2 latches when logic latchup circuit 1 latches and logic latchup 1 latches when the antenna with the "reacquisition" track mode selected, tracks from the clear track area to the scan limit. Latching of logic latchup 1 also internally switches the antenna to manual track. For the

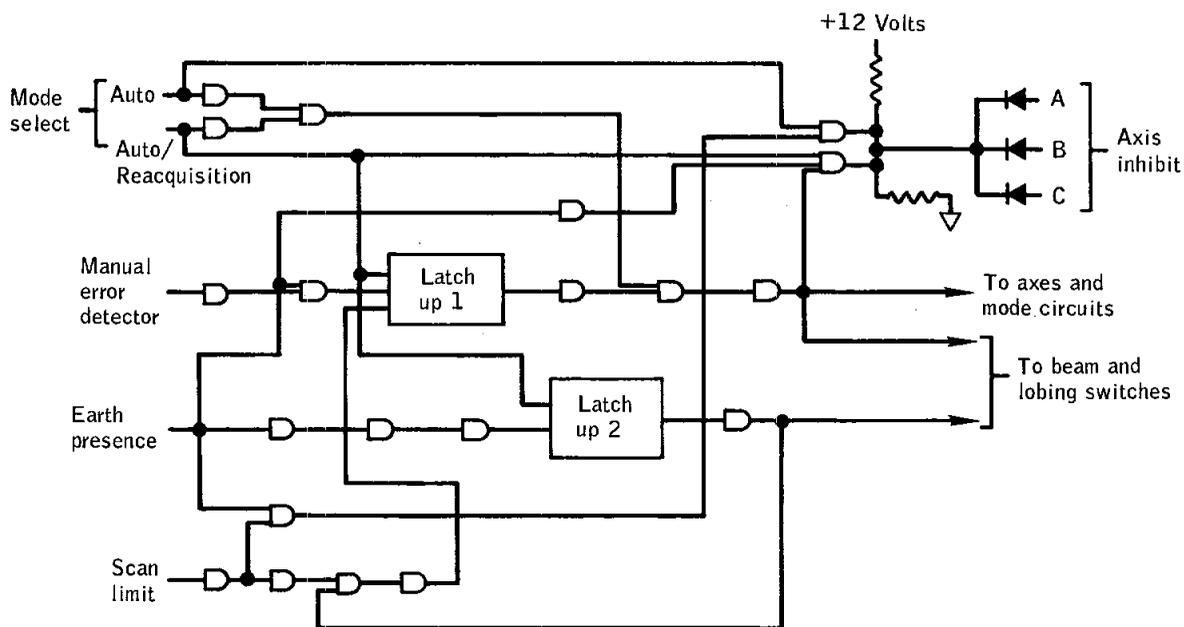
Figure 14-20.- High-gain antenna logic diagram.

no noise has been associated with the "inhibit" mode. Figure 14-20 shows that selecting the "automatic" mode and reaching the scan limit triggers an "inhibit" circuit.

Tests did indicate, however, that the anomaly could be the result of simultaneous selection of both the "reacquisition" and "automatic" track modes. In this case, an inhibit would result if the antenna entered, and remained inside the scan limit (fig. 14-20). Simultaneous selection of both "reacquisition" and "automatic" track would require a fault, or malfunction in the mode select switch, associated spacecraft wiring, or internally in the high-gain antenna electronics. Although the telemetry data indicate no voltage on the "automatic" select line, such a condition could occur and not be detected. The mode select switch and the associated wiring, however, were thoroughly checked, including disassembly and inspection of the switch, and no discrepancies were noted.

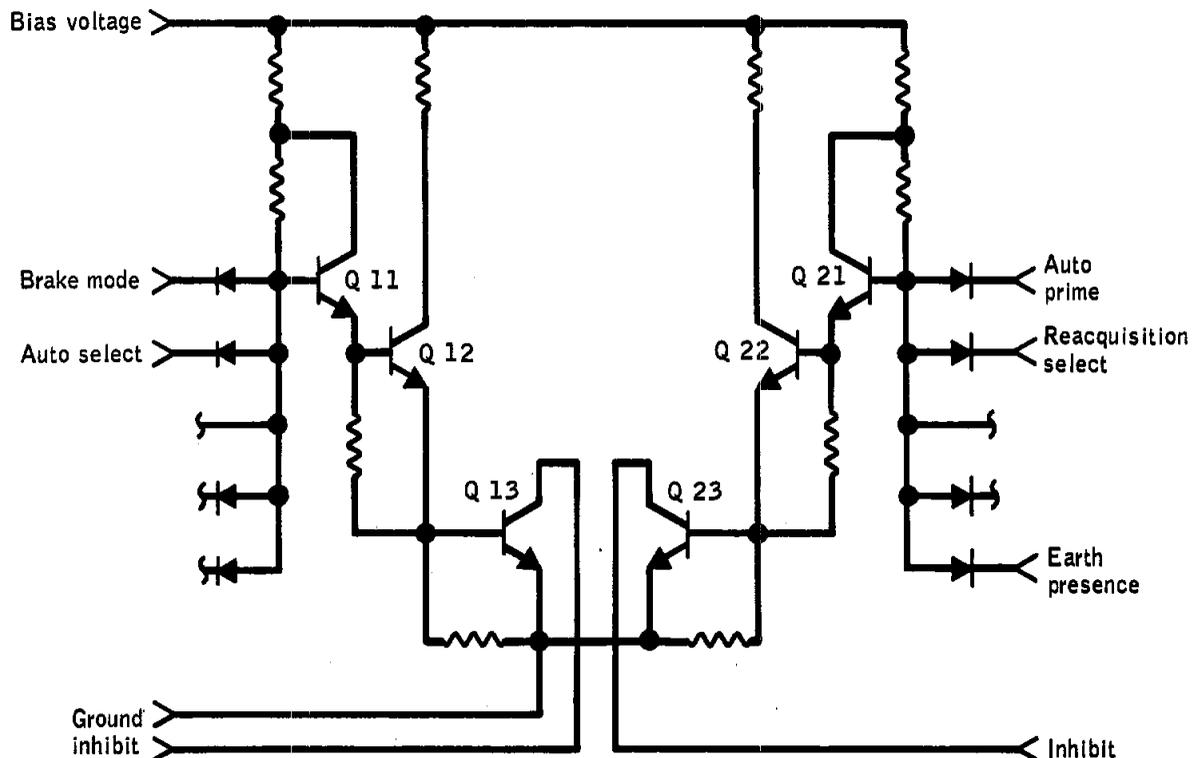
Figure 14-21.- Schematic of integrated circuit within uplink package.

The integrated circuit generating the inhibit is shown in figure 14-21. These types of devices have been found susceptible to contamination from internal floating particles. A particle can move as a result of acceleration or electric fields, and create an internal short which changes the state. Additional acceleration or changes in the electric fields can result in the particle moving again and either clearing the problem, or showing itself as an intermittent problem.

A particle resulting in any one of the following shorts (fig. 14-21) would result in an unscheduled inhibit.

No corrective action is planned because experience shows contamination in the electronics box has a low probability of occurring. Further, if the problem became permanent in one electronics box, the secondary unit can be selected.

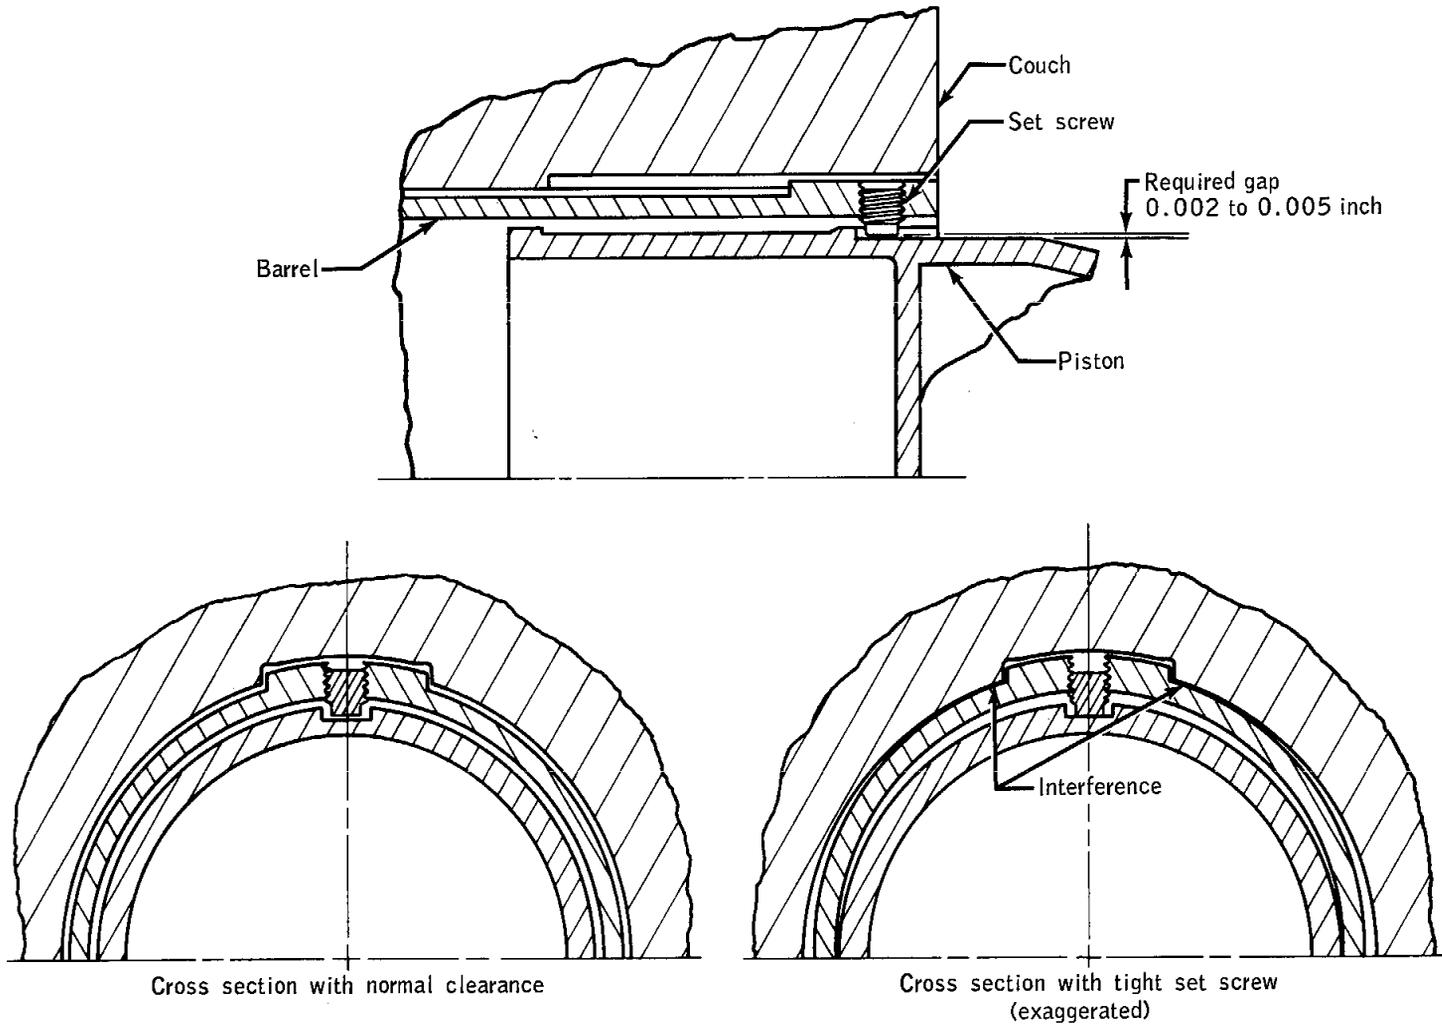
Figure 14-22.- Couch strut interference.

Postflight investigation showed no significant binding during strut operation. Visual examination (fig. 14-22) showed:

- a. Wear areas along the keys
- b. The strut barrel was 2.757 inches in diameter and should have been between 2.740 and 2.750 inches
- c. The set screws which provide a stop for the strut piston in the strut barrel were bottomed out against the piston.

The strut barrel was deformed by the set screws and caused the wear along the keys because the barrel became within tolerance as soon as the set screws were adjusted to the specified gap of 0.002 to 0.005 inch.

A similar condition was reported on the Apollo 17 spacecraft and corrected by adjusting the set screws. Engineering has been released to verify these dimensions prior to installation for future spacecraft.

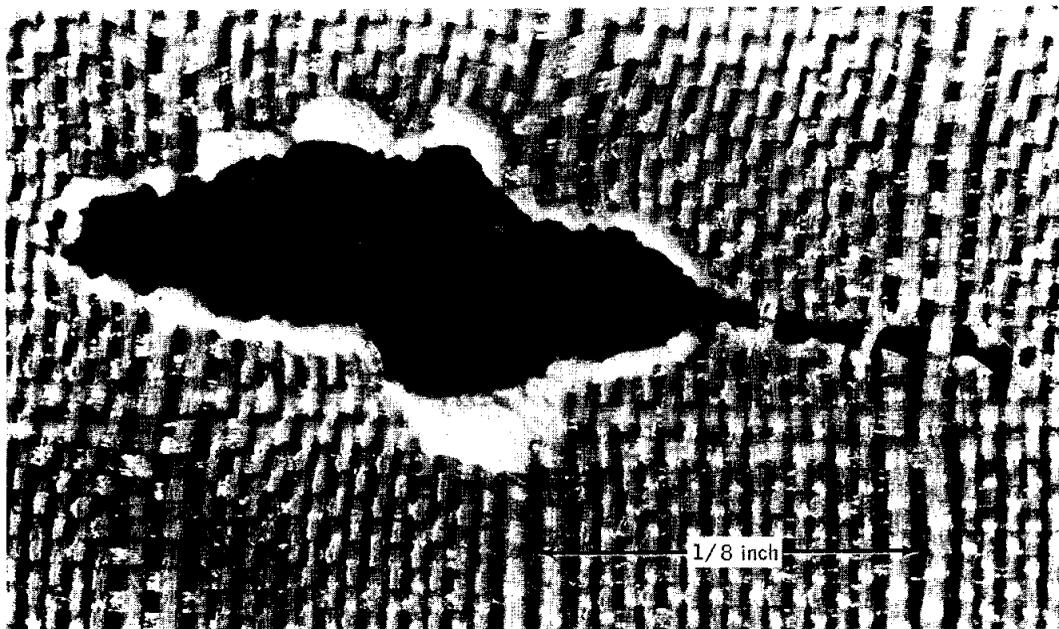
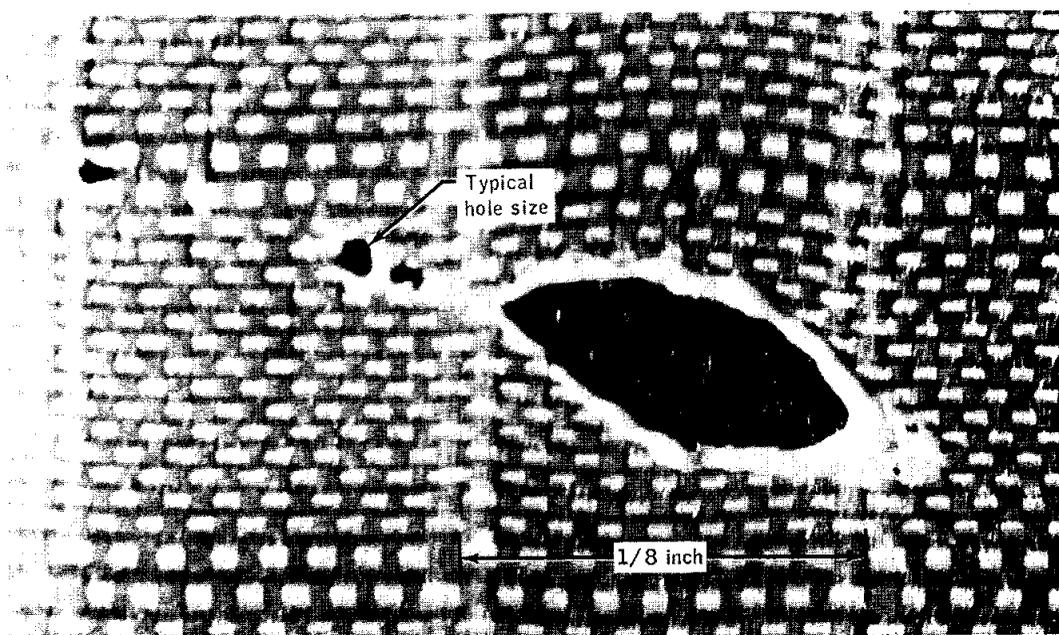
Figure 14-23.- Typical burn holes found in recovered parachutes.

Inspection of the canopy of one of the recovered main parachutes indicated numerous small burn holes which are similar to the burn holes observed on parachutes from previous missions (fig. 14-23). The cause of the earlier holes had been attributed to the reaction control system oxidizer.

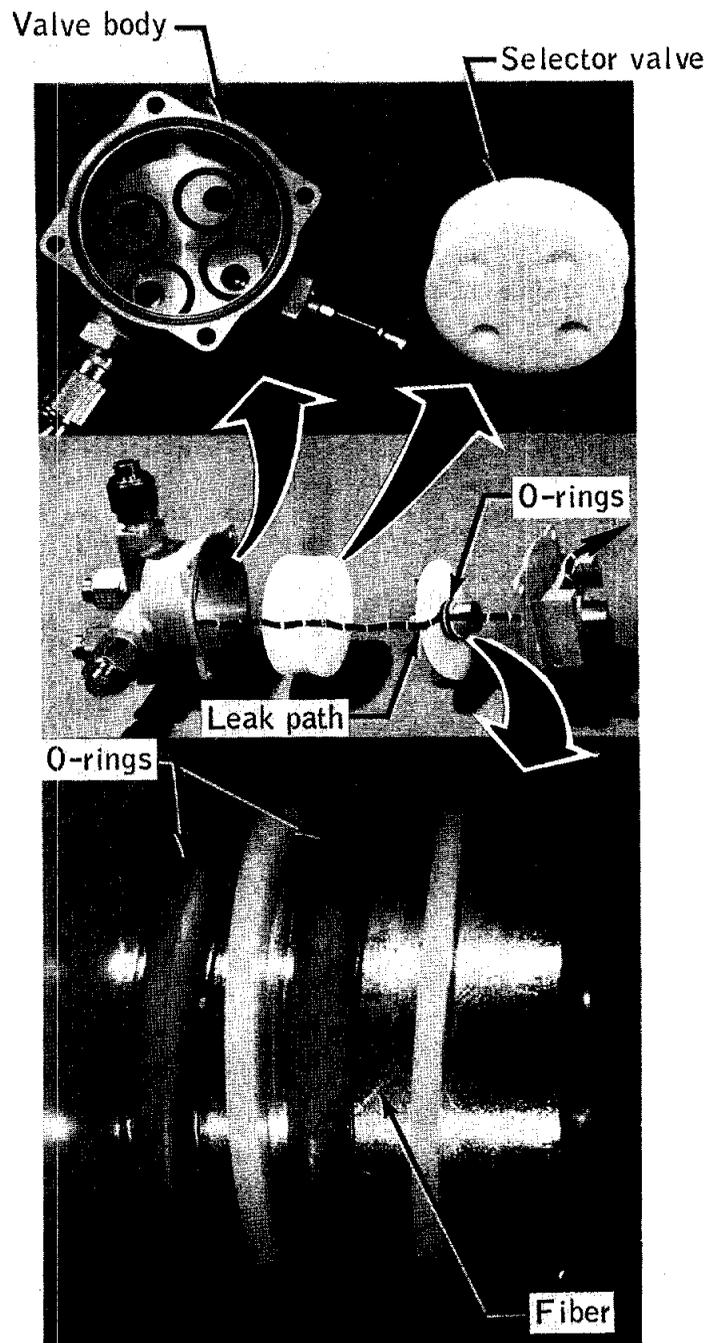
Figure 14-24.- Disassembled heat exchanger bypass valve.

During the helium pressure decay check, a leak of 255×10^{-7} scc/s was observed during repositioning of the suit heat exchanger bypass valve. A fiber was found under the two O-ring seals on the control key shaft when the valve was disassembled (see fig. 14-24). The valve is motor driven between two positions. The O-rings around each of the four openings (fig. 14-24) in the valve body normally maintain a seal at the selector and valve body interface, i.e., when the selector is in either position. During the movement of the selector from one position to the other, which requires about 20 seconds, system integrity through the valve is maintained by the two O-rings on the key shaft. Although the only time this valve is moved during the mission is just before entry into the earth's atmosphere, it is activated numerous times during spacecraft testing after the system is filled with water/glycol and pressurized.

The environmental control unit area, i.e., the bypass valve, B-nut connections, and cabin floor will be inspected for glycol leak prior to launch on subsequent missions.

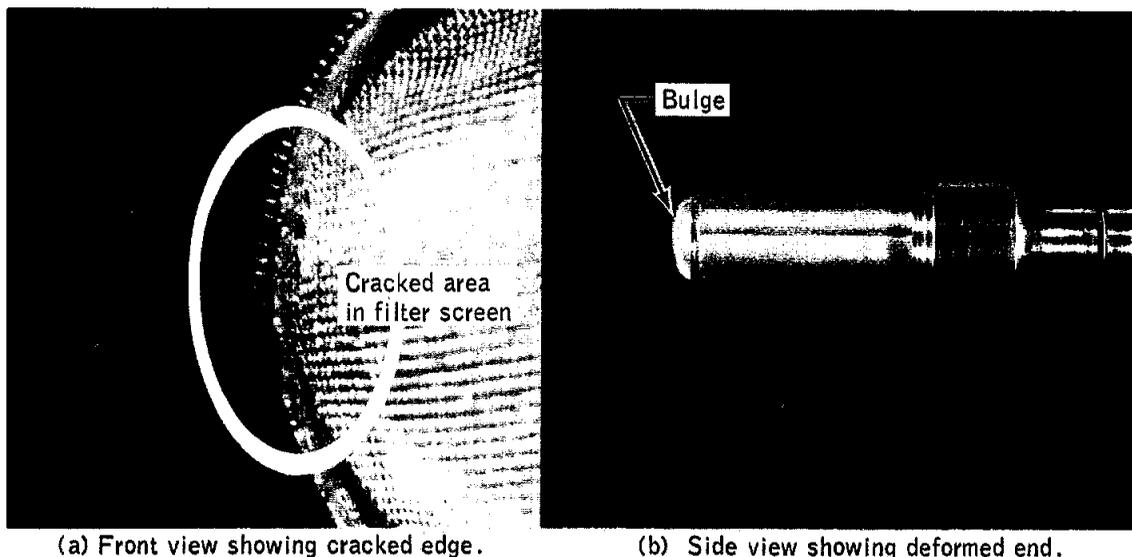
Figure 14-25.- Reaction control system regulator filter.

The deformed filters are being evaluated. This evaluation includes retesting the filters for bubble point and performing a microscopic examination and a metallurgical examination in the areas of the wire separation. The objective of this investigation is to establish if the deformation is a normal condition resulting from system activation or if a unique condition occurred on Apollo 16.

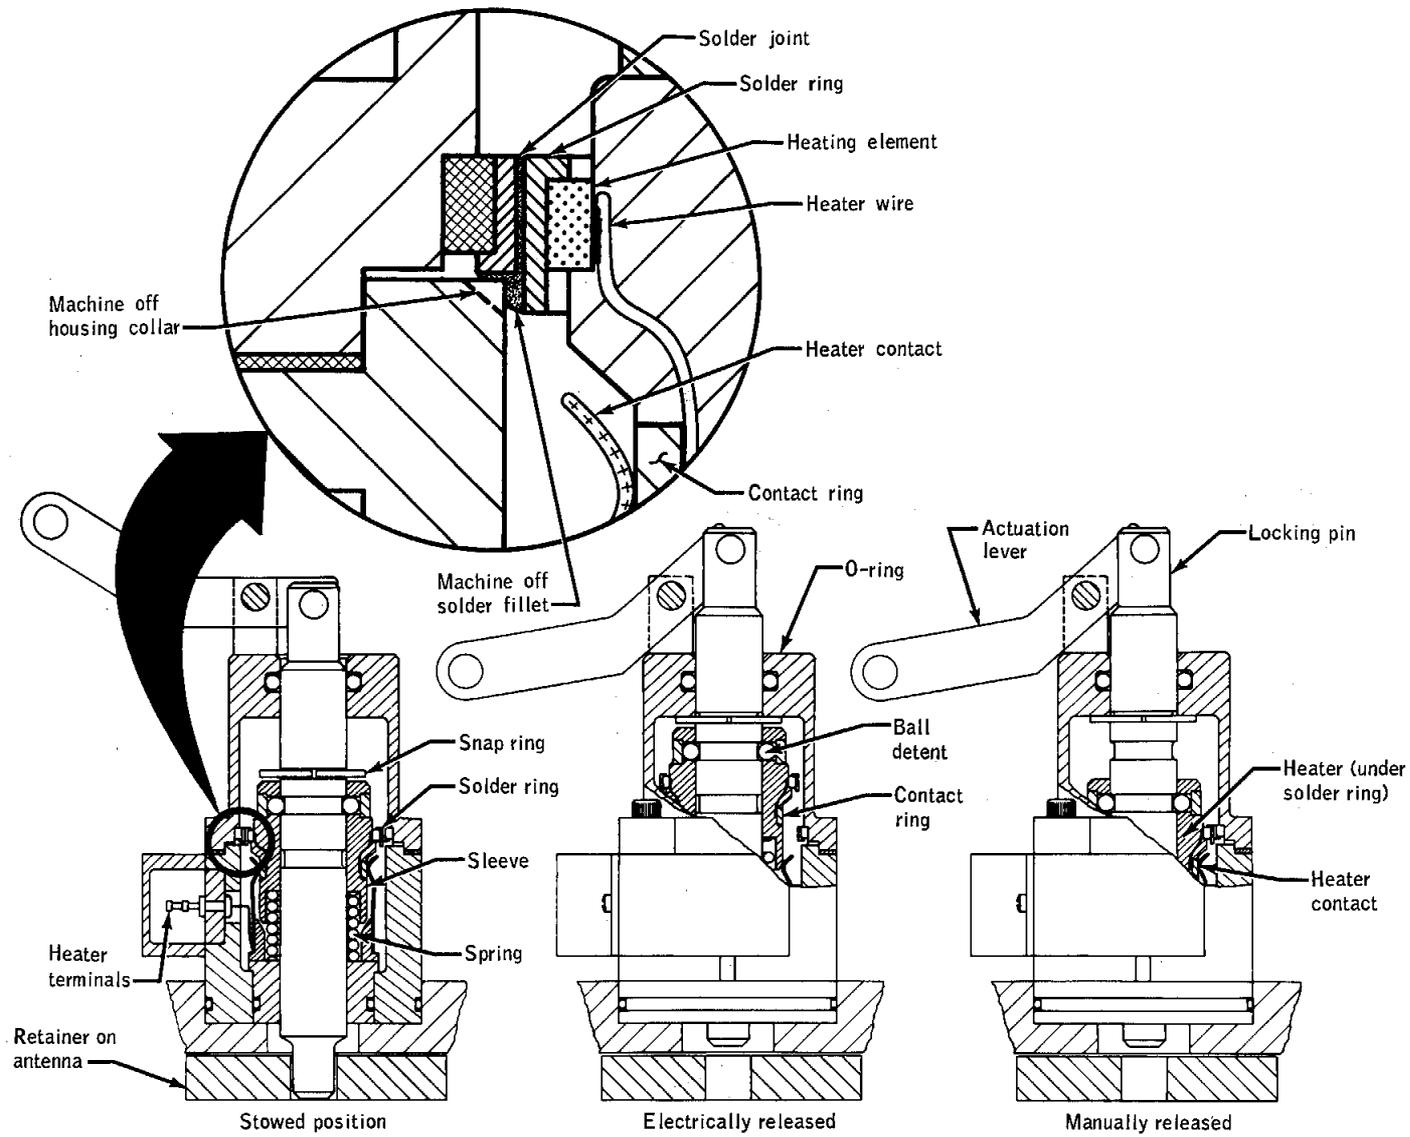
Figure 14-30.- Antenna stow latch mechanism.

Functionally, the stow latch restrains the antenna during launch. Figure 14-30 shows the functional operation of the latch. The lock pin, when extended, holds the antenna in the stowed position. A spring is held under compression by a sleeve which is constrained to the latch housing by a shoulder soldered to the sleeve. Melting the solder allows the spring to push the sleeve which, in turn, raises the lock pin out of the retainer. A manual mode is provided for checkout purposes. The lever (fig. 14-30)

There are several areas in the electrical circuitry which could have caused the problem. One is that one contact in the safe/arm switch (figure 14-31) did not make. The second is that an open may have existed downstream of the safe/arm switch, either in the solder-melting element or in the wiring back through ground. A resistance measurement is made across the two parallel solder-melting elements prior to flight. About a 3-ohm increase in resistance was found at the last check. This change is equivalent to a possible 10-ohm increase in one of the elements which could have reduced the power dissipation below that required to melt the solder. Allowable tolerances on mechanical drawings and tests on sample latches have shown that it is possible for a solder fillet extending below the ring to make physical contact with the housing (fig. 14-30). The

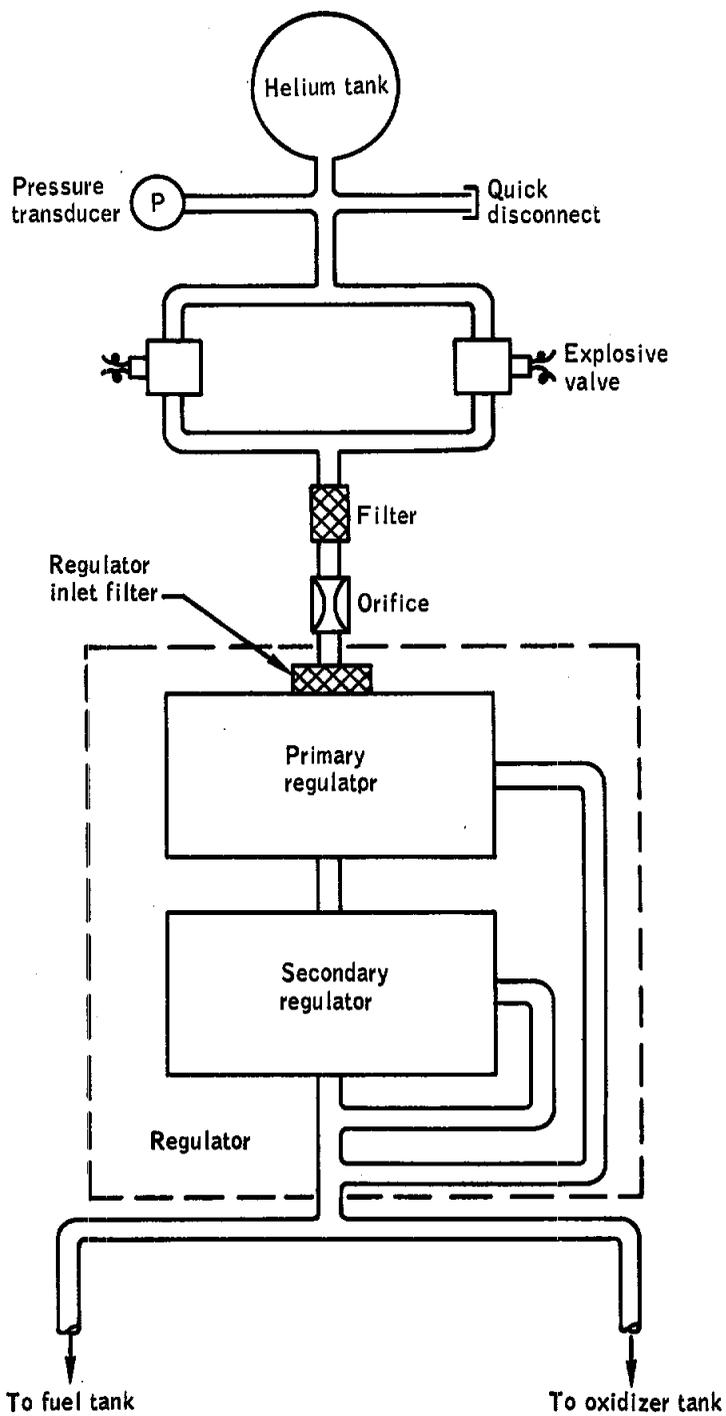
Figure 14-32.-- Reaction control system pressurization system.

During pressurization of the system at about 95 hours, the regulator outlet pressure in system A (fig. 14-32) increased above regulator lockup pressure. The normal pressurization is characterized by a sharp increase from the nominal pad pressure, in the interval of 1 to 2 seconds, to the normal regulator outlet pressure. The outlet pressure of system A, after reaching the normal value of 184 psia, continued to rise at approximately 10 psi/minute, a condition which clearly indicated the existence of internal leakage in the regulator assembly.

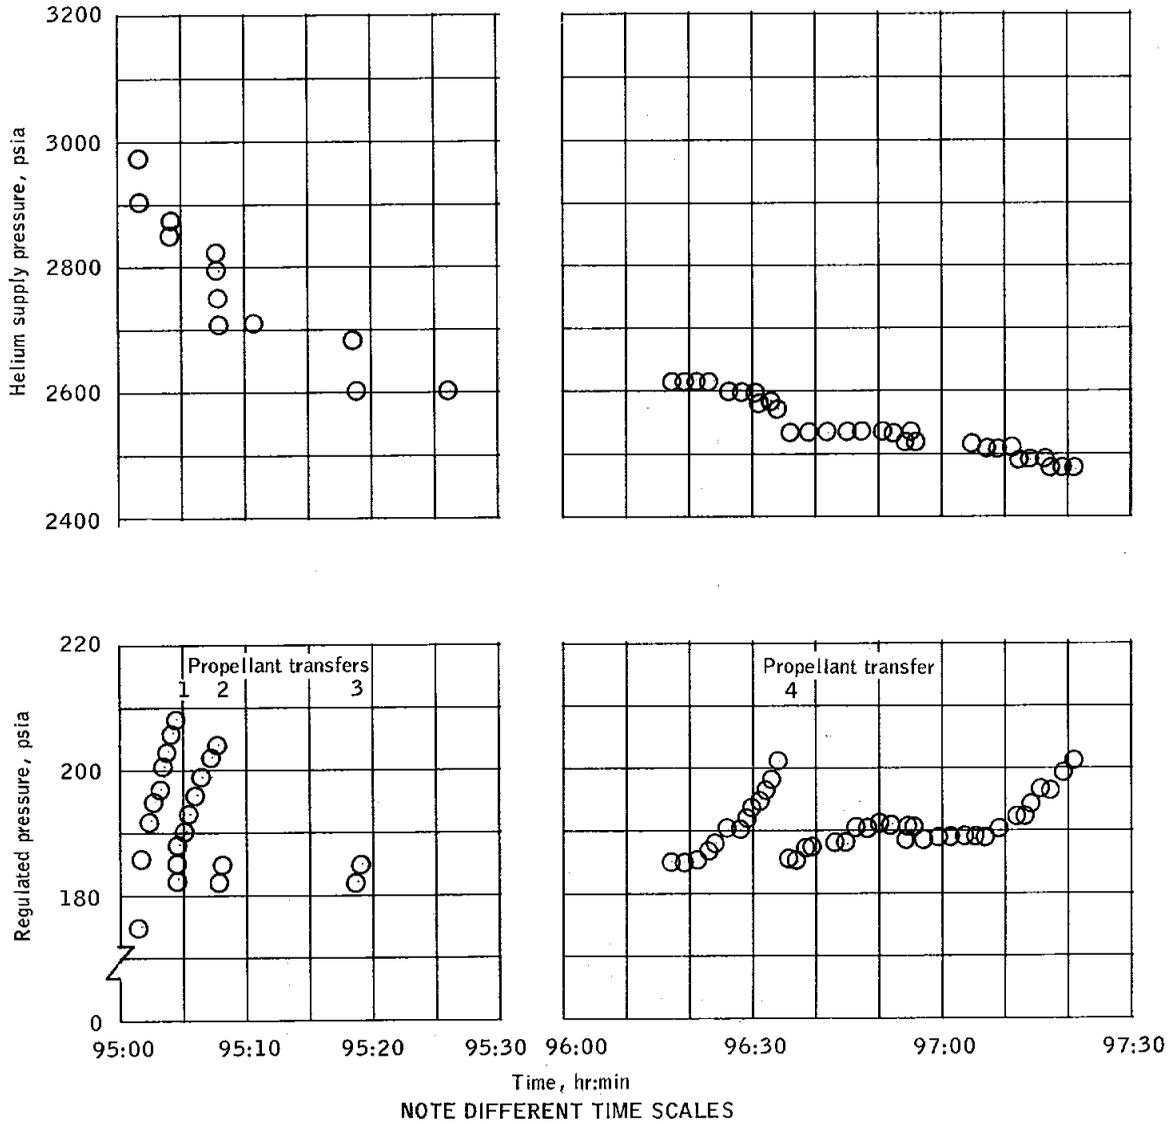
Figure 14-33.- Comparison of helium supply pressure and regulator outlet pressure following reaction control system pressurization.

Approximately 3 minutes after pressurization, the first of four propellant transfer operations was performed (fig. 14-33) to lower the ullage pressure and to create a larger pressurant volume in the propellant tanks, thereby obtaining a blowdown capability for expulsion of the remaining propellant in case of total loss of system A pressurization gas through the relief valves. The helium leakage continued throughout the mission, although the leakage rate varied from essentially zero to a maximum of about 1100 scc/min (figs. 14-34 and 14-35). The regulator outlet pressure eventually increased to about 237 psia at which time the relief valves of system A started to periodically relieve the pressure to about 232 psia.

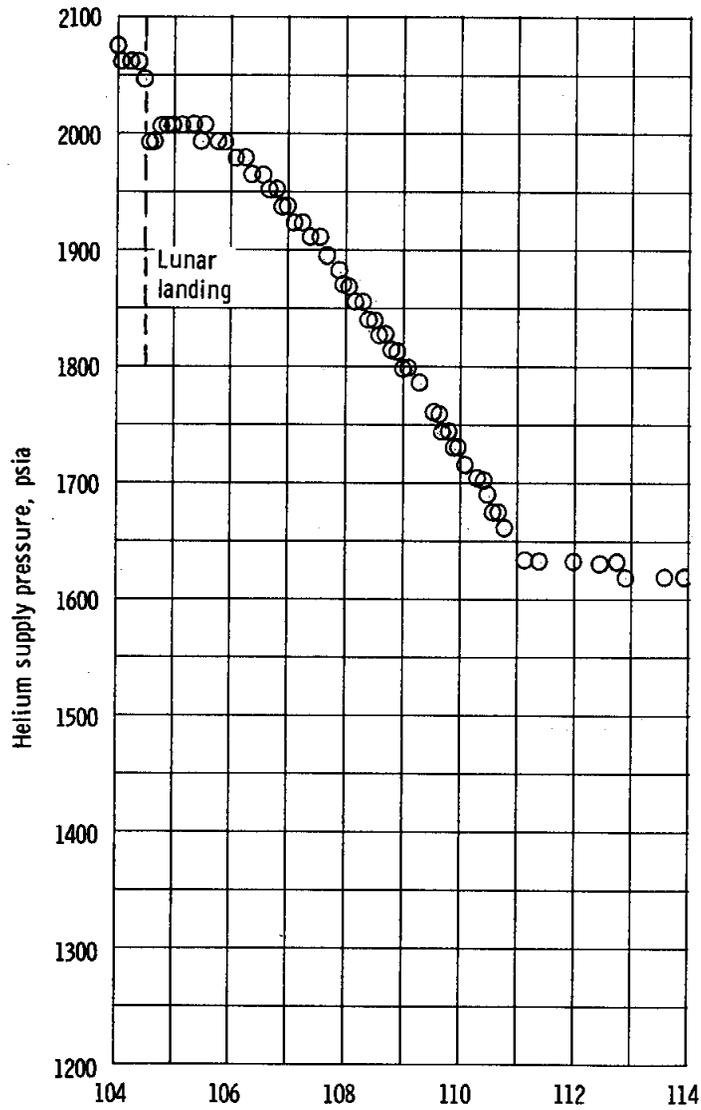
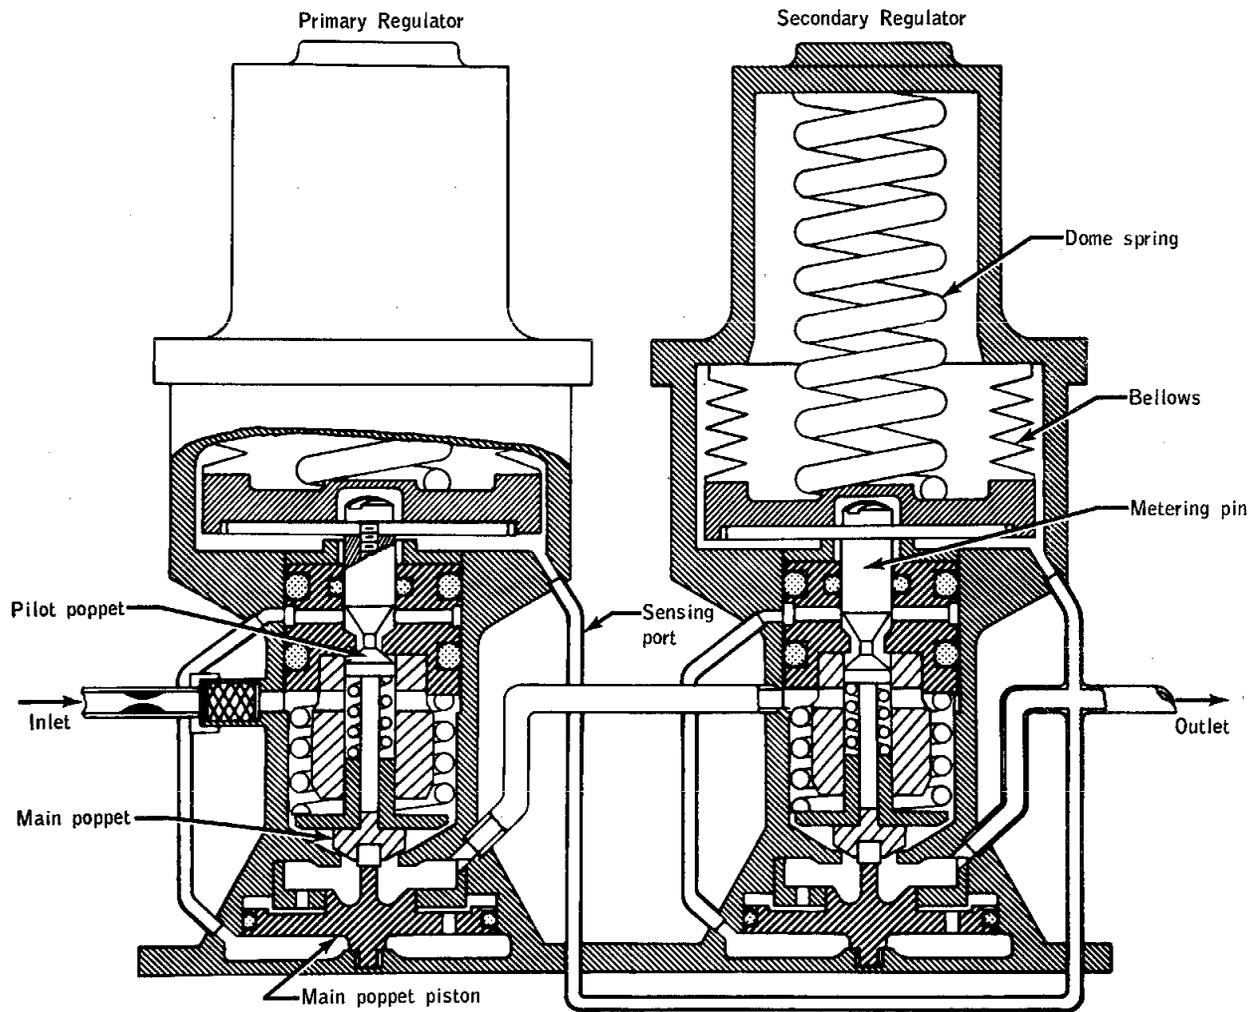
Figure 14-36.- Cross-section of reaction control regulator.

The helium regulator assembly consists of two series regulators (figure 14-36). The unit immediately exposed to the high pressure source is designated as the primary regulator and the downstream unit as the secondary regulator. Both units are identical in configuration with the exception of shims which are used to determine their pressure settings. The primary unit is set to regulate at 181 ± 3 psia; the secondary, at 185 ± 3 psia.

During buildup of the Apollo 16 reaction control system module, a quick disconnect (fig. 14-37) located directly downstream of the regulator outlet was replaced three times. During one change a five-legged fitting (fig. 14-37) required replacement. The repairs required seven brazing operations in an area which is directly above the regulator outlet when installed in the vehicle. Any contaminants introduced during these operations would be trapped in the volume downstream of the regulator by various filters (fig. 14-37). These contaminants could have been moved around during reaction control system module installation or when the lunar module ascent stage was rotated during the cleaning process. During these operations, any contaminants present could have been transported to the area directly downstream of the secondary regulator primary poppet. This volume has many areas where contaminants can be trapped (fig. 14-36).

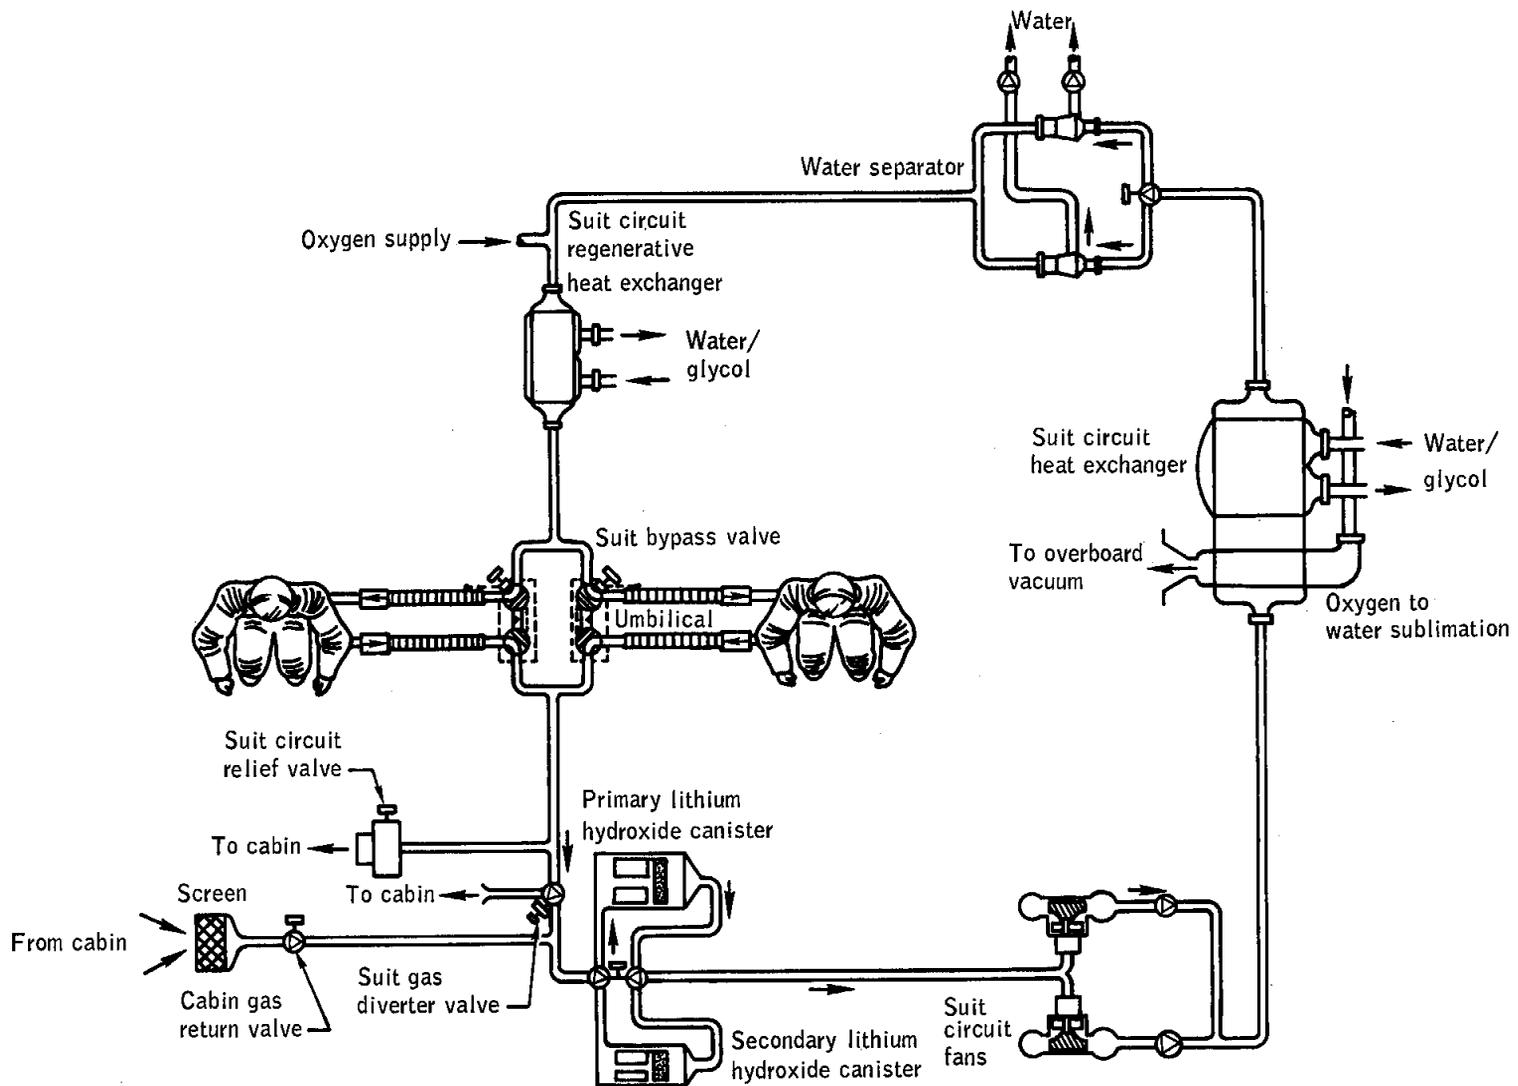
Figure 14-38.- Atmosphere revitalization section.

The crew reported hearing a chattering noise and experiencing a pulsating, insufficient flow in the suit circuit at 95:47 while configured to the cabin mode of operation (fig. 14-38). Data indicate that the cabin mode flow was normal at system activation (93:41), and this was confirmed by the crew after the mission. The pulsing and chattering occurred again after the demand regulator check (95:55) and after lunar landing (105:57).

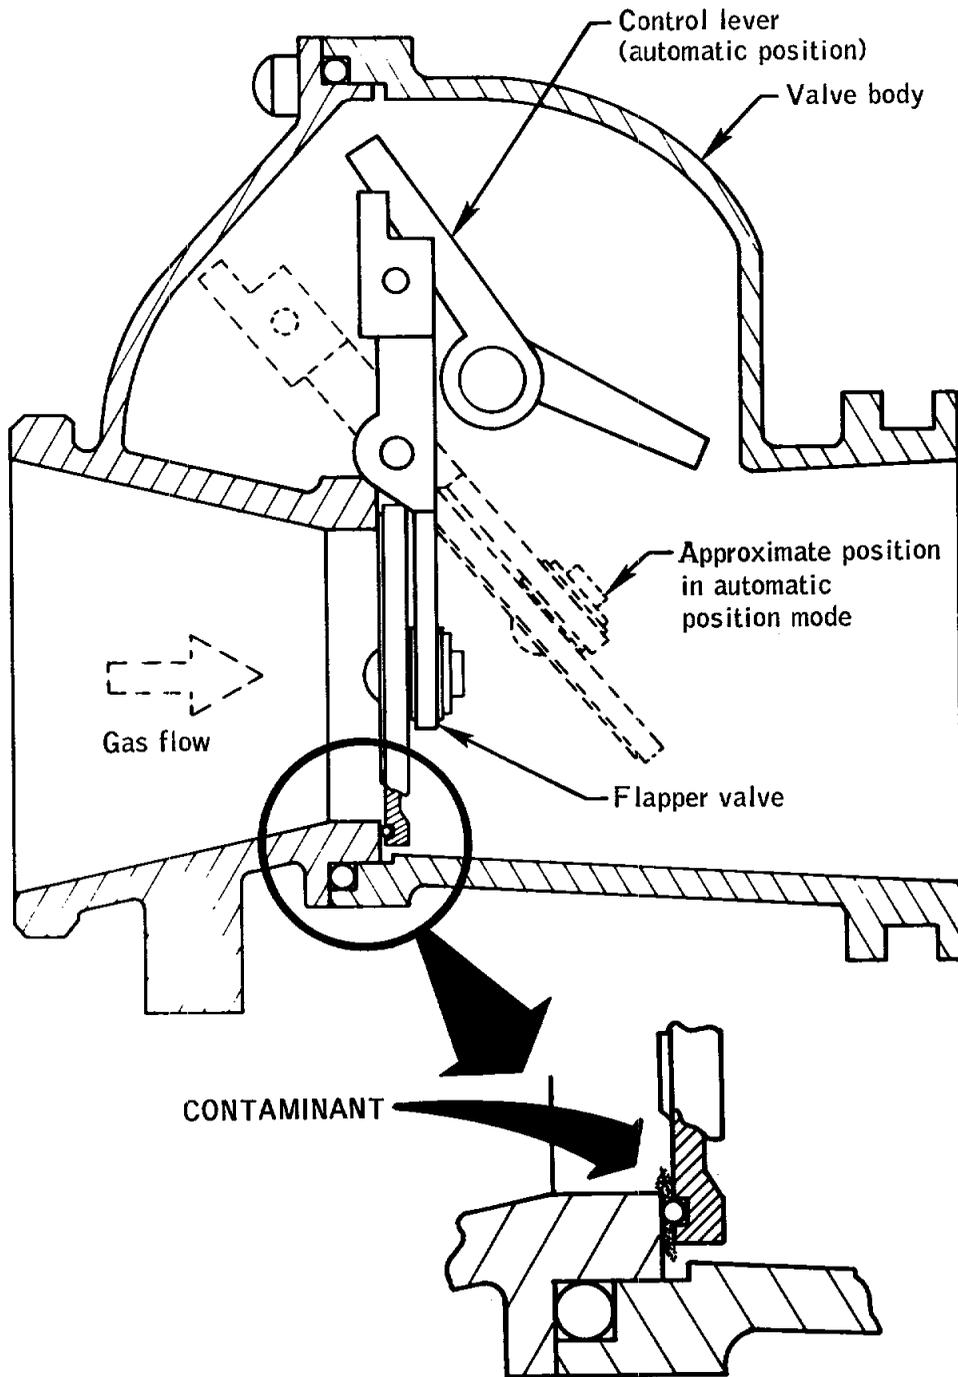
Figure 14-39.- Cabin gas return valve.

Since the valve functioned properly upon activation and again late in the lunar stay, the apparent cause of the problem was contamination. There are two possible areas of contamination: material on the inlet screen or residue on the flapper seal (fig. 14-39). A suspected source of residue is the orange juice that leaked from the drink bags.

A test will be performed on the Apollo 17 lunar module to check the force needed to open the cabin gas return valve flapper in the "automatic" position, thus increasing confidence in the ground checkout of the valve.

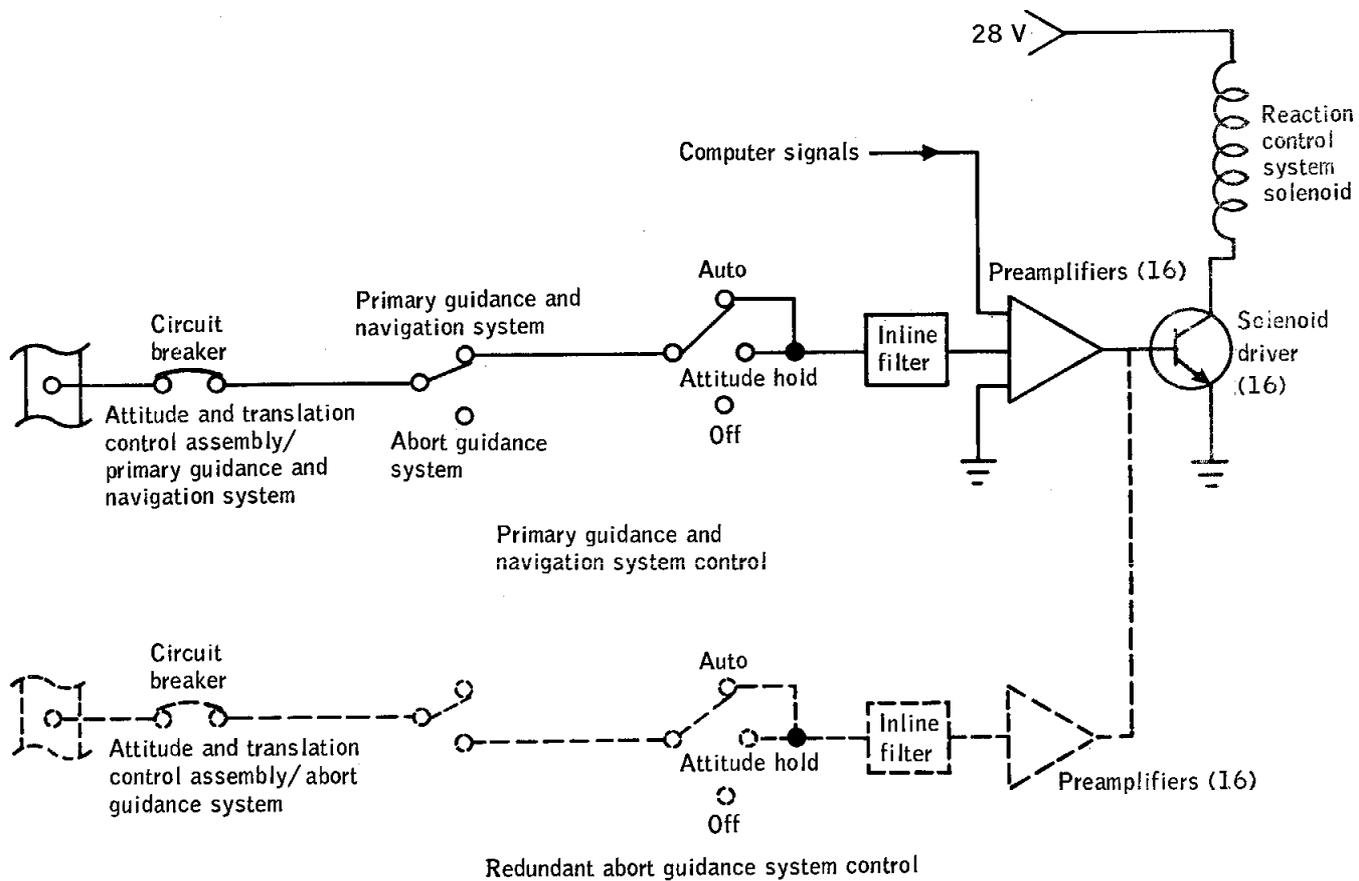
Figure 14-40.- Reaction control system control schematic.

Any of the following conditions could have caused the problem (refer to fig. 14-40):

Review of flight data and failure histories has been performed and the following conclusions reached:
