MSC-07230

APOLLO 16 MISSION REPORT

MANNED SPACECRAFT CENTER

AUGUST 1972

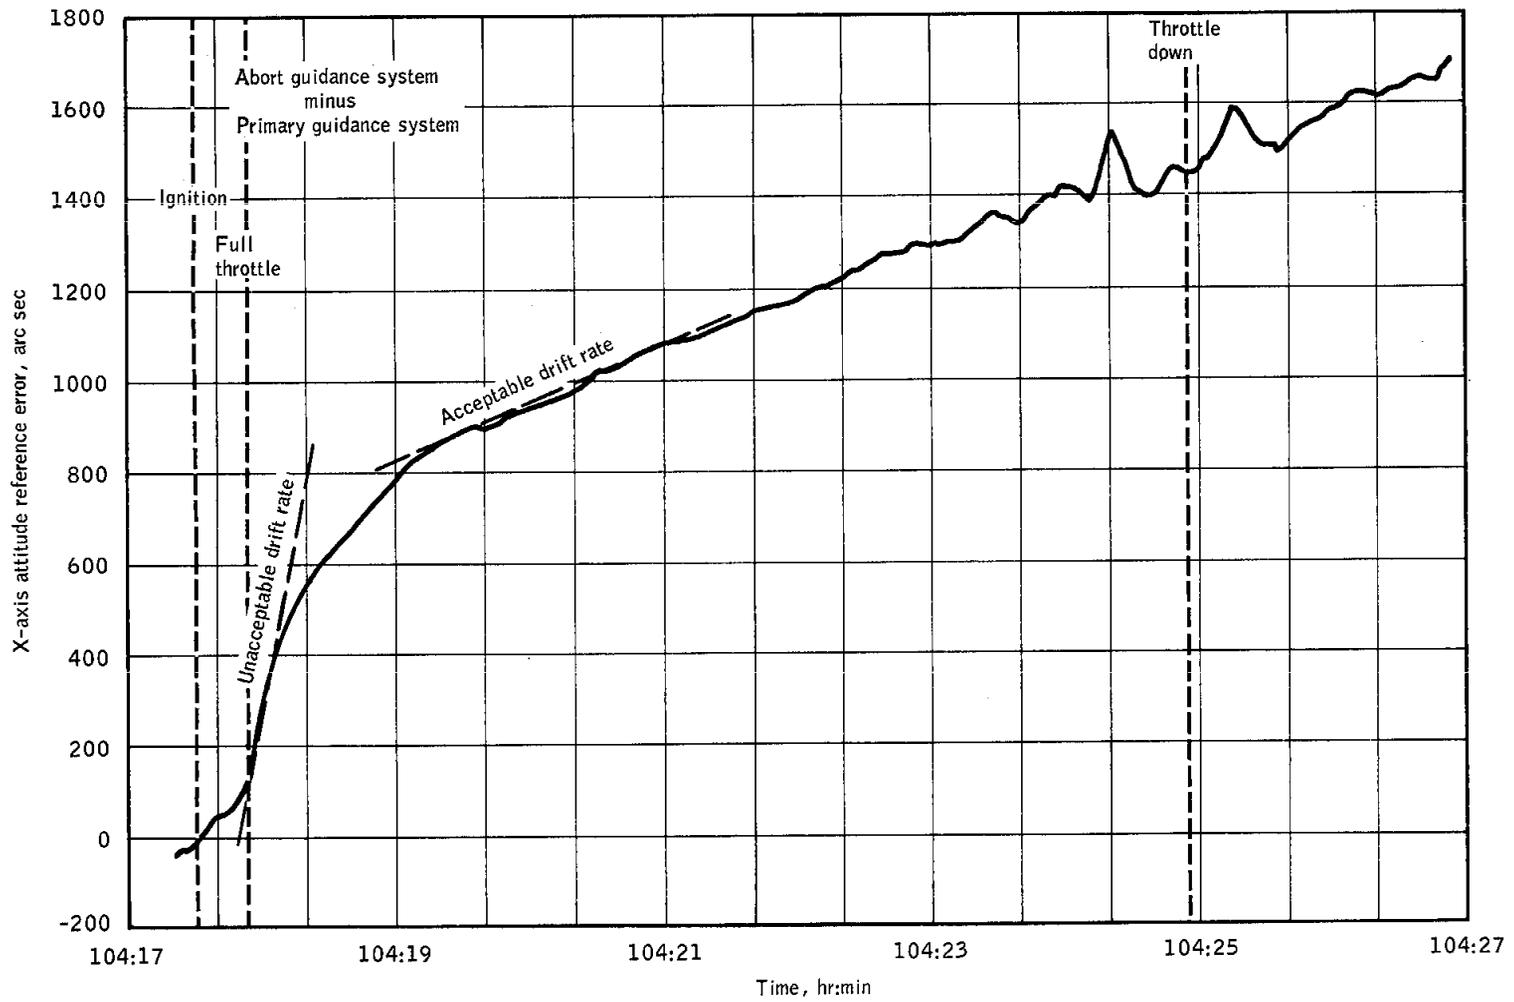
Figure 14-41.- Attitude reference error during descent.

Figure 14-41 is a time history of the difference between the abort guidance system and the primary guidance system X-axis attitude reference during descent. The rapid error buildup during the first 2 minutes indicates drift rates of up to 19 degrees per hour. No reason can be given for these high drift rates; however, a change in the X-axis gyro performance characteristics obviously took place. The steady drift rate of 2 degrees per hour during the last 8 minutes is believed to have been caused by a shift in a mass unbalance along the X gyro spin reference axis. Drift caused by this mass unbalance was also apparent in the data for the lunar surface calibration (due to gravity) and during ascent (due to the ascent engine thrust).

The roll axis misalignment is accounted for by the higher-than-normal drift rates during descent.

No indication of a problem existed before launch. Hardware malfunctions of the gyro and associated electronics have been hypothesized in an attempt to construct a model which would reproduce the error curve shown in figure 14-41. The worst-case electronics failure would only produce drift rates of 1 degree per hour compared to the 19 degrees per hour observed. Mechanical failures within the gyro which would duplicate flight results have a very low probability of occurrence. Therefore, the most likely cause is contamination or an air bubble in the fluid between the gyro float and case.

Settling tests have been performed on abort sensor assemblies to detect contamination or air bubbles and determine the best unit to install in the Apollo 17 lunar module. No evidence of contamination or air bubbles was found.

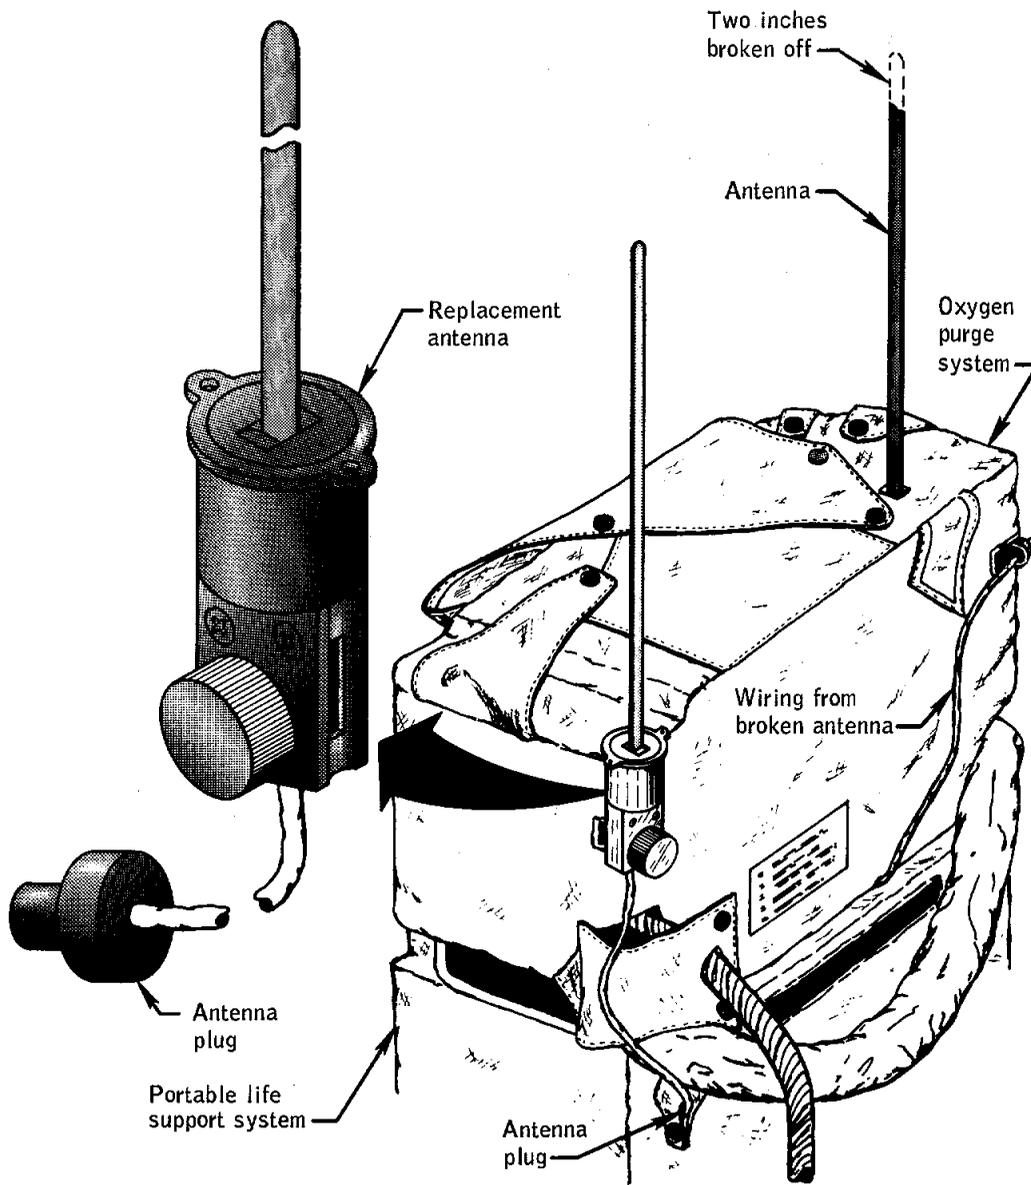
Figure 14-43.- Oxygen purge system antenna.

Following ingress after the second extravehicular activity, the crew reported that approximately 2 inches had been broken off the tip of the antenna on the Commander's oxygen purge system (fig. 14-43). The antenna had inadvertently been left unstowed while ingressing and it is believed that the antenna was broken when it struck the ascent propulsion system engine cover as the Commander was entering through the hatch.

One spare oxygen purge system antenna will be carried on Apollo 17 and will be stowed in the buddy secondary life support system bag on the lunar roving vehicle.

Installation of the spare antenna is accomplished by clamping the antenna adapter to the oxygen purge system right-hand D-ring and connecting the spare antenna coaxial connector in place of the broken antenna's connector (fig. 14-43).

The installation will be made by the other crewman when operating in the pressurized suit condition.

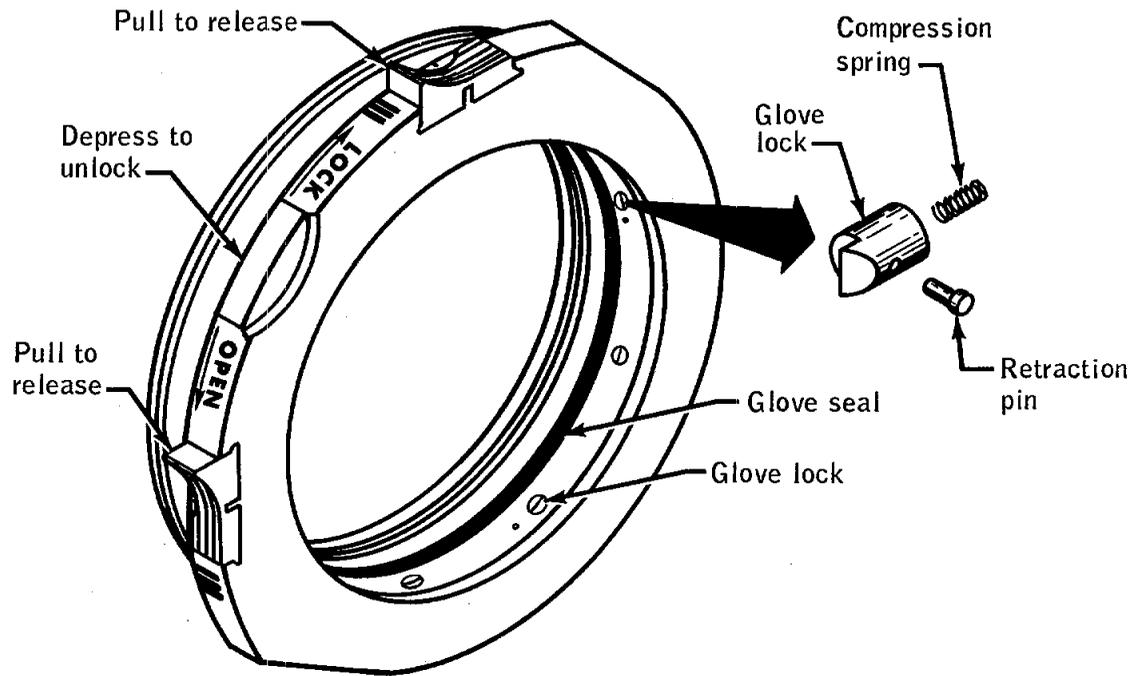
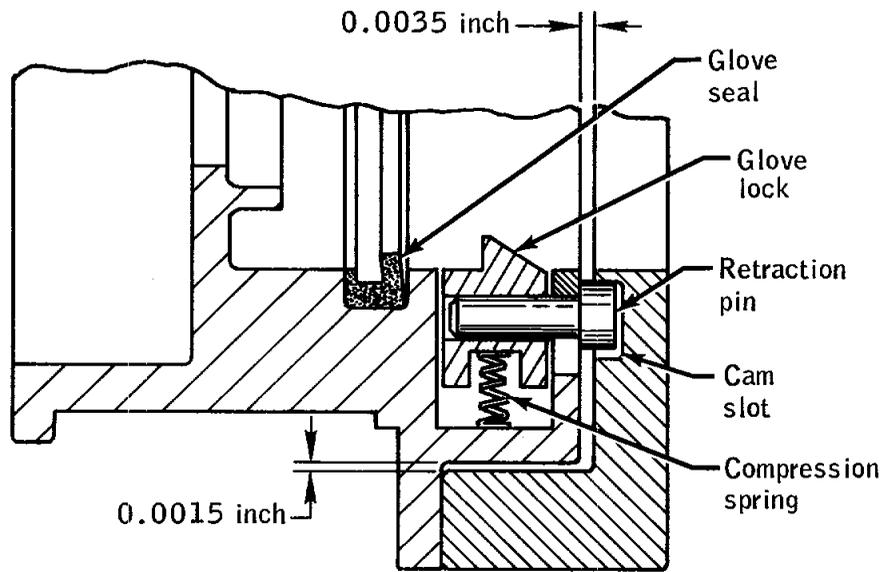
Figure 14-45.- Wrist disconnect.

The wrist disconnect attaches the glove to the suit sleeve (fig. 14-45) and is covered by a gauntlet on the glove. The gauntlet is loose fitting around the suit sleeve and dirt can get to the wrist disconnect. Small tolerances between the sliding surfaces are inherent in the design to make it impossible to accidentally unlock the wrist disconnects.

Postflight inspection of the wrist disconnects showed that lunar dust in the clearance areas caused the problem. Rubber dust covers for the ring disconnects which will afford better protection from contamination will be added for Apollo 17.

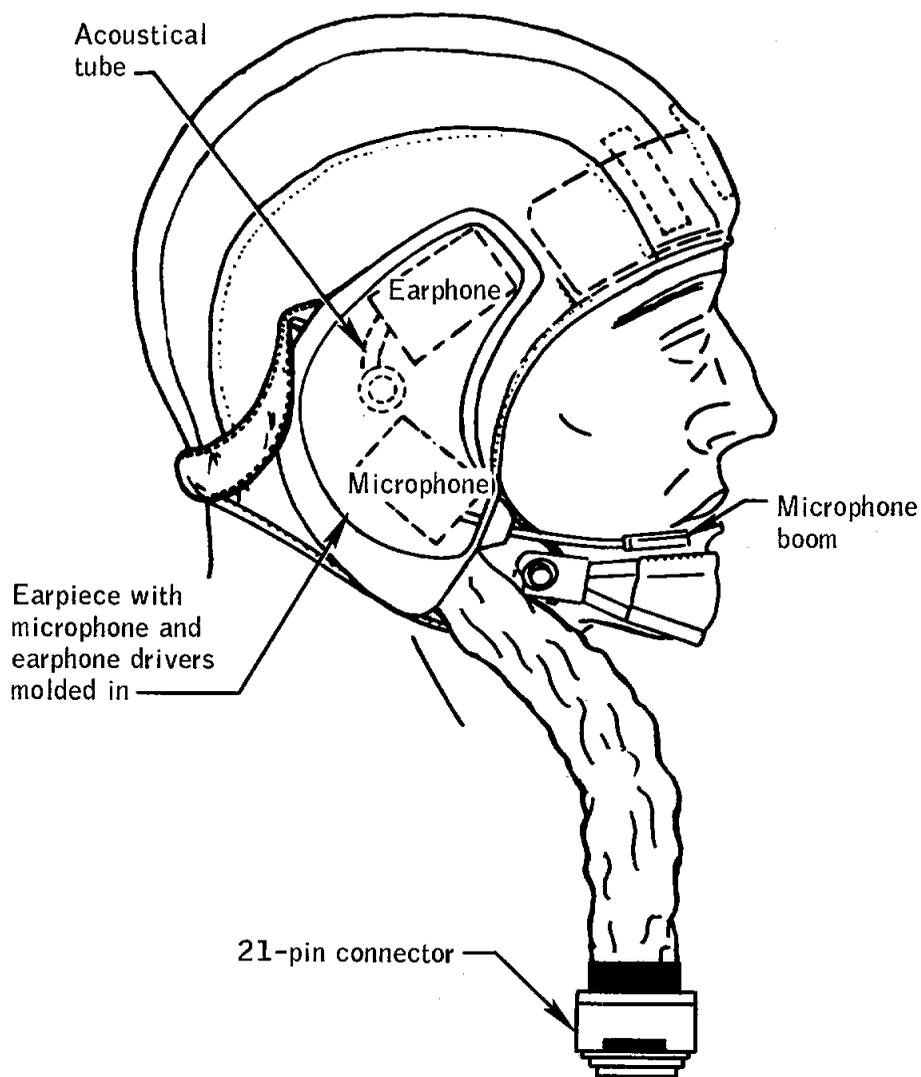
Figure 14-47.- Communications carrier.

During the transearth coast phase, the Lunar Module Pilot experienced intermittent operation of his communications carrier headset earphone circuit. This condition was cleared by flexing the constant wear garment harness near the 21-pin connector (fig. 14-47).

Indications are the problem was caused because the connector was not fully seated and the flexing of the harness seated the connector.

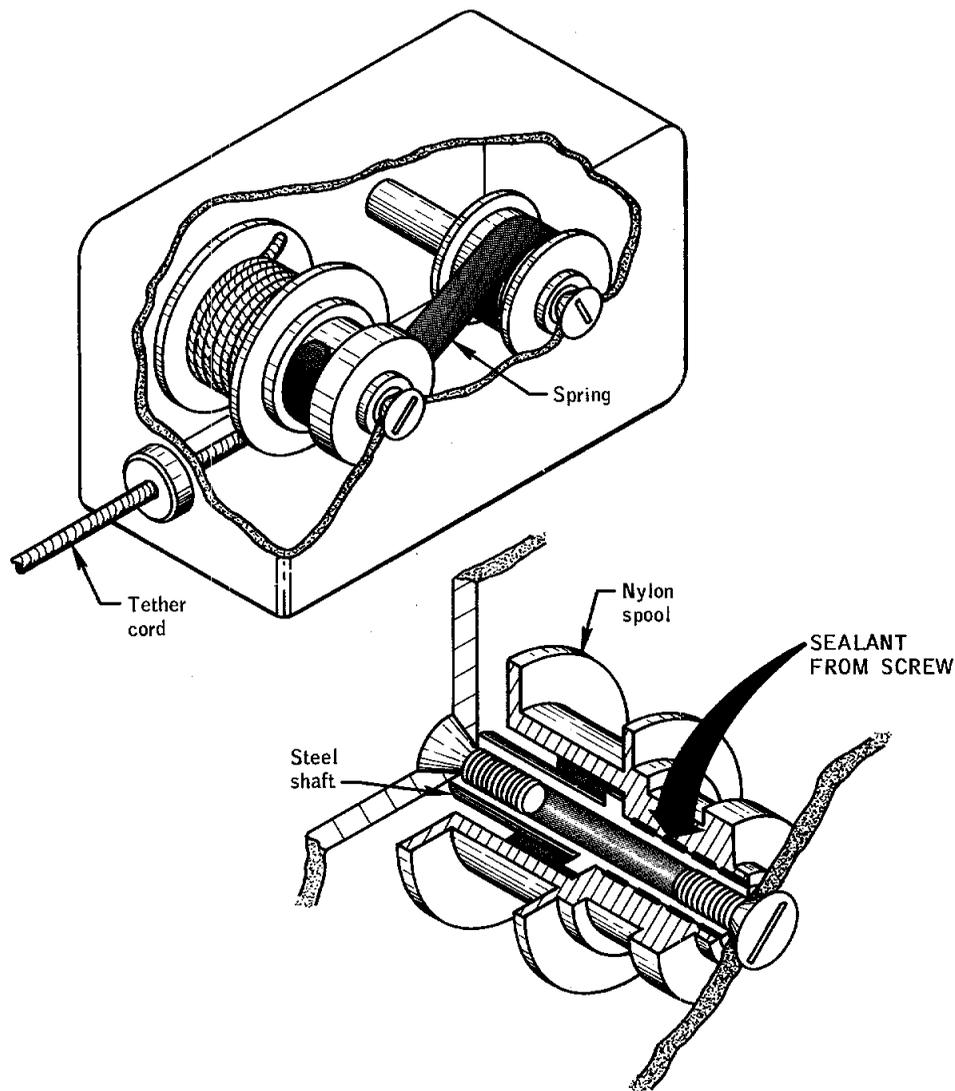
Figure 14-48.- Retractable tether.

Postflight inspection indicates that the tether is now operating; however, there is a noticeable increase in friction (fig. 14-48) during the retraction cycle. A thread sealant (loctite) was found on the spool shaft, which increased the friction.

Future units will be tested for friction buildup prior to flight.

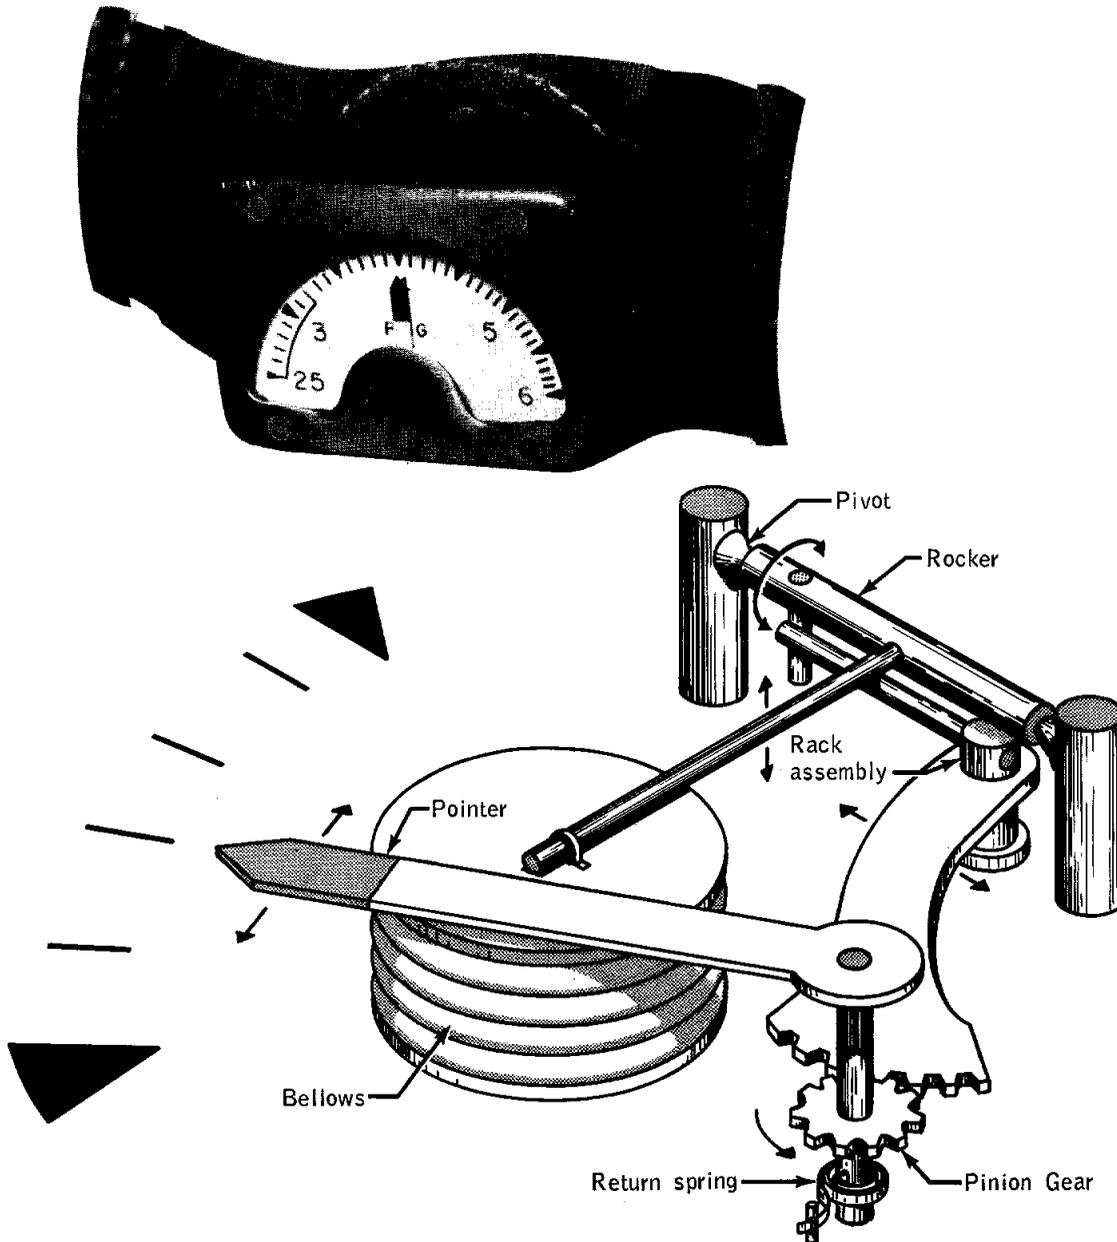
Figure 14-49.- Cuff gage mechanism.

The Commander reported that his cuff gage indicated a different pressure from that of the Lunar Module Pilot during the transearth extravehicular activity. The Commander's gage indicated approximately 3.5 psia, whereas the Lunar Module Pilot's gage indicated approximately 3.9 psia. The normal suit pressure should have been approximately 3.8 psia. During the previous suit integrity check, the cuff gages indicated approximately the same. The crew did not read the gages again after the reported problem.

The cuff gage (fig. 14-49) is a bellows-actuated aneroid-type mechanical gage which indicates differential pressure and has an accuracy of ± 0.1 psia. The gage opening to the outside of the gage is protected by a centered plug. When the bellows is pressurized, it lifts the rocker arm, rotating the rocker in its pivots. The other arm on the rocker then rotates the rack assembly, causing the pinion gear and pointer to rotate.

During postflight testing at ambient and vacuum conditions, both the Commander's and the Lunar Module Pilot's gages read well within 0.1 psi of the 4.0 psi to which they were pressurized.

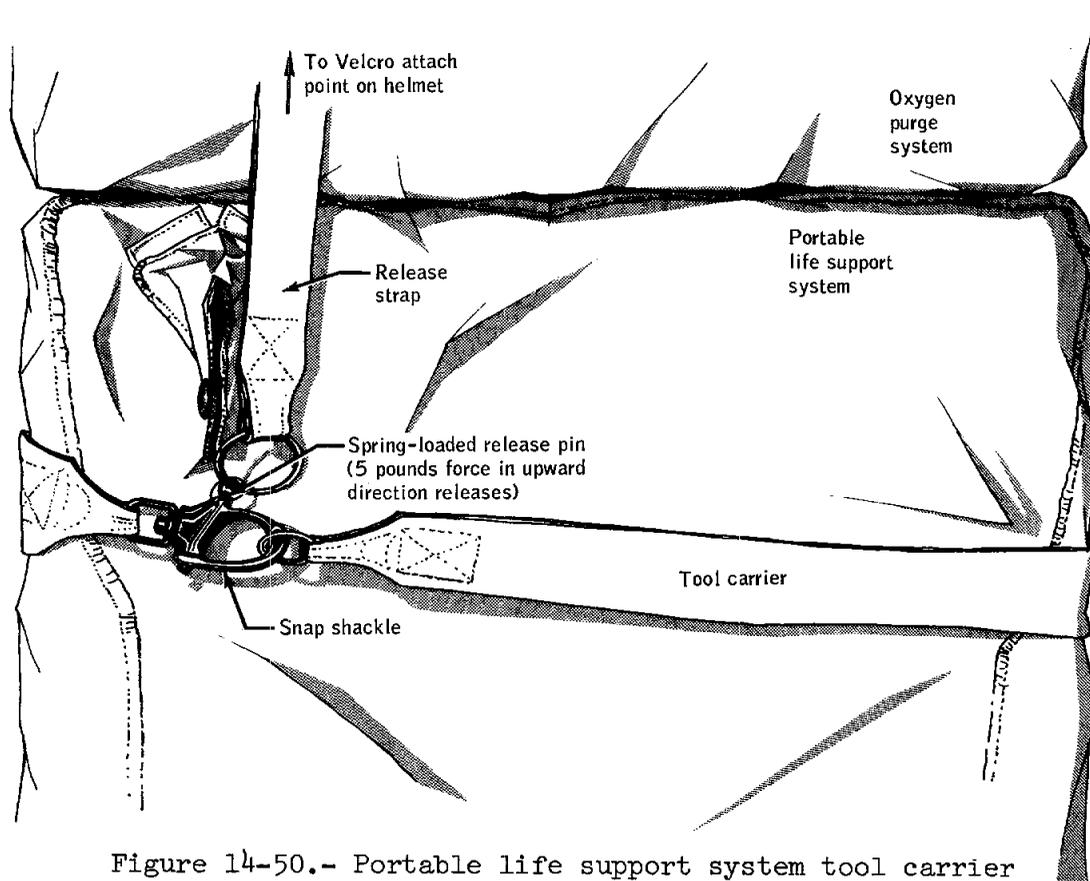
Figure 14-50.- Portable life support system tool carrier spring-pin shackle connection.

The harness is held together by a quick-disconnect snap buckle which has a spring-loaded release pin (fig. 14-50). Only a small force (5 lb) on the release strap is required to move the pin. The pin was inadvertently pulled during the cabin activity.

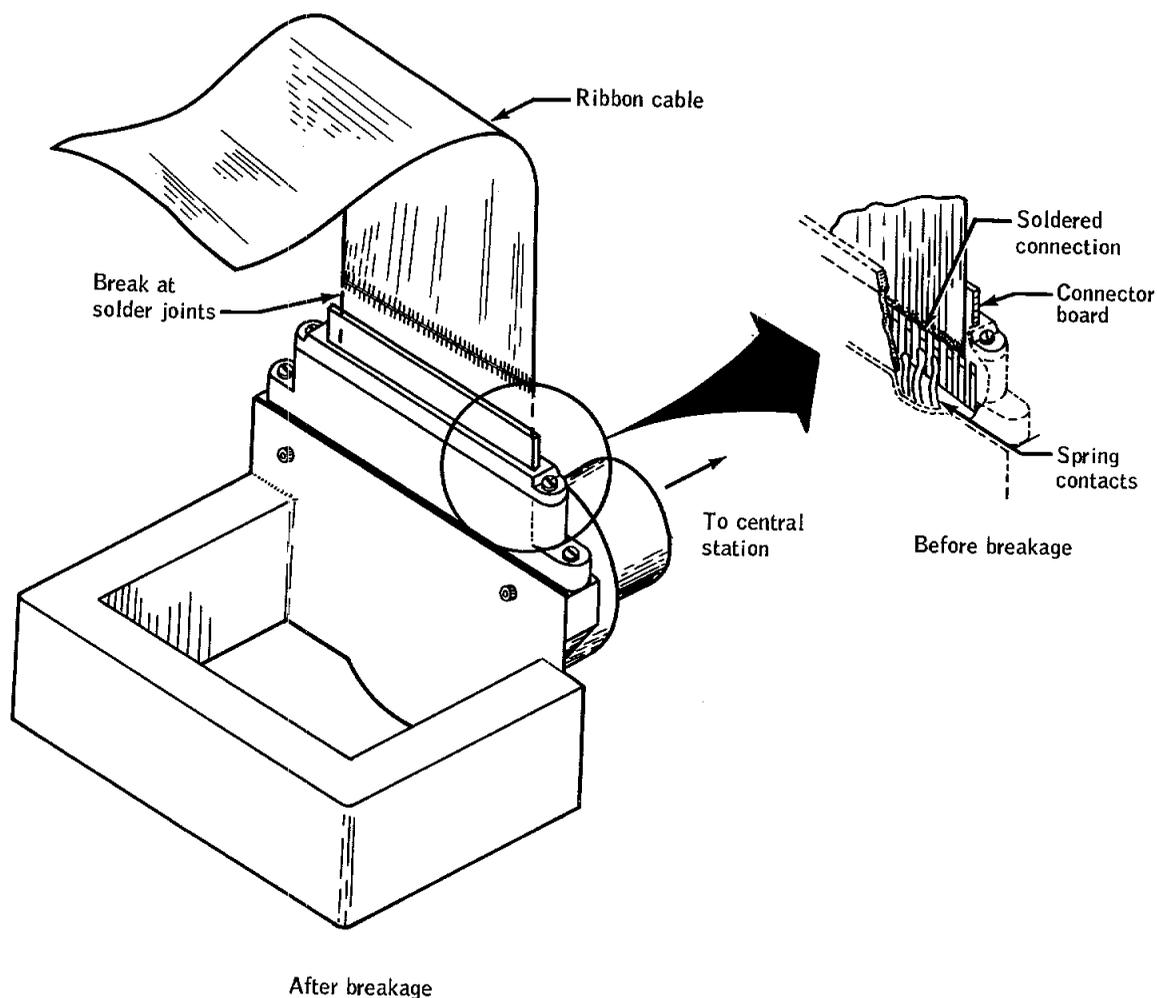
Figure 14-51.- Heat flow experiment connector.

The heat flow experiment is stowed on subpackage 2. Upon arrival at the Apollo lunar surface experiments package deployment site, the experiment is removed from the subpackage and the electrical ribbon cable is connected to the central station by an Astromate connector (fig. 14-51). The cable is bonded and soldered to a printed circuit board which is clamped in a connector. The cable-to-board joint is reinforced by two to four thicknesses of 0.5-mil Kapton tape.

Pull tests performed on the cable/Astromate connector configuration indicate the strength at the cable/board interface was 31 pounds. A modified joint assembly (fig. 14-52) which provides for strain relief and has a pull strength of over 100 pounds will be used for the heat flow experiment connector and similar connectors on Apollo 17.

No corrective action is required as the experiment is not scheduled for another mission.

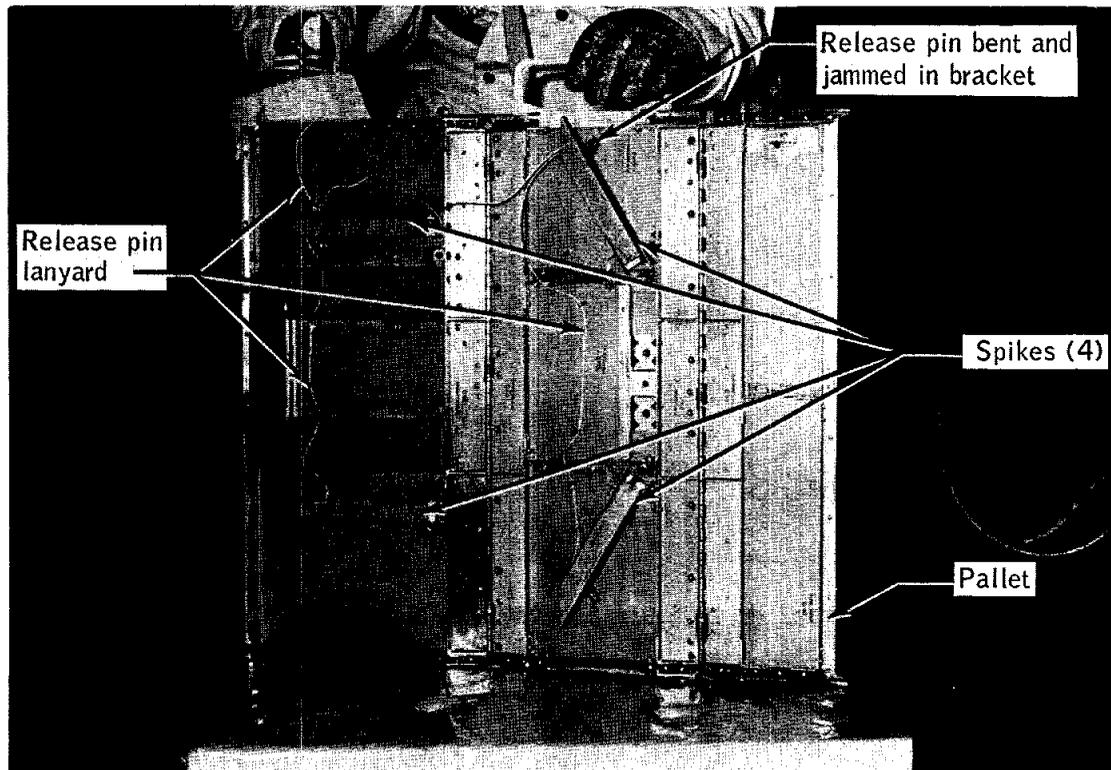
Figure 14-53.- Bottom view of active seismic experiment mortar package pallet.

The mortar package pallet assembly includes four 7-inch long stakes (fig. 14-53) which deploy normal to the pallet when the release pins are removed. When the pallet is properly positioned, the stakes are pressed into the lunar surface to provide additional stability to the platform.

Tests performed during the development of the pallet assembly showed three deployed stakes are adequate to provide stability.

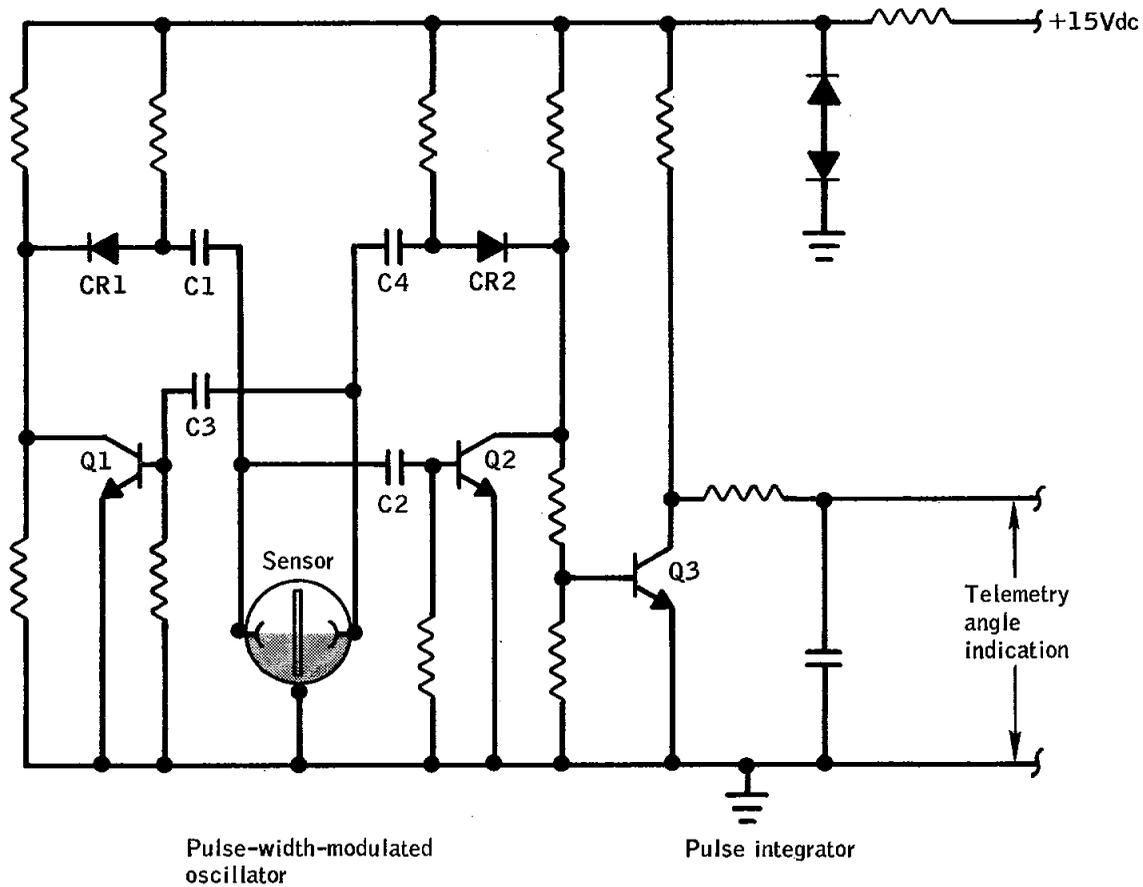
Figure 14-54.- Roll or pitch angle sensor electronics.

The sensor circuitry includes a free-running multivibrator, with the pulse-width ratio controlled by the sensor which functions as a potentiometer (fig. 14-54). Numerous failure possibilities in the circuit, such as open transistors, shorted capacitors, and open solder joints could have caused failure of the multivibrator and the off-scale high reading.

Note: An open in any component in the pulse-width-modulated oscillator (CR1, CR2, C1, C2, C3, C4, Q1 and Q2) is a single-point failure, or an open in the pulse integrator (Q3) is a single-point failure.

No corrective action is required as the experiment is not scheduled for another mission.

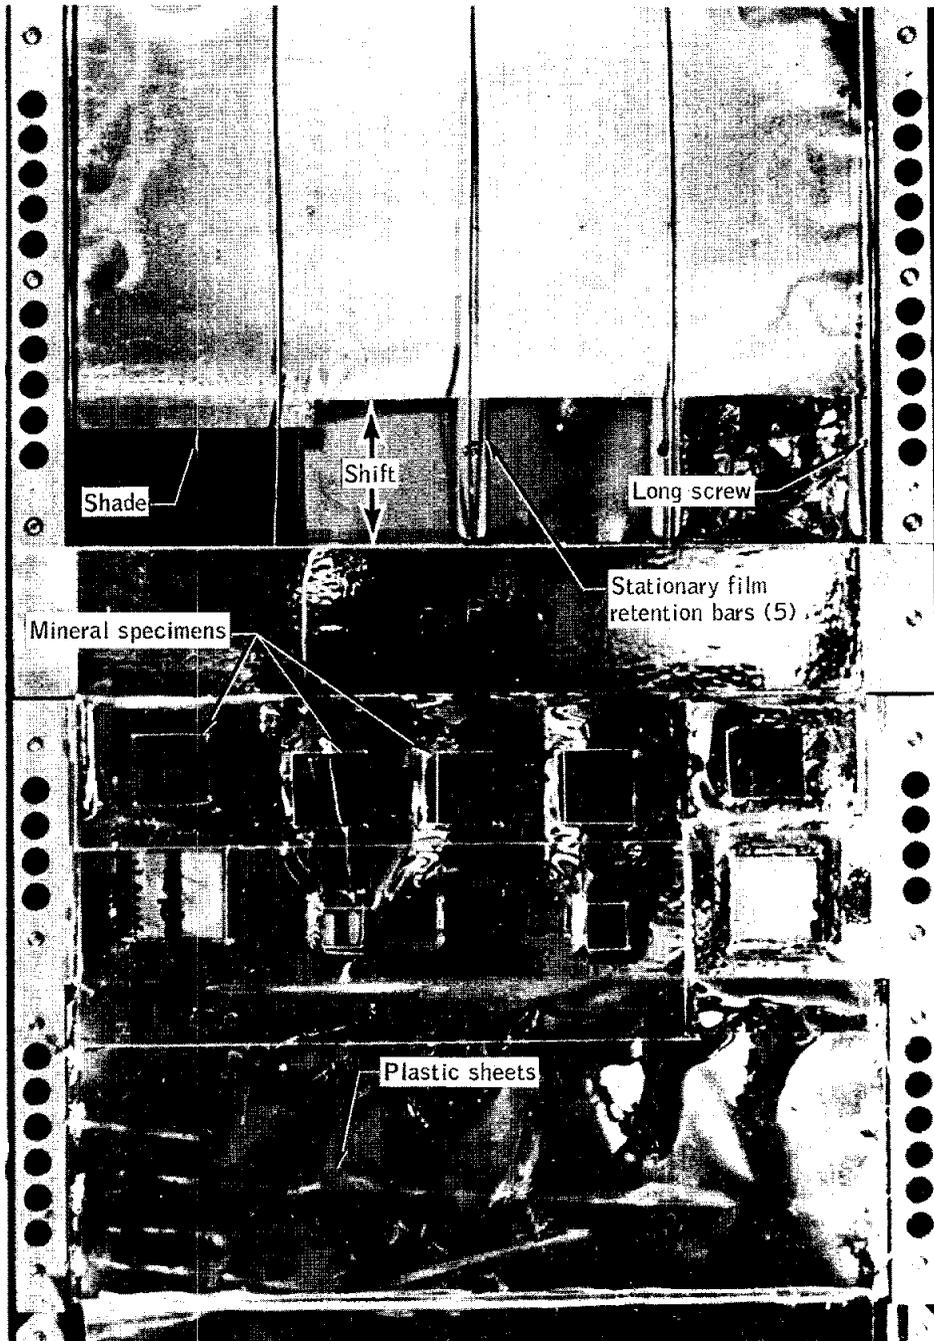
Figure 14-55.- Panel 4 with partially deployed shade.

The Commander pulled the red-ring lanyard to shift the shade in panel 4. The shade moved only 1 inch instead of about 3.5 inches and the lanyard broke.

A movable platinum shade (fig. 14-55) covers the top half of panel 4 during translunar flight and until after the radioisotope thermoelectric generator is removed from the area during lunar surface operations. The

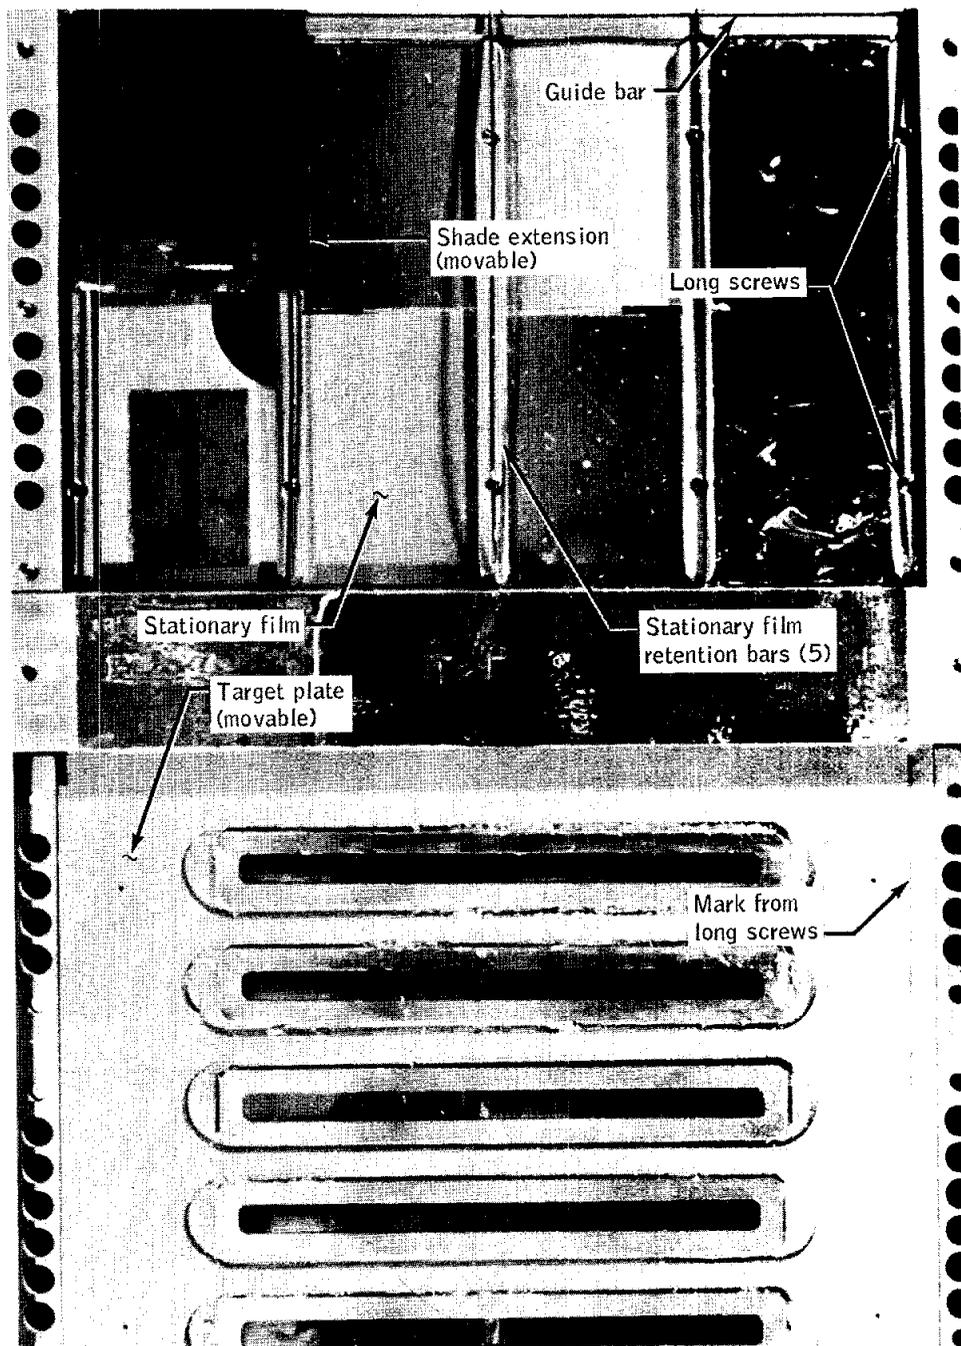
Figure 14-56.- Panel 4 target plate and fully deployed shade.

Figure 14-56 shows the panel 4 assembly with the target plate and shade fully deployed after having backed off the two projecting screws. Note the rub mark from the screws on the target plate.

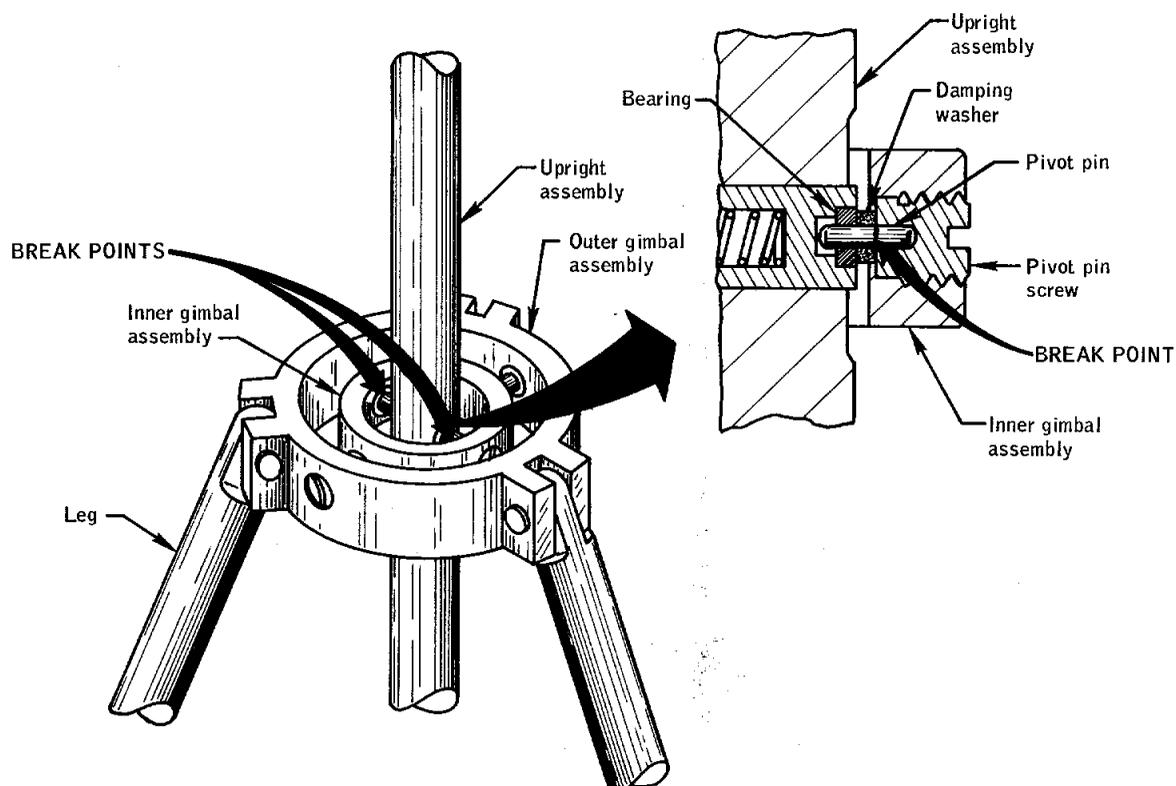
Figure 14-59.- Gnomon gimbal assembly

The staff can be separated from the leg assembly by backing out the gimbal pivot screws. However, all four screws must be backed out (fig. 14-59). There was no indication in the photographs of any screws backing out. During ground operations, a staff separated from the leg assembly by breaking the inner gimbal pivot pins. The break occurred where the 0.040-inch-diameter pivot pin is pressed into the pivot screw.

The pivot assembly consists of standard high-speed steel reamer blank material pressed into a stainless steel adjusting screw or retainer. The reamer blank material provides the high strength and hardness required,

but has a tendency to be brittle without additional tempering. In addition, the combination with stainless steel can be conducive to stress corrosion. Either, or a combination, of the two conditions is considered as the most likely cause of the anomaly.

Pivot pins for the Apollo 17 gnomon will be given the additional tempering required for greater toughness, and a thin film of oil will be applied for protection against corrosion. Ground tests have shown the

damping will be unaffected. Assembly of the pin in the screw will be delayed until as late as possible before launch so as to reduce the time for possible stress corrosion to occur.

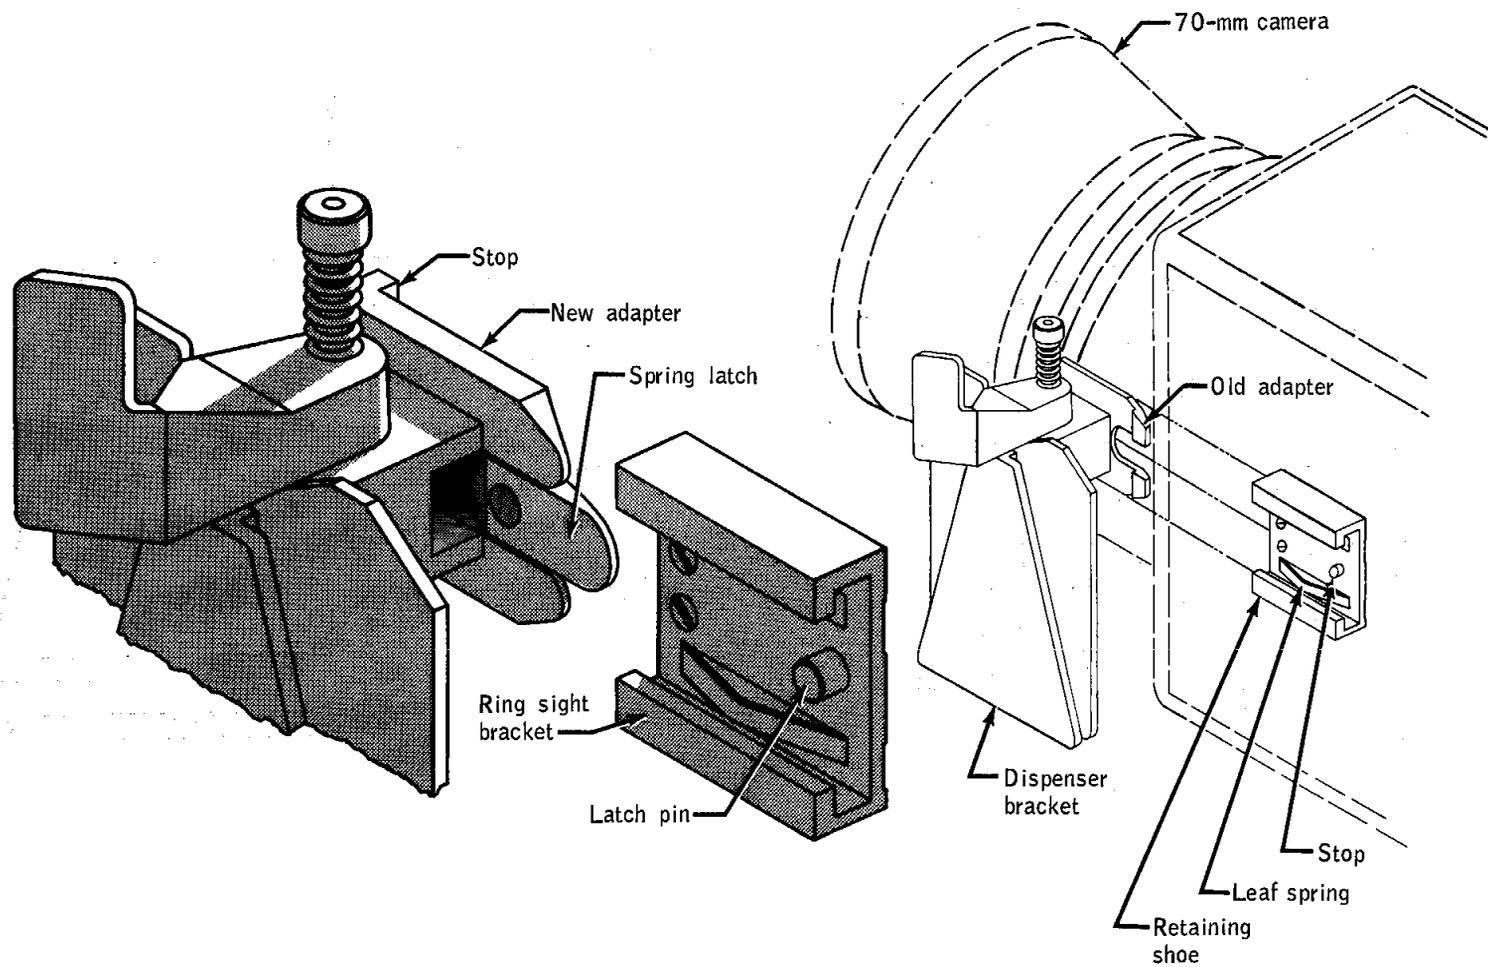
Figure 14-60.- Sample bag dispenser retention.

The dispenser is mounted on an adapter (fig. 14-60) which is inserted in the ring-sight tee-slot bracket on the camera. The adapter-to-tee slot interface is horizontal and depends on springs in the tee slot to hold the adapter in the latched position. This latching method is inadequate.

The adapter has been redesigned so as to provide a positive lock in the installed position as shown in figure 14-60.

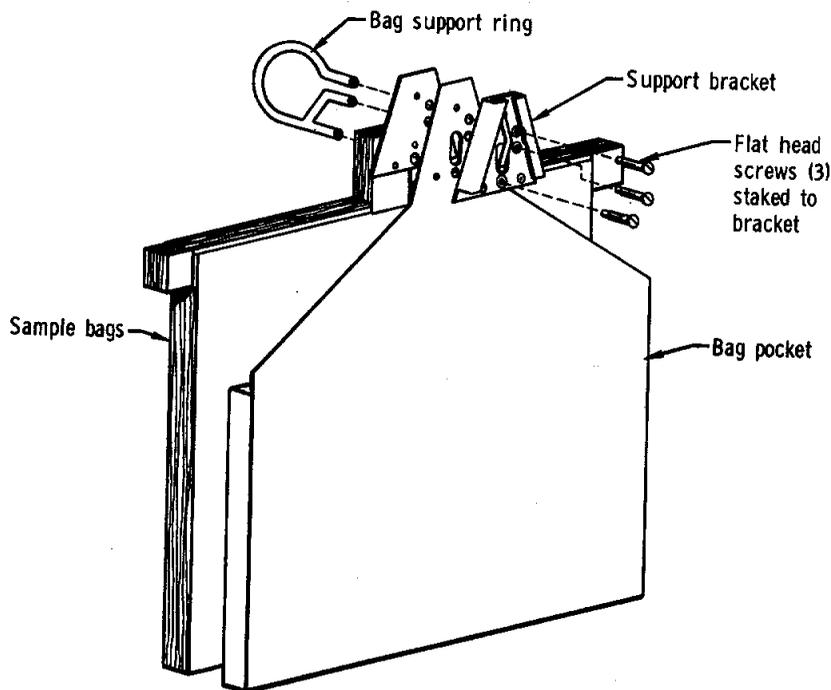
Figure 14-61.- Documented sample bag dispenser assembly.

The three flat-headed stainless steel screws mate with threads in the aluminum ring (fig. 14-61). The heads are staked to the aluminum bracket plate. Thread sealant materials are not permitted because of the possibility of lunar sample contamination.

The Apollo 17 dispensers will be re-inspected to assure proper staking of the screws and tightness of the threads in the aluminum ring.

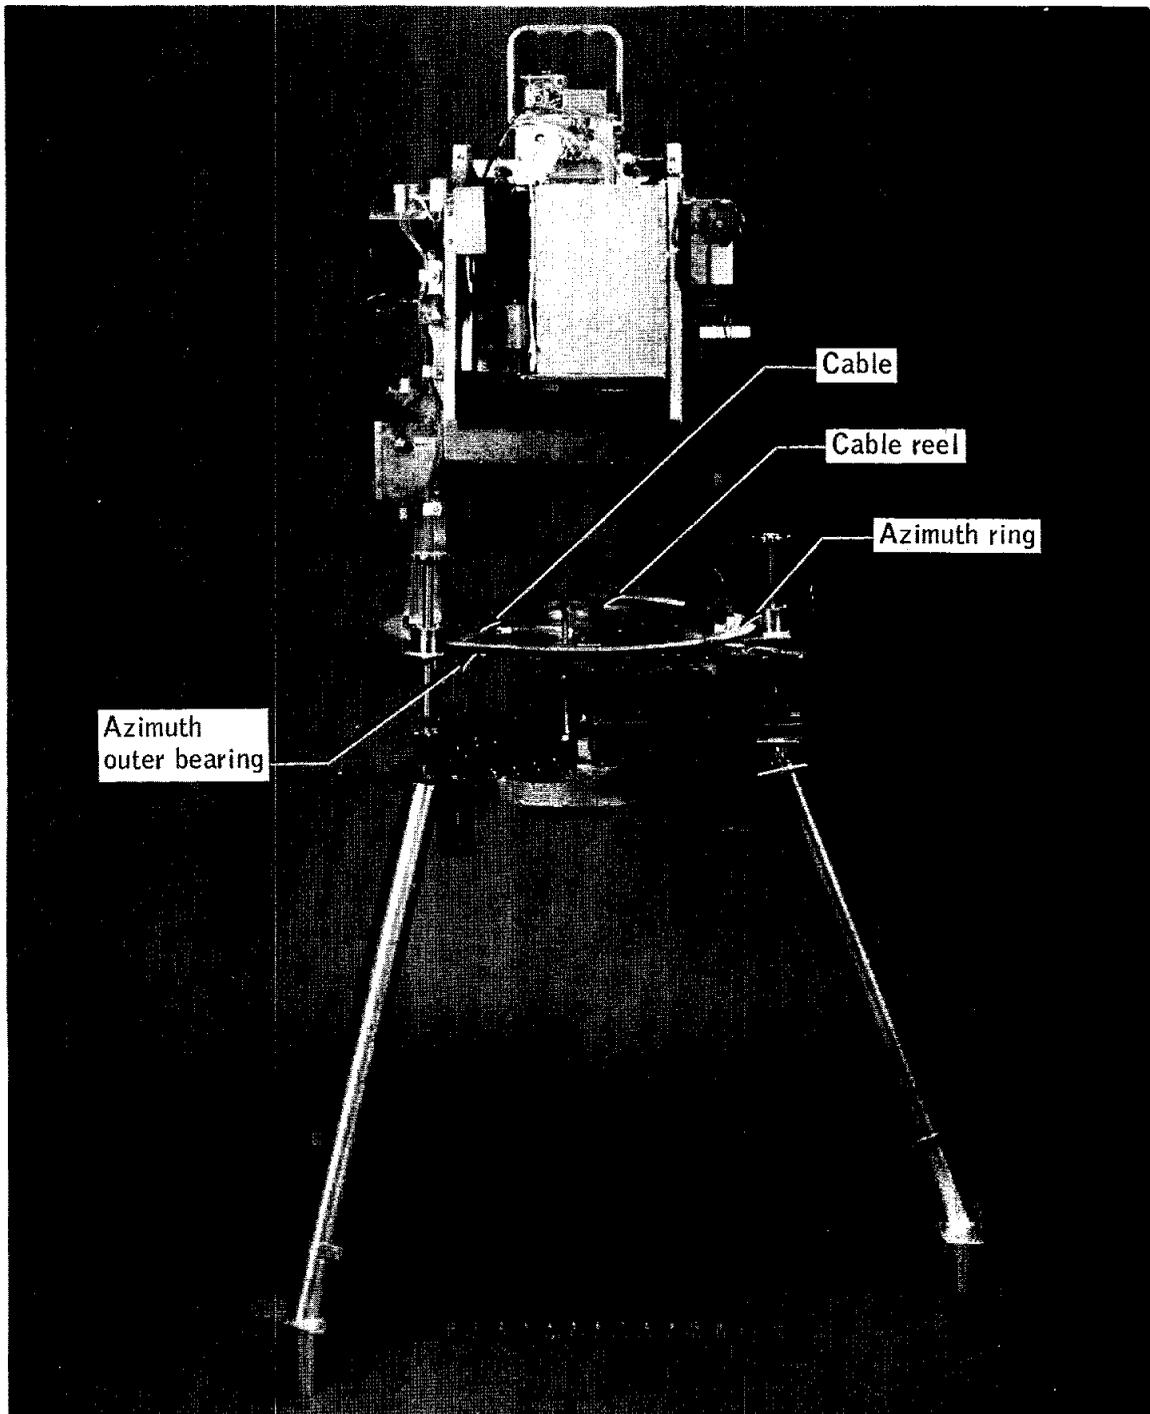
Figure 14-63.- Far ultraviolet camera.

To adjust the azimuth to the proper dial reading, the camera is rotated on a 12.5-inch diameter ball-bearing ring (fig. 14-63). The bearing is not sealed; however, the crew did not observe any lunar dust on the bearing.

The azimuth ring bearing was packed with a waxy, low-outgassing grease which stiffens appreciably at temperature below 50° F. This grease is normally used as a sealant rather than a lubricant. The camera was intentionally kept in the shade to protect the film from high temperatures. As a result, the grease stiffened. The manual azimuth adjustment operation was not included in cold chamber tests with other operations of the camera.

The difficulty was caused by the use of the wrong type of grease in the azimuth ring bearing.

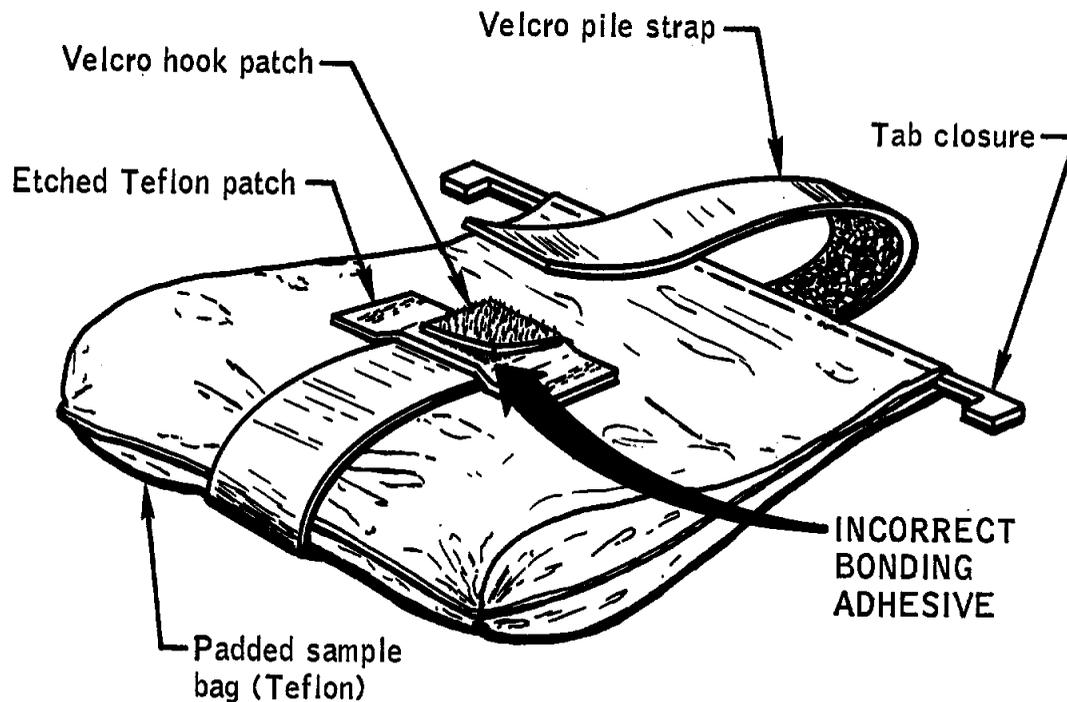
Figure 14-64.- Padded sample bag.

When the crew wrapped the Velcro strap around each of the padded sample bags to further secure them, the Velcro attachment patches came off the bags and the straps were ineffective.

A 20-inch-long wrap-around Velcro pile strap is provided to hold the bag closed in addition to the usual tab closure (fig. 14-64). One end of the strap is bonded with a fluorel adhesive to an etched Teflon patch which

is heat-sealed to the Teflon bag. A Velcro hook patch is bonded to the etched Teflon patch with a pressure-sensitive adhesive and provides the attach point for the other end of the strap. The peel strength of the pressure-sensitive bond was less than that of the Velcro pile-to-hook connections. Consequently, when the Velcro strap was adjusted to the proper tension, the hook patch came off the bag.
