MSC-07230

APOLLO 16 MISSION REPORT

MANNED SPACECRAFT CENTER

AUGUST 1972

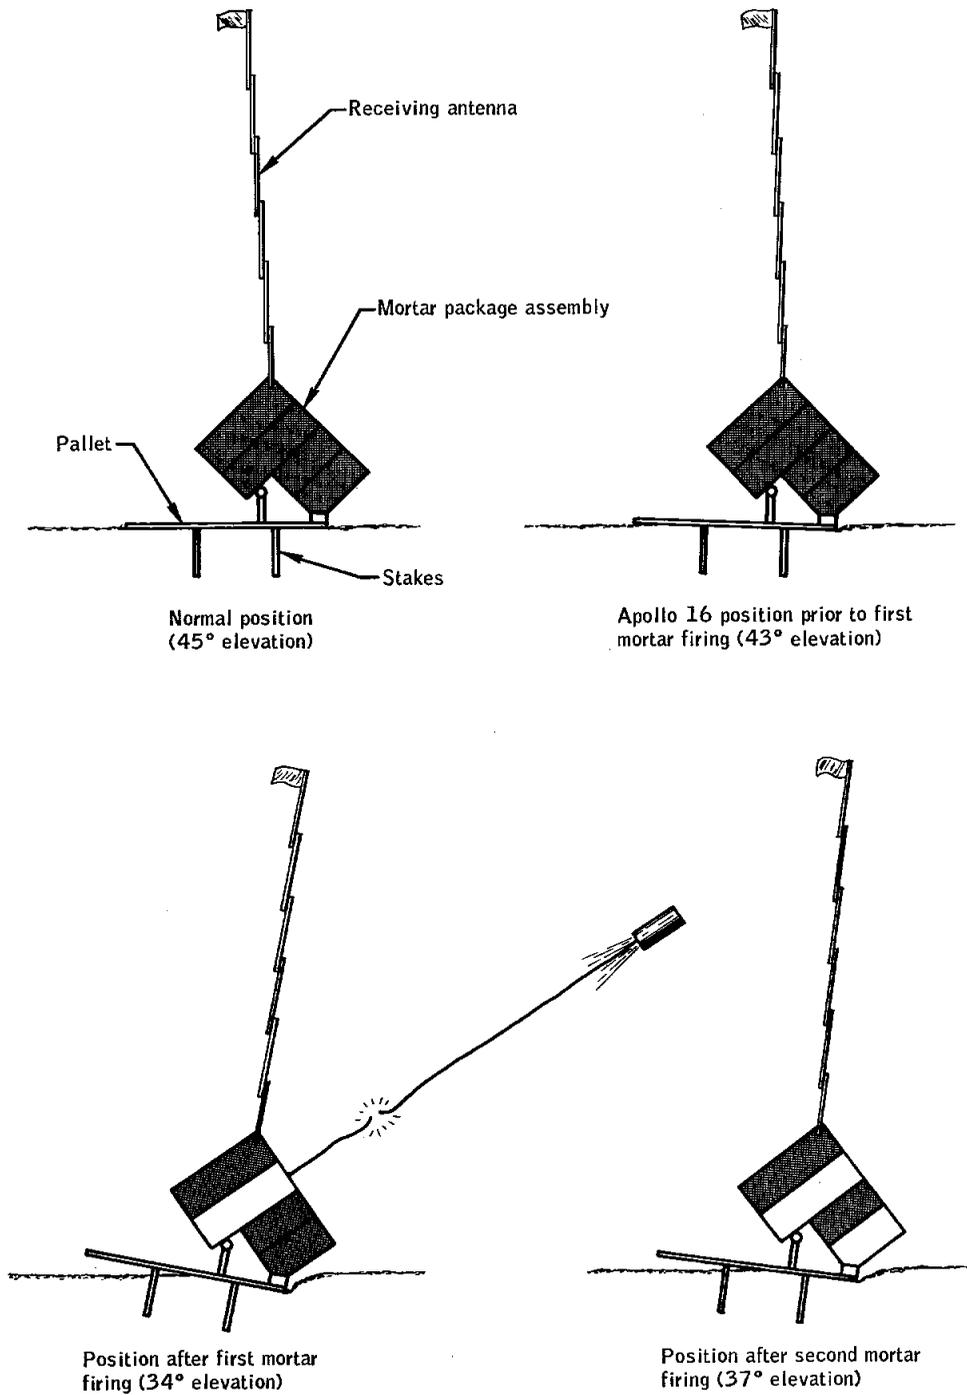
Figure 14-65.- Pitch movement of mortar package assembly.

Immediately prior to launching the third grenade, the pitch sensor indicated that the mortar package assembly was pitched down about 8° from the nominal plus 45° elevation (fig. 14-65). Within 2 seconds after firing the mortar, the sensor indication was off-scale-high and has remained off-scale-high.

Based on ground tests during which the assembly was rotated through 360°, an off-scale-high indication means either that the mortar package assembly is pitched up between 25° and 155° above the normal plus 45° elevation, or that the sensor has failed. There are two stable positions of the mortar package and pallet assembly between these two points: (1) pitched up 30° above normal (75° elevation), and (2) pitched up 135° above normal (180° elevation). The temperature profiles for the two temperature sensors on the mortar package assembly, when compared with the calculated temperature profiles for elevations of 45° and 75°, indicated that the mortar package assembly was not in the 75° elevation position. In the 180° elevation position, the receiving antenna would have been broken off or badly bent and lying on the ground. In this case, complete real-time event data would not have been received during the flight of the third grenade. However, complete real-time event data were received during the entire 19-second flight, indicating that the mortar package assembly was not in the 180° elevation position.

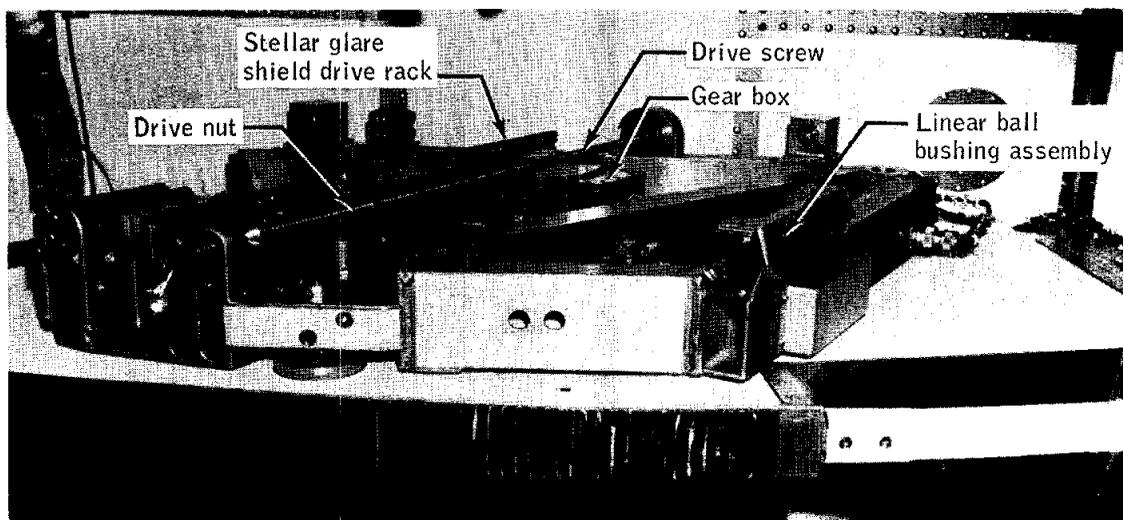
Figure 14-66.- Mapping camera deployment mechanism.

Deployment rails attached to the bottom of the camera slide through ball-bushings that are part of the deployment mechanism (fig. 14-66). Deployment of the camera is accomplished by the drive screw turning within the drive nut, which is bolted to the camera. Friction in this screw-nut drive is minimized through the use of recirculating streams of ball bearings riding between the threads of the nut and screw.

Preflight deployment operations had disclosed a chattering noise in the mechanism when the retraction was aided by the pull of the cable harness to the camera. An analysis of the drive train indicates that a state of dynamic instability may exist in a zero-g environment because of the resultant loss of the damping provided by the deployment rail friction. Simulated zero-g tests are being conducted by suspending the camera with a long cable in order to remove the weight from the rails while maintaining the inertial properties of the camera during the deployment.

A separate anomaly report will be published upon completion of analysis and testing.

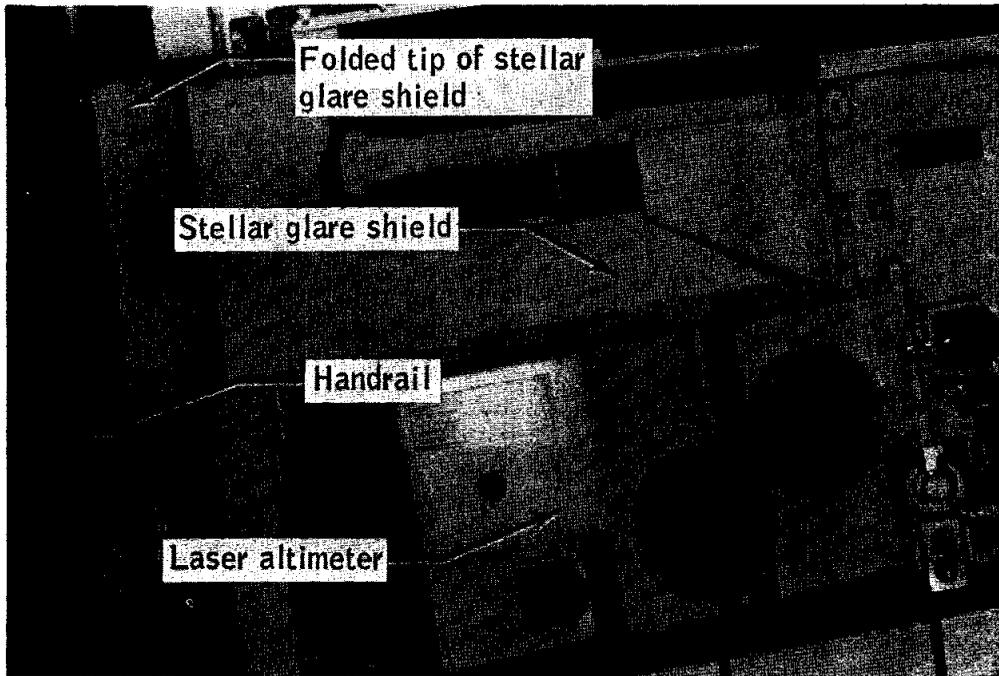
The Command Module Pilot observed that the glare shield for the stellar camera was jammed against the handrail paralleling the scientific instrument module bay (fig. 14-67) during the transearth extravehicular activity. In the 16-mm photography of the extravehicular activity, the outermost edge of the folding tip of the glare shield is visible above the handrail, in the fully-extended position as shown in figure 14-64.

Scientific instrument module bay photographs taken from the lunar module indicate that the glare shield was properly retracted at rendezvous; therefore, the failure to retract occurred at the third, fourth, or fifth (last) camera retraction. A review of the stellar film indicates that this anomaly did not affect the stellar photography.

Figure 14-67.- Mockup photograph of glare shield handrail.

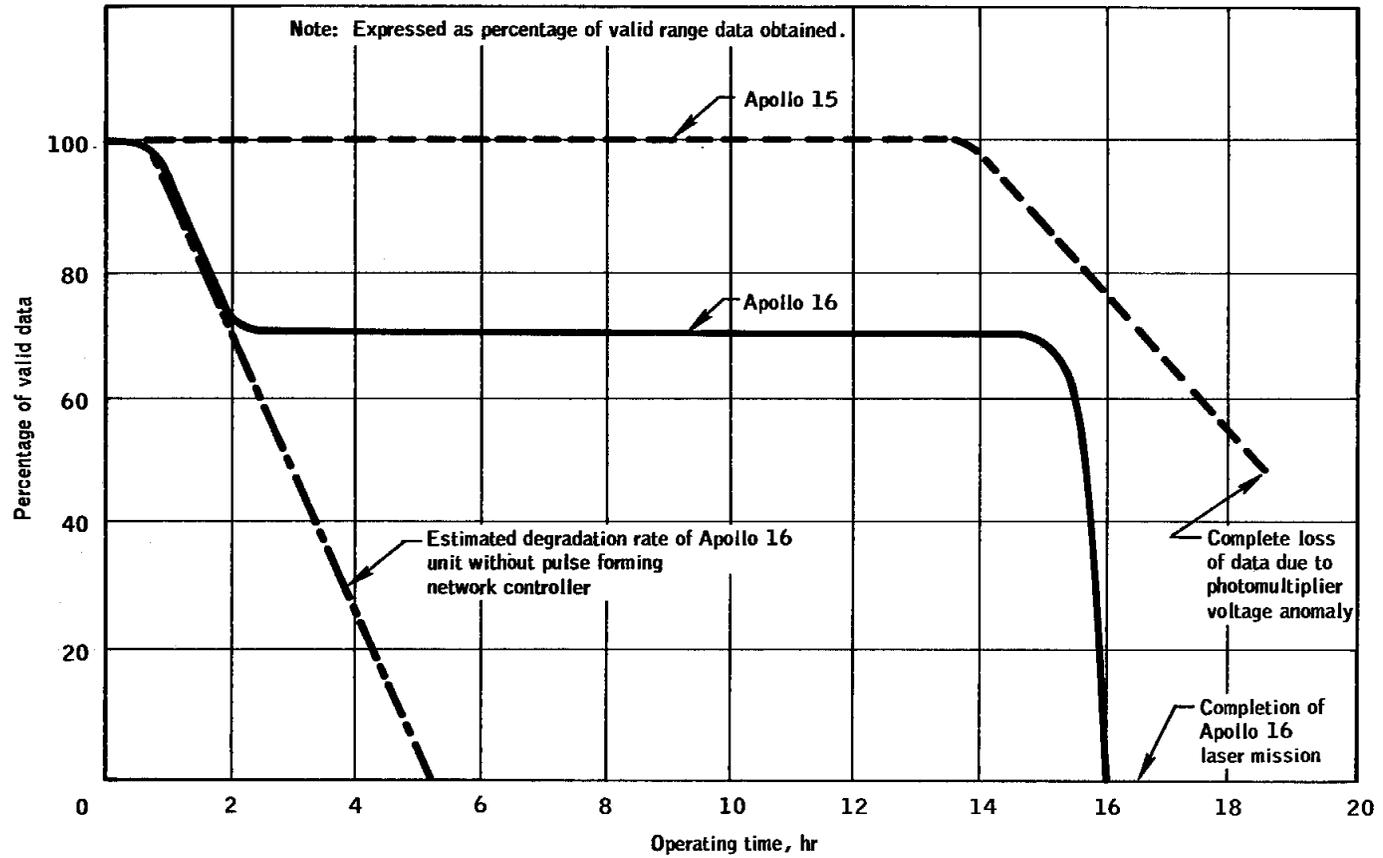
There were approximately 2400 laser operations (firings) during the mission. The laser output appeared to degrade more rapidly than during the Apollo 15 mission (fig. 14-68) but was compensated by the action of the pulse forming network voltage controller added for this purpose as a result of the Apollo 15 anomaly. The voltage controller consists of a laser power status sensor (photodiode) located inside the laser module and associated circuitry to increase the output of the pulse forming network power supply if the sensed laser power is lower than a pre-established threshold.

Figure 14-68.- Laser degradation versus operating time.

The plots of data validity versus operating time in figure 14-68 are approximate in that the effects of laser module temperature and lunar surface illumination have been averaged out. During the first 11 hours of laser operation during Apollo 15, the command and service module was in a highly eccentric orbit which, due to the range limitations of the laser altimeter, caused the loss of approximately 50 percent of the altitude data. Since the data loss was not due to a hardware malfunction, the curve for Apollo 15 is drawn at 100 percent during this period.

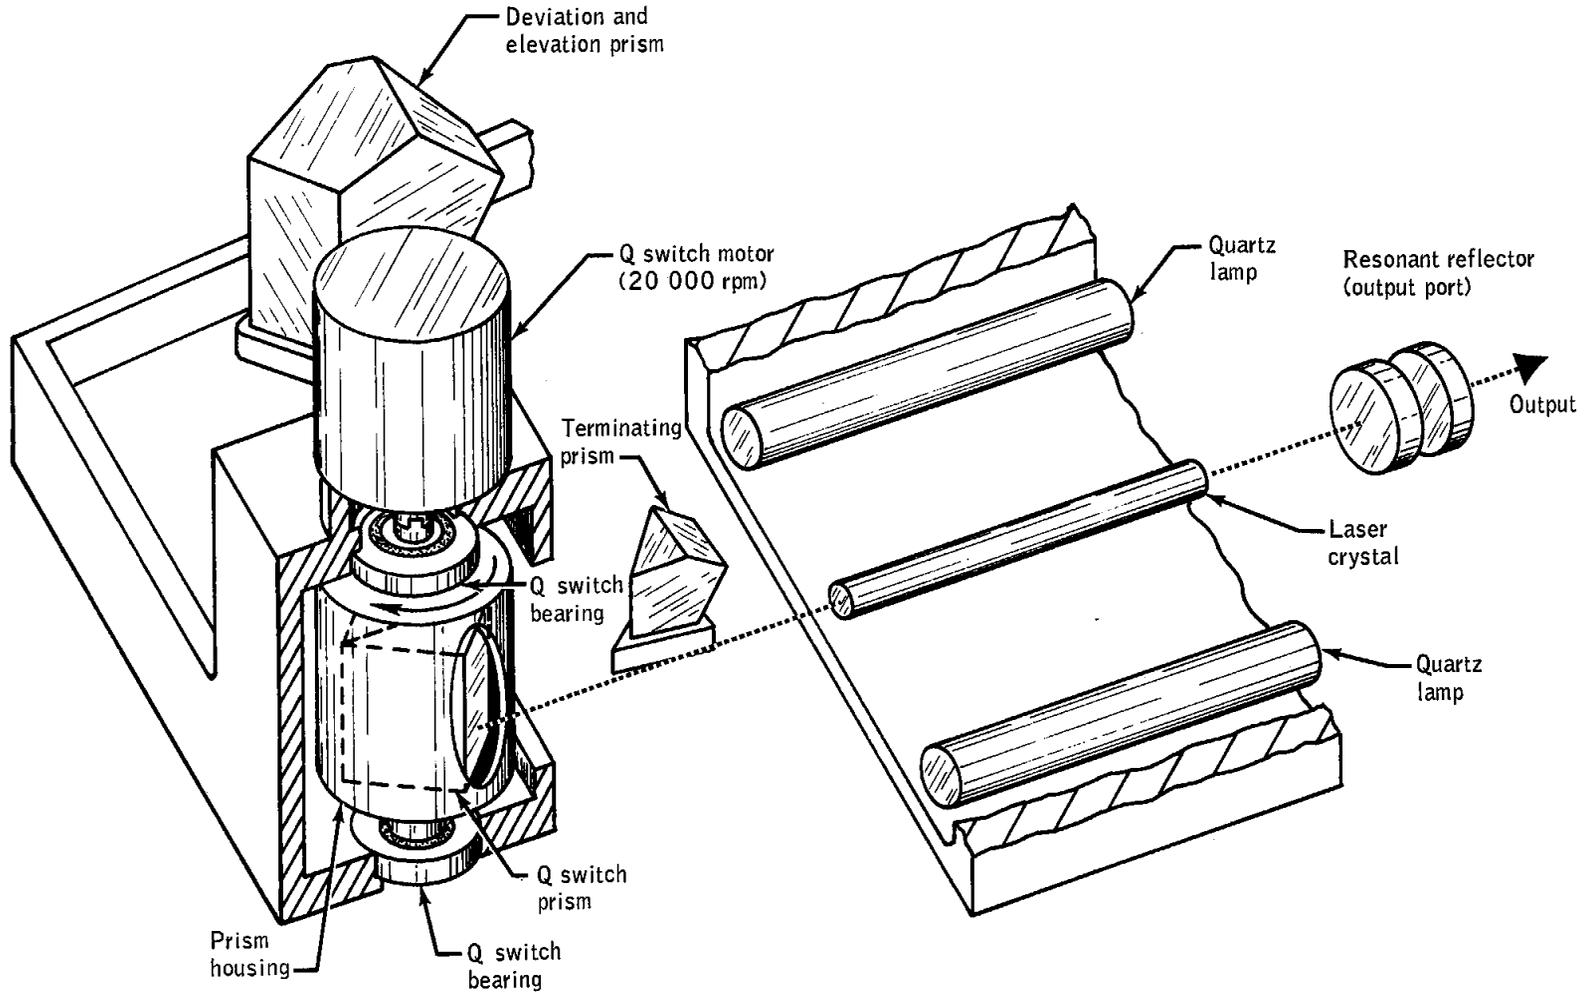
Analysis of the Apollo 15 failure indicated that the most probable cause was contamination of the internal optical surfaces by oil from the Q-switch bearings (fig. 14-69). Consequently, a delta qualification test was performed on a laser module, using new bearings incorporating oil-retainer shields. The qualification test consisted of a 220-hour thermal vacuum test which included a 50.5-hour mission operation timeline. Over 9000 laser firings were performed and the voltage controller had only reached step 4 by the end of the test.

Contamination of the optical surfaces within the laser module is considered to be the most likely cause of the degradation. A secondary cause is the degradation of the flashlamps because of discoloration of the lamp quartz as the result of the repeating high intensity light flashes and impurities in the quartz. The lubricant in the Q-switch motor and rotor bearings is apparently the principal source of contamination. Bearing life tests indicated that elimination of the oil reservoir in the bearings by the use of oil-impregnated bearings does reduce oil migration. Consequently, the Apollo 17 laser module will be modified to incorporate Q-switch bearings with oil-impregnated ball retainers and selection of flashlamps using a high purity quartz which is not as subject to degradation. Cover plates, installed over both access openings to the motor coupling, will complete the enclosure of the motor bearing.

Figure 14-69.- Laser altimeter module light reflection components.

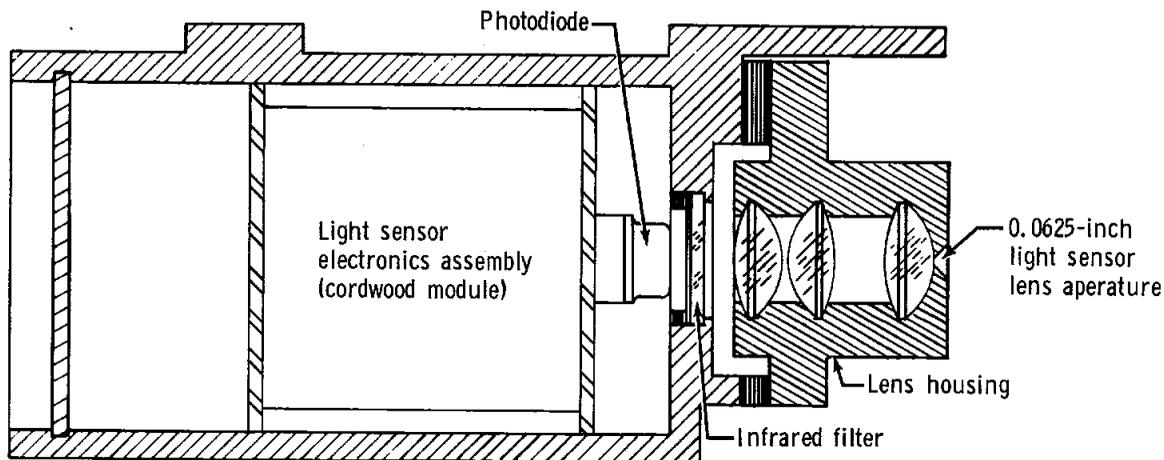
The problem could have been the result of contamination on the sensor optics or a failure in the light sensor or its associated circuitry (fig. 14-71). Analyses and tests have shown that component open or short circuit failures could not have caused the problem since the amount of overexposure could not be duplicated. Feedback capacitor leakage (equivalent to about 6 megohms leakage resistance), or a decrease in the gain of the photodiode input amplifier (an integrated circuit), or a decrease in photodiode sensitivity, shown in figure 14-70, could have caused the problem. These components, however, have no previous history of these types of failures; therefore, no corrective action will be taken.

A review of data indicates that the problem occurred preflight, at some time between January 5, 1972, and February 25, 1972. The failure was not detected because the test merely ascertained that the light sensor responded to stimulation (a light source placed in front of the sensor). Although sensor output voltage was recorded, no voltage tolerances had been established for the test.

Figure 14-71.- Panoramic camera light sensor assembly.

To preclude a similar problem not being detected in ground testing, sensor output voltage limits have been added to the test procedure.

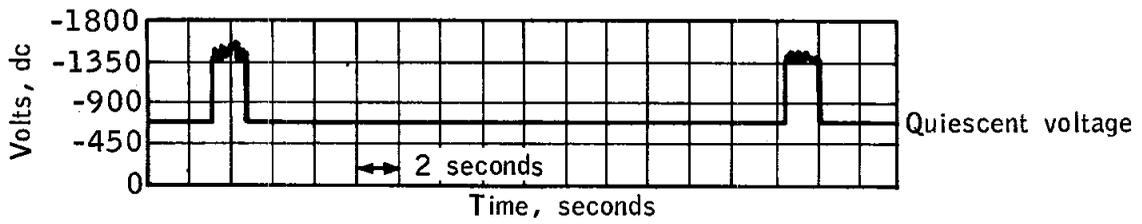
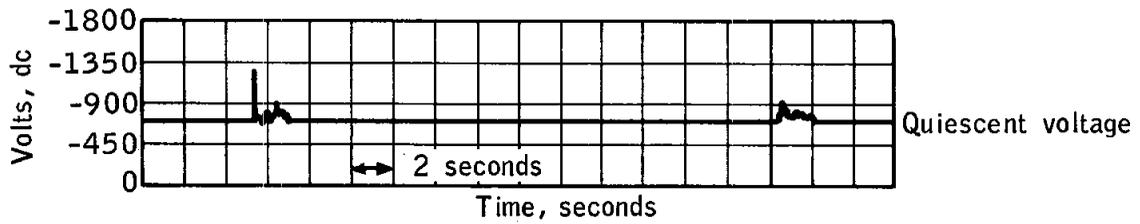
During the revolution-60 operation of the laser altimeter, the high voltage supply for the photomultiplier tube was occasionally erratic. During the next operating period (revolution 63) the erratic behavior became more pronounced (fig. 14-72), and there were several instances when the voltage failed to rise from the quiescent (idling) level.

Figure 14-72.- Laser altimeter photomultiplier voltages.

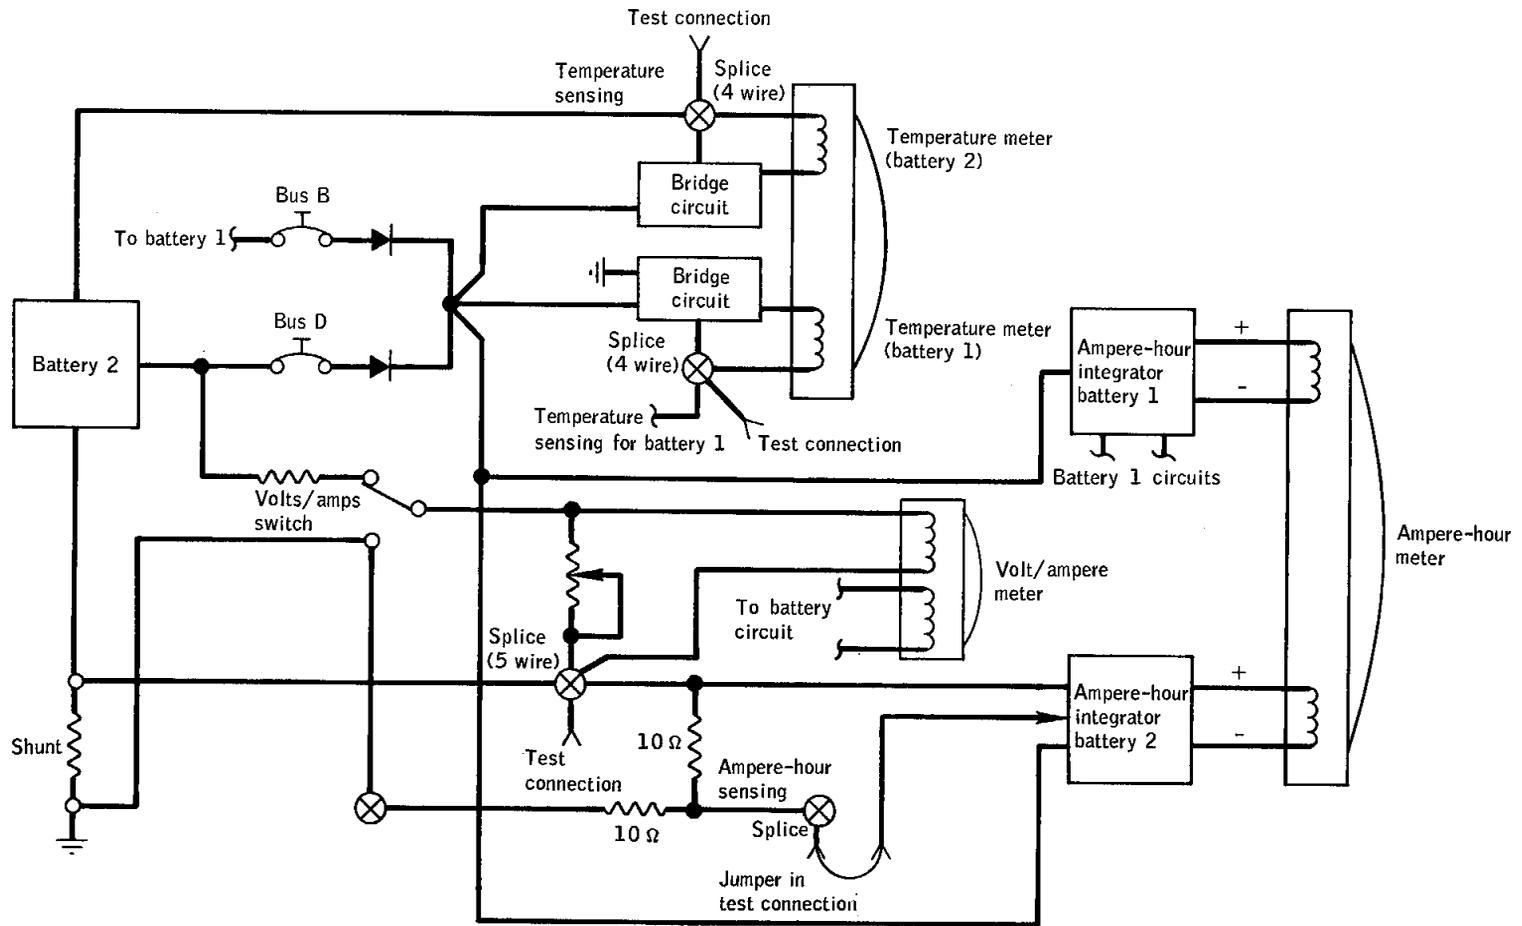
The circuitry associated with the electrical system meters is shown in figure 14-76. Note the multiple wire-crimp splices in the system. The return for the volt/ampere meter is connected to the battery return with a five-wire crimp splice containing one 12-gage wire, one 20-gage wire, and three 22-gage wires. This splice was associated with the electrical modification made on the Apollo 16 lunar roving vehicle at the launch site. An intermittent connection at this splice would explain the volt meter reading off-scale low and then later reading properly. An open connection at this splice would reverse the polarity on the ampere-hour integrator sense line and give a false indication of battery 2 charging as observed during the second and third extravehicular activities (see fig. 14-77). Also, the battery 1 ampere-hour meter indicated a 20-ampere-hour decrease rate which was greater than predicted. However, a review of the data shows that the current readings taken during this period of time were correct and a 20-ampere load was present. Therefore, the ampere-hour integrator for battery 1 was working properly.

Both battery temperatures reading off-scale low and then reading properly could be caused by an intermittent connection at the four-wire splice (fig. 14-76). However, this would require a simultaneous open circuit at two splices initially, which later corrected themselves, and finally, failure of a single splice in the battery 1 temperature circuit.

Figure 14-76.- Lunar roving vehicle electrical meter circuitry.

If no sneak circuit can be identified, the most likely cause of temperature meter anomalies would be the four-wire splice in the temperature meter circuits.

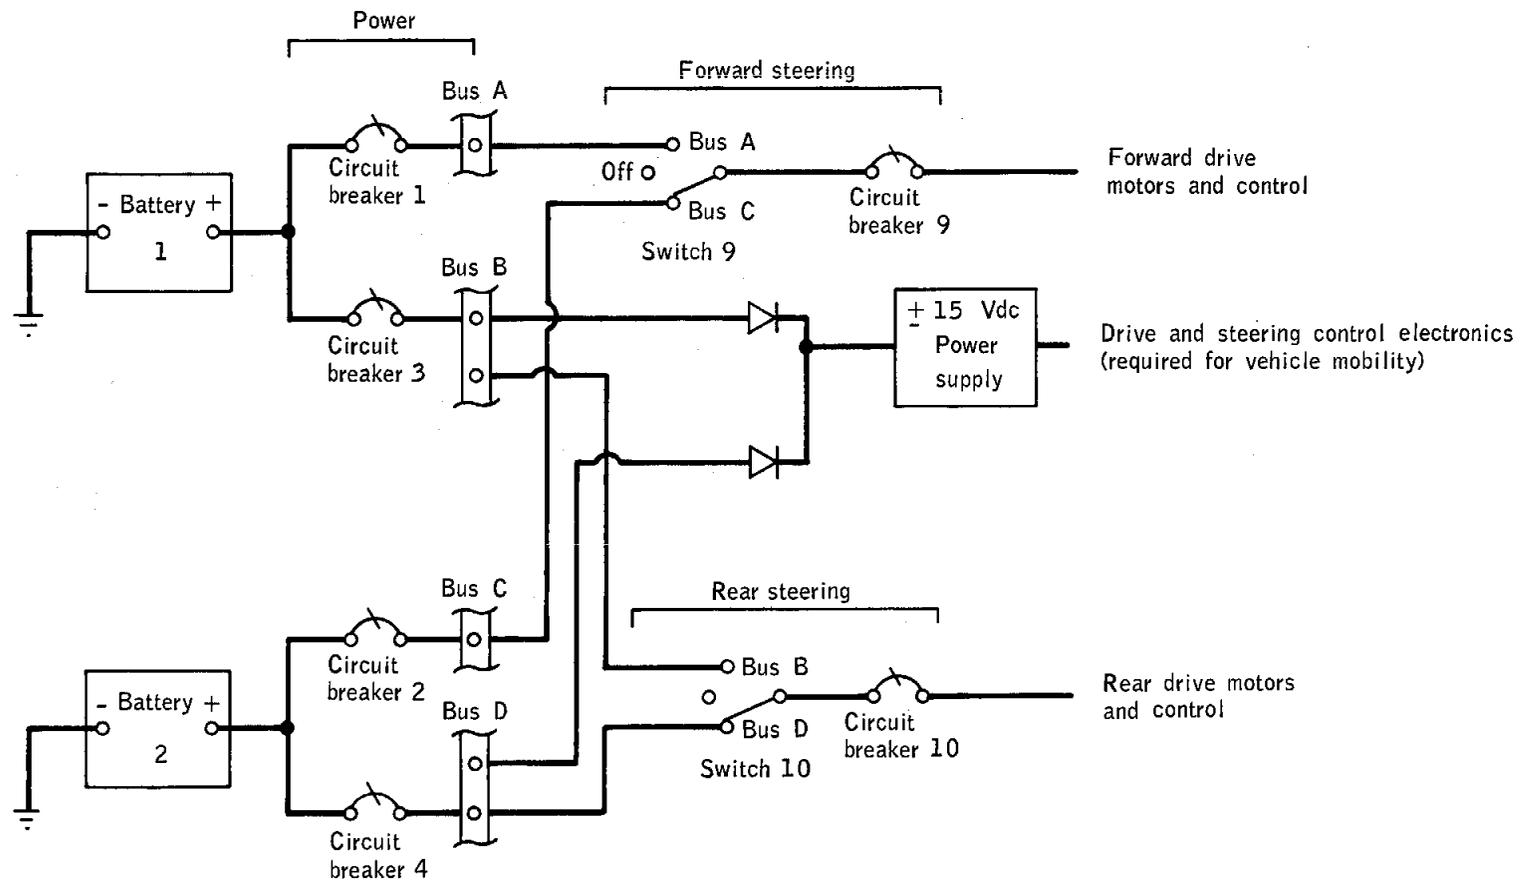
Figure 14-78 shows that switch 10, circuit breaker 10, and circuit breakers 3 or 4 must be closed to provide power to the rear steering system. In addition, circuit breakers 3 or 4 must be closed to provide ± 15 Vdc for the drive as well as steering control electronics. Since the vehicle had both mobility and forward steering, at least one of these breakers made contact. Switch 10 was cycled after vehicle motion; however, the rear steering remained inoperative. Circuit breaker 10 could possibly have been open due to some contaminate existing in the breaker.

Figure 14-78.- Lunar roving vehicle steering power schematic.

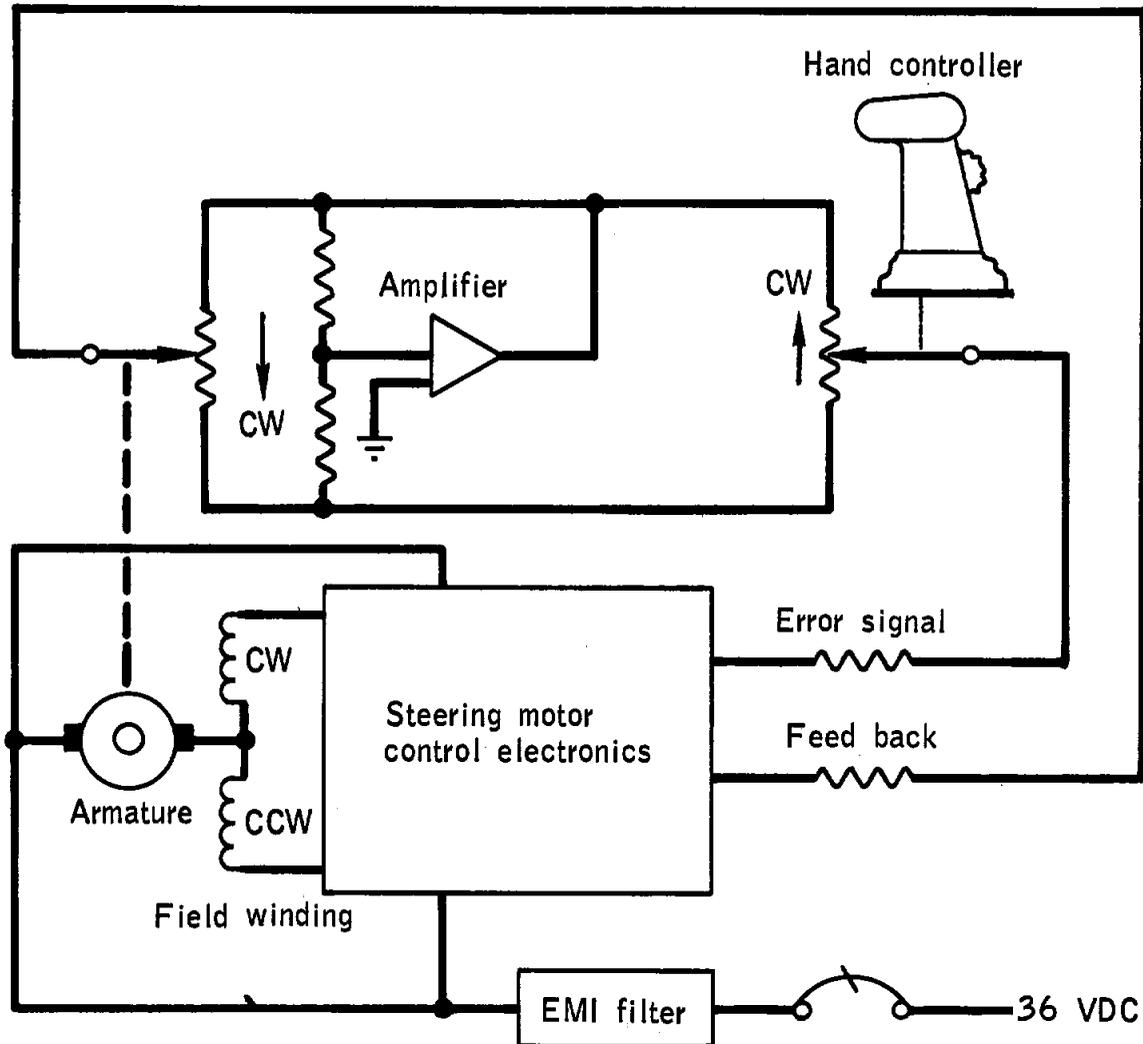
Another possible cause of the anomalous condition is in the steering servo system (fig. 14-79). A signal generated by the hand controller is coupled to the input servo amplifier as an error signal across a bridge. This signal is amplified and applied to the steering motor field coils in a direction determined by the polarity of the input signal which depends upon the direction of the hand controller deflection. The feedback potentiometer is driven by the steering motor in a direction to balance the bridge, thus cancelling the original error signal. A non-conductive lubricant (DC 40), is applied to the wiper and resistive element of the potentiometers to produce smooth operation and reduce noise. At low temperatures, this lubricant could become more viscous and insulate the wiper

Figure 14-79.- Steering system electrical.

from the resistive element. No error signal would then be present at the input to the servo amplifier, although the hand controller was deflected. As the steering electronics heat up, the lubricant becomes less viscous. Exercising the hand controller then cleans the lubricant from the wiper and resistive element, allowing contact to be made. This would account for the anomalous condition. Tests will be conducted to determine the effect of the lubricant on the potentiometers at low temperatures.

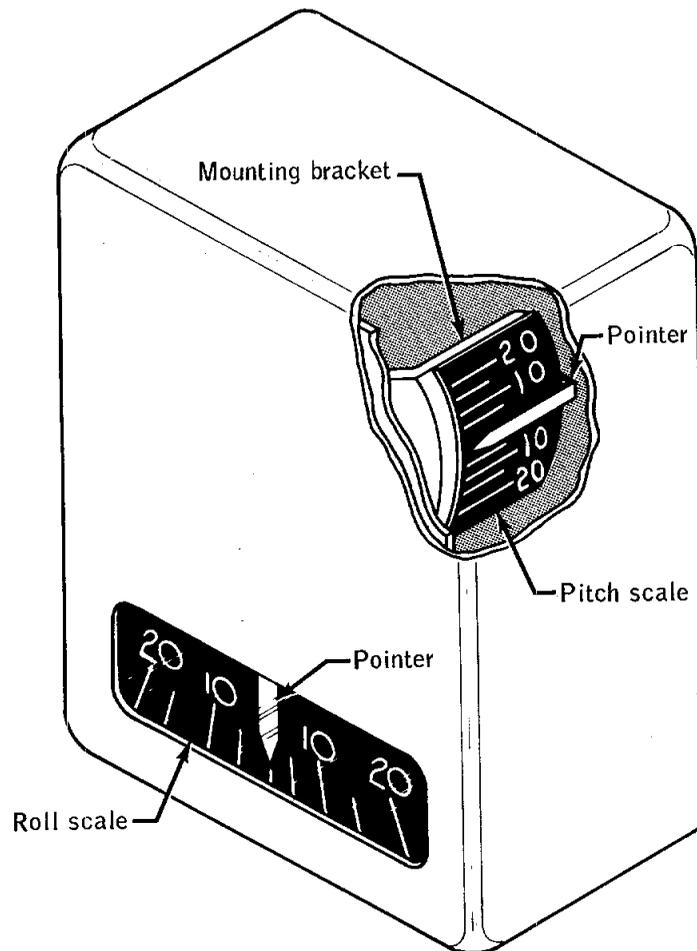
During the second extravehicular activity, the crew reported that the lunar roving vehicle pitch attitude indicator scale had fallen off. The indicator provides a vehicle pitch reference between plus and minus 20 degrees. The loose pitch scale did not impact the mission because the pointer for the indicator continued to work properly and the crew could adequately estimate the vehicle pitch from the pointer position.

The pitch attitude indicator scale is bonded to a bracket (fig. 14-81) which is attached to the indicator case. The scale is constructed of 2024T3

aluminum and the bracket is 6/6 nylon. A comparison of the coefficients of thermal expansion of the materials indicate approximately a 4-to-1 ratio for nylon-to-aluminum. With this expansion ratio, stress factors of safety for an ideal bond are 3 and 4 at temperatures of minus 100° F and plus 250° F, respectively. Although a review of the bonding procedures did not reveal any problems, a flaw most probably existed in the bond and this allowed stress buildup which caused the scale to become unbonded. The crew experienced no difficulty in estimating the pitch angle after the scale became unbonded. The back of the meter case must be machined off to gain access to the scale, and special handling permits must be obtained before working on the meter because of the radioactive materials within the case. For these reasons, no hardware changes will be made for Apollo 17.

Figure 14-81.- Pitch attitude indicator.

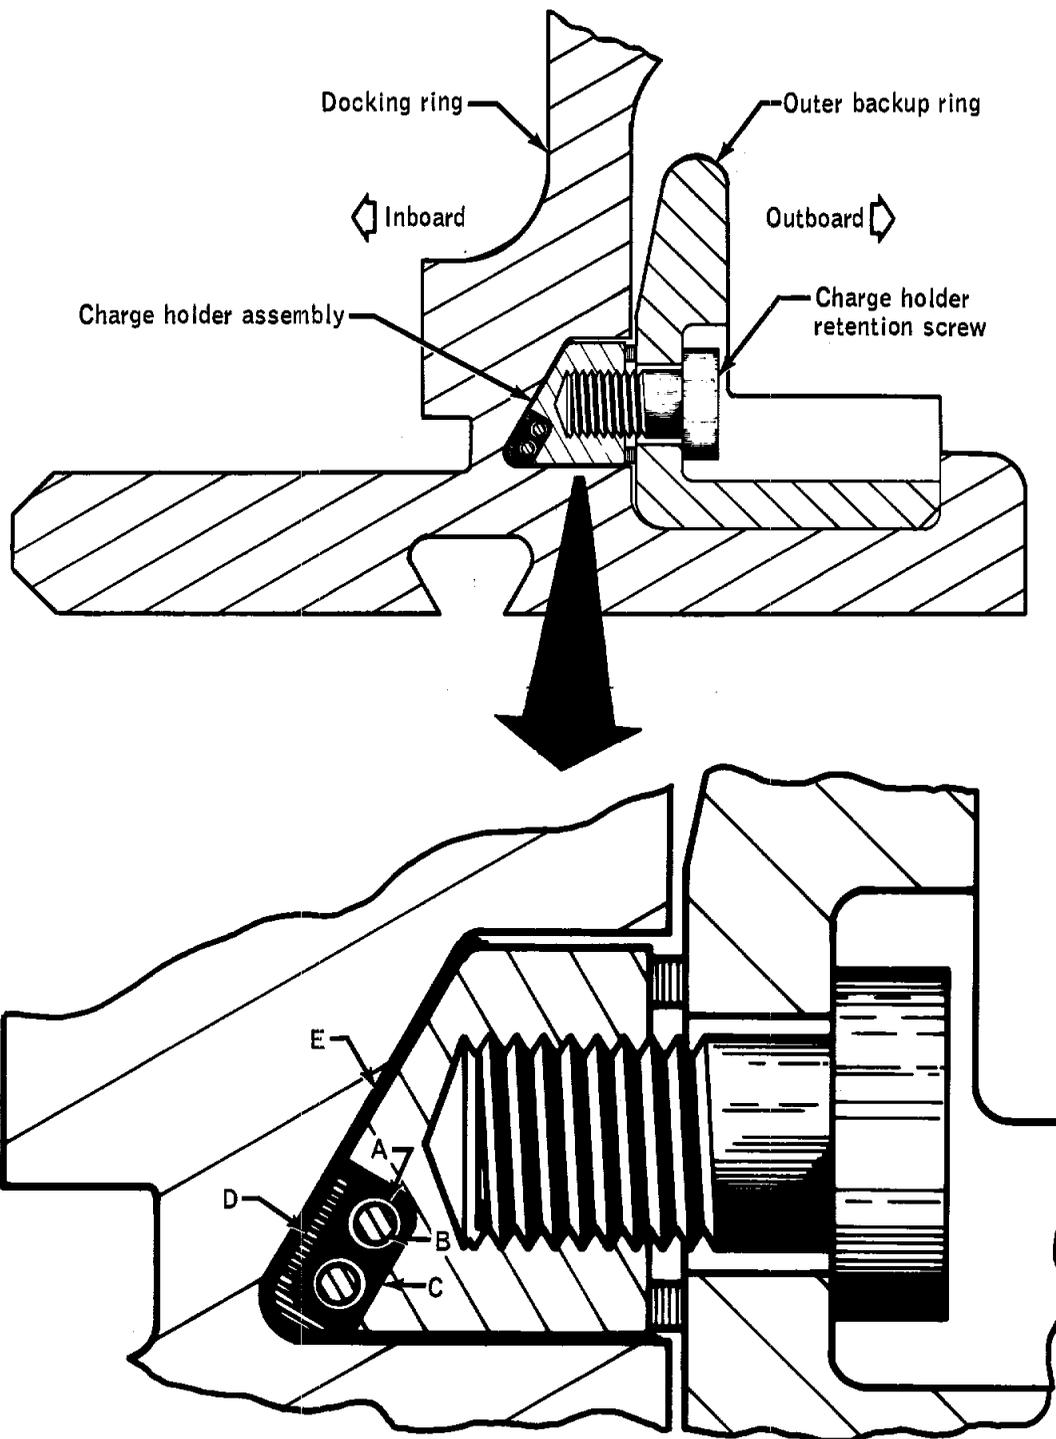
Figure A-1.- Modifications to docking ring separation system.

The configuration of the docking ring separation system was modified to insure single-cord cutting capability, thus insuring redundancy in the separation system (fig. A-1). This modification eliminated free volume between the explosive charge and docking ring, thus enhancing the energy transfer from the explosive charge to the docking ring.
