MSC-01855

APOLLO 12 MISSION REPORT

HOUSTON, TEXAS
MARCH 1970

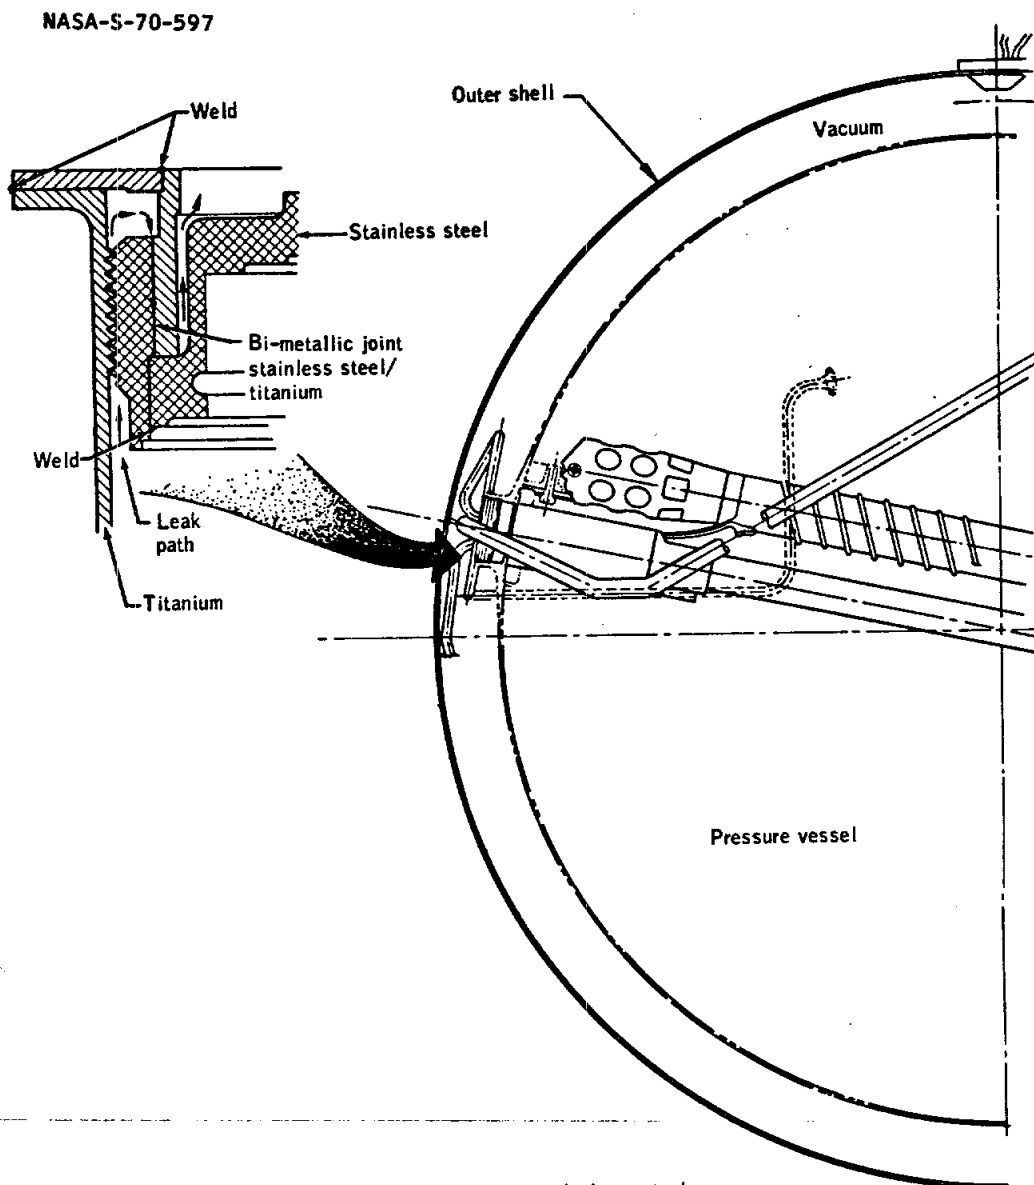
During cryogenic loading about 51 hours before launch, the heat leak of hydrogen tank 2 was unacceptable. Visual checks showed a thick layer of frost on the tank exterior, verifying an inadequate vacuum in the insulating annulus. The tank was removed and replaced. A failure analysis performed before launch identified the cause of the vacuum loss as an incomplete bond in the stainless steel/titanium bimetal joint, which permitted hydrogen to leak from the inner tank into the annulus (fig. 14-2). The bimetallic joint provides a seal between the two metals, which are not compatible for welding to each other. The joint is made from a billet such that the two metals are extruded together and machined. The machined fitting is welded in place, as shown in figure 14-2.

Figure 14-2.- Cryogenic hydrogen tank.

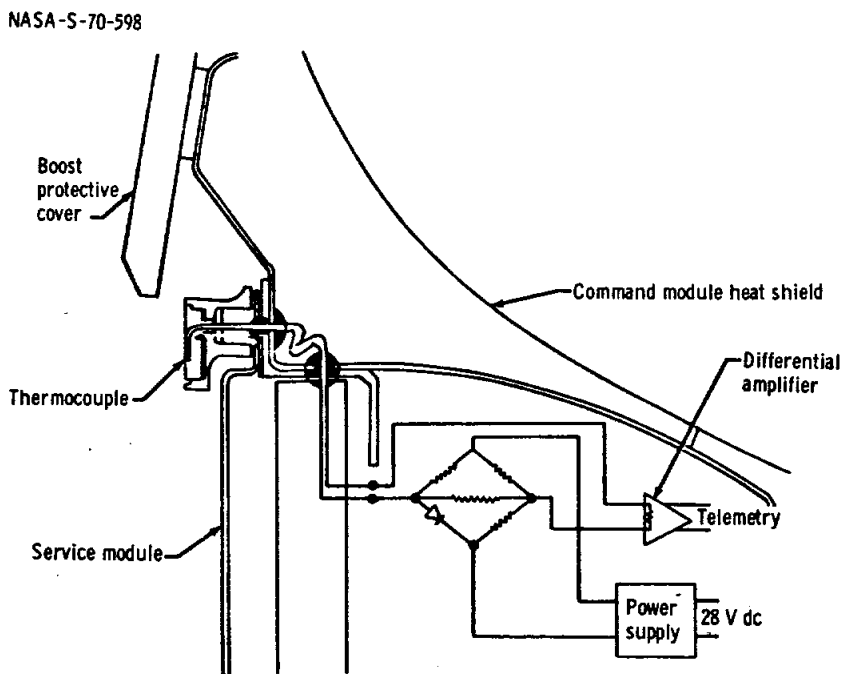
Instrumentation loss.- The only permanent effect on the spacecraft was the loss of nine measurements at the first discharge. Of these nine, four were service module outer surface temperature sensors, four were reaction control system propellant quantity measurements, and one was a temperature measurement on the nuclear particle analyzer. All of the failed measurements are located on the service module near the interface of the command and service modules.

The service module outer surface temperature measurements use a chromel-constantan thermocouple and a reference junction. The reference junction is a bridge made up of three resistors and a temperature-sensitive diode (fig. 14-3). The resistors normally operate at about 0.020 ampere and will open in the region of 0.100 ampere. An open bridge resistor would drive the signal output off-scale high or low depending upon which resistor fails.

Figure 14-3. - Simplified schematic and location of a typical outer skin temperature sensor.

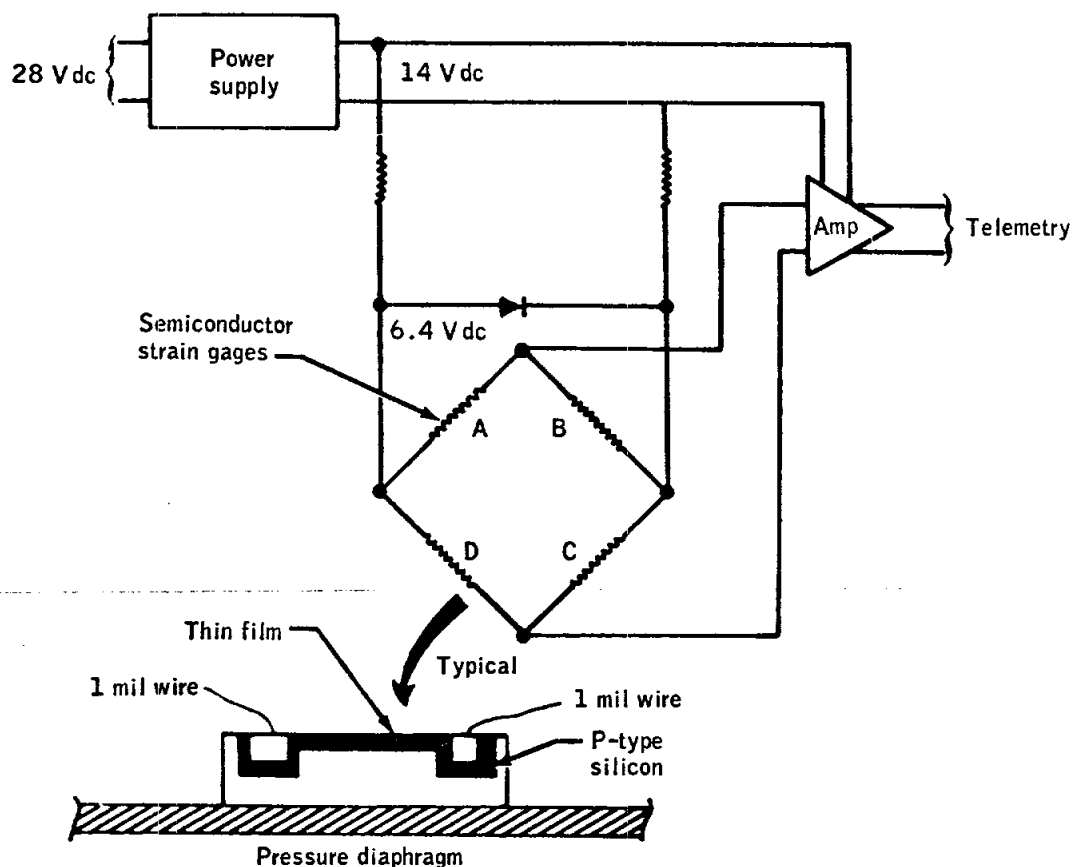
The reaction control propellant quantity measurements use semiconductor strain gages on a pressure-sensitive diaphragm (fig. 14-4). The semiconductors are a thin film type, and excessive current would probably damage their capability to operate as pressure-sensitive resistors. An alternate possibility is that the Zener diode, used to regulate the 14-volt supply to 6.4 volts, was burned out. Loss of this diode would explain the instrumentation symptom, which in all four cases was full-scale and unchanging.

Figure 14-4.- Propellant quantity transducer schematic.

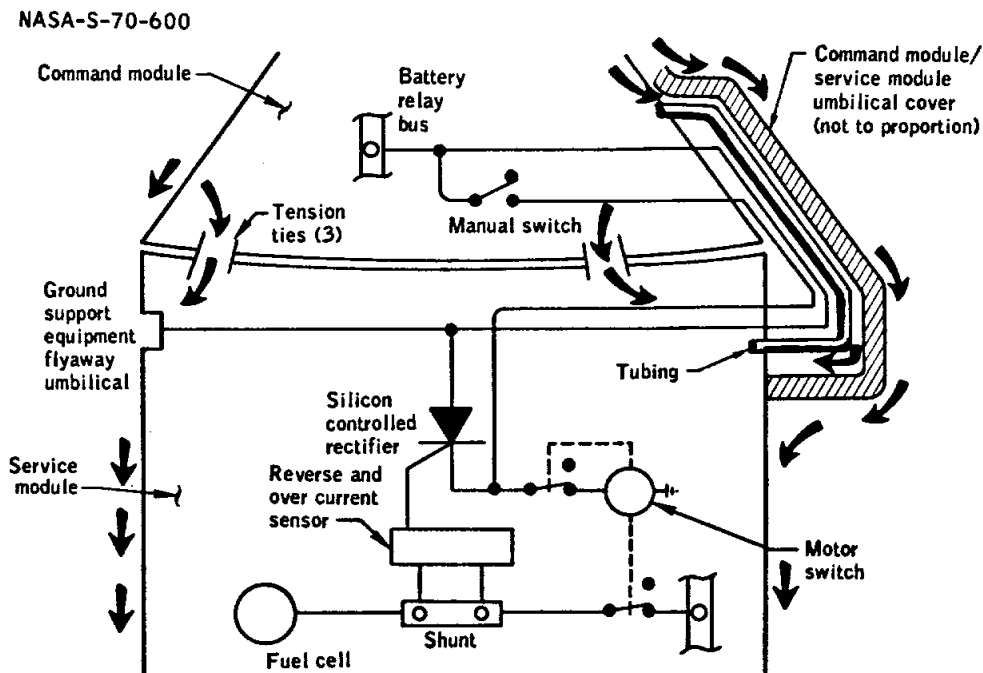
The voltage transient that was induced on the battery relay bus by the static discharge exceeded the current rate-of-change characteristics of the silicon controlled rectifiers in the fuel cell overload sensors and disconnected the fuel cells from the bus (fig. 14-5). As a result, the main bus loads of 75 amperes were being supplied totally by entry batteries A and B, and the main bus voltages dropped momentarily to approximately 18 or 19 volts, but recovered to 23 or 24 volts within a few milliseconds. The low dc voltage on the main buses resulted in the illumination of undervoltage warning lights, a drop out of the signal conditioning equipment, and a lower voltage input to the inverters. The momentary low-voltage input to the inverters resulted in a low output voltage which tripped the ac undervoltage sensor causing the ac bus 1 fail light to illuminate. The transient that disconnected the fuel cells from the buses also caused the silicon controlled rectifier in the overload circuits to indicate an ac overload. At 2 minutes 22 seconds into the flight, the crew restored fuel cell power to the buses. All bus voltages remained normal throughout the remainder of the flight.

Figure 14-5.- Fuel cell disconnection circuitry.

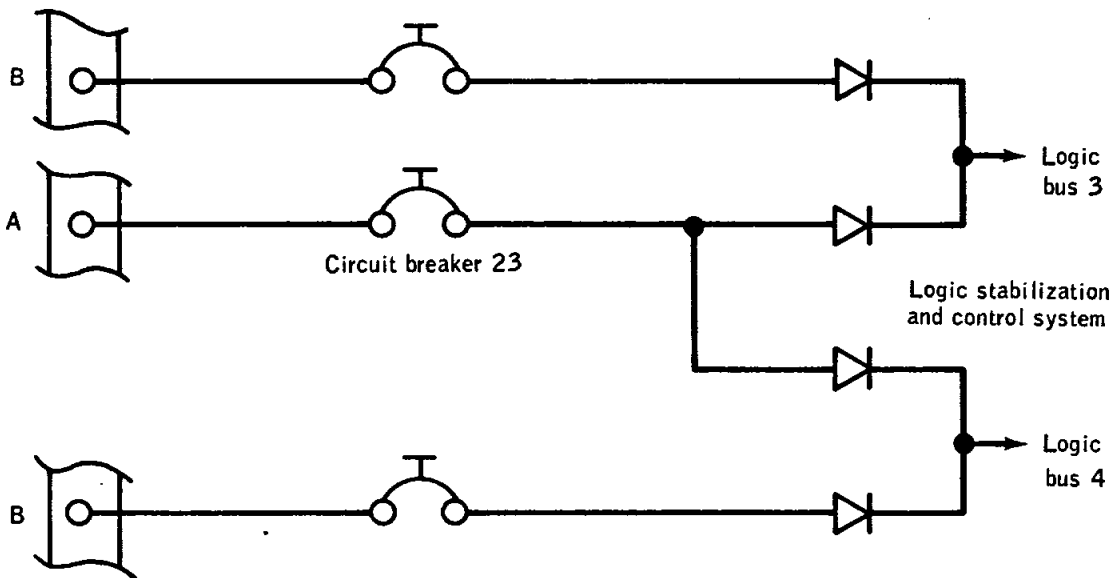
During systems checks after earth orbit insertion, circuit breaker 23 for stabilization and control logic bus 3 and 4 on panel 8 was found in the open position (fig. 14-6). A crewman closed the circuit breaker and

Figure 14-6.- Stabilization and control circuit breaker schematic.

As shown in the figure, the breaker was supplying power in parallel with two other breakers which did not open. This fact plus no abnormalities indicate that the breaker was probably not set during the prelaunch switch and circuit breaker positioning checks. These breakers are not specifically verified to be in proper position.

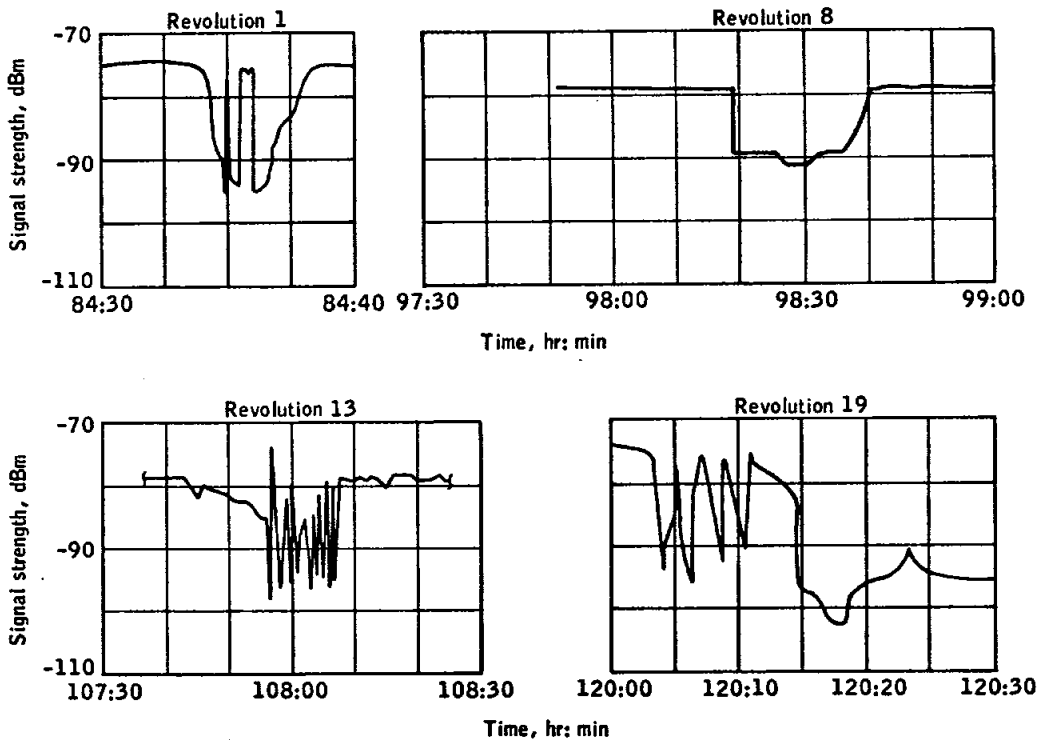
Operation of the S-band high gain antenna in the narrow beam mode resulted in a decrease of approximately 10 to 12 dB in both uplink and downlink signal strength on several occasions. Illustrations of the first and other unexpected signal-strength variations are shown in figure 14-7. The first decrease occurred in lunar orbit revolution 1.

Figure 14-7.- Typical high gain antenna uplink signal strengths during abnormal operations.

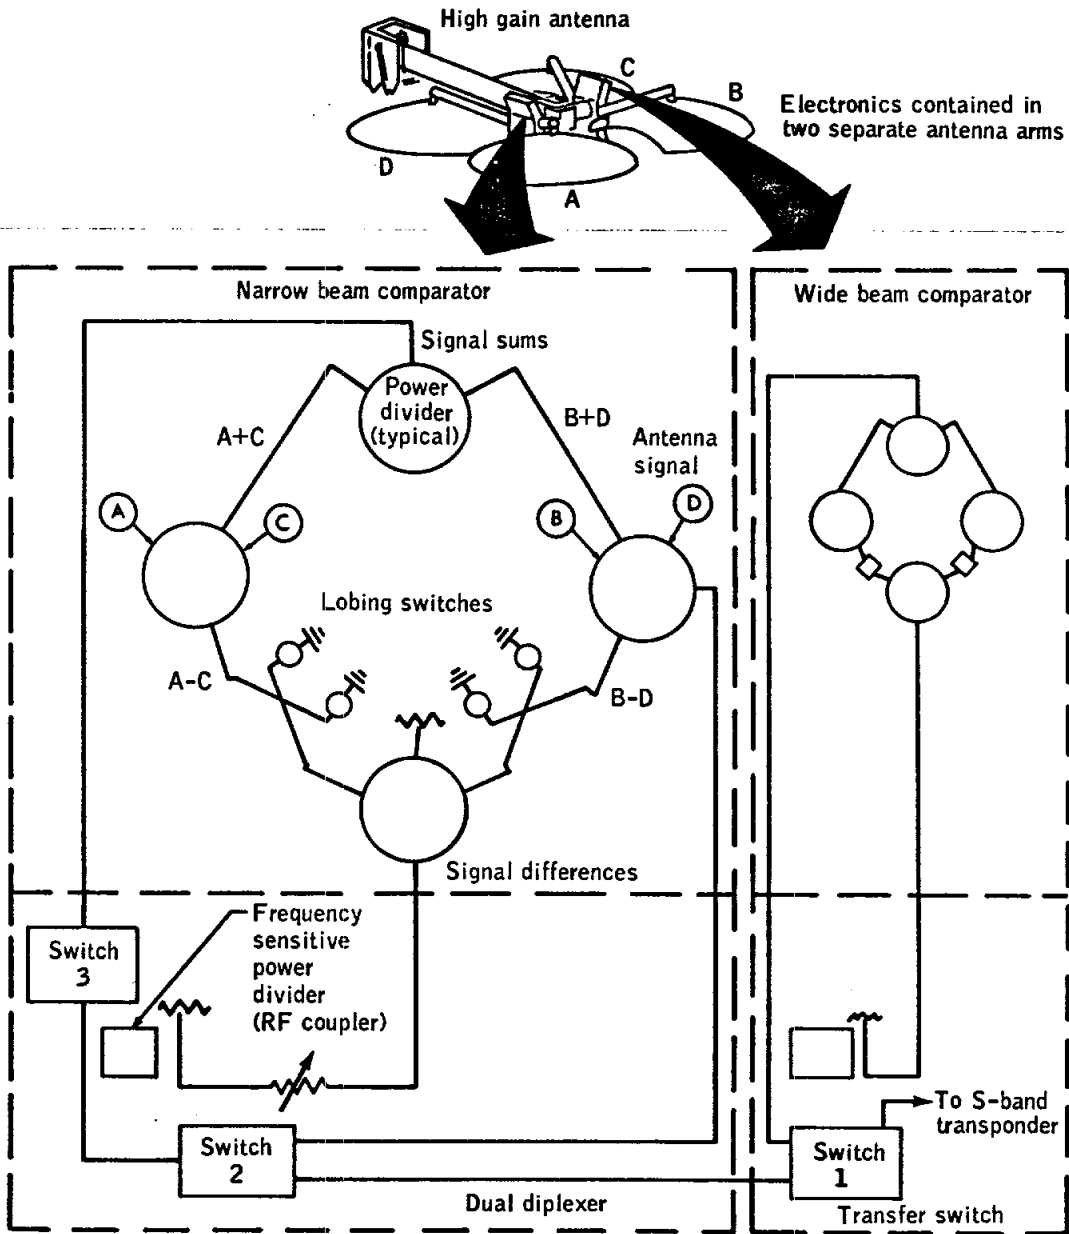
There is a total of four stripline units with one contained in each of the following antenna components: narrow-beam comparator, transfer switch, and dual diplexer, as shown in figure 14-8. Based on the inflight tests, the wide beam comparator has been eliminated as a cause of the anomaly. Also, investigation of the circuitry and correlation of data has ruled out the transfer switch as being the anomaly cause. Therefore, the malfunction could only have been in the narrow beam comparator or the dual diplexer.

The narrow beam comparator combines the patterns of four dish antennas to provide the sum and difference patterns which provide the angle pointing information. Two malfunctions that could produce boresight shifts have been identified in the narrow beam comparator. Under normal operating conditions, the lobing switches function as digital phase shifters and provide either a zero or 180-degree phase shift. If a diode fault occurs that changes the phase or amplitude characteristics of either switch, tracking errors can be produced. The opening of one set of diodes would have to be intermittent to produce the observed flight anomaly, thus suggesting the presence of temperature or pressure sensitive connections in the traces that connect the diode switches. Another diode fault which can occur is a loss of the drive voltage to one of the lobing switches. In this case, the switch will provide a constant phase shift. The multiplexed difference signal for the case when the phase shift of switch 1 (fig. 14-8) is constant at 180 degrees results in unsymmetrical lobing. The antenna, in this case, will seek those pointing angles that make the elevation and azimuth angles equal in magnitude, thus suggesting that the resultant tracking error could be large and not repeatable. This condition would give the observed antenna performance characteristics. Therefore, a malfunction in the diode wiring or circuit connections is suggested. The intermittence associated with this malfunction could be explained by a temperature sensitive circuit connection (solder crack or wire break).

Figure 14-8.- S-band high gain antenna electronics.

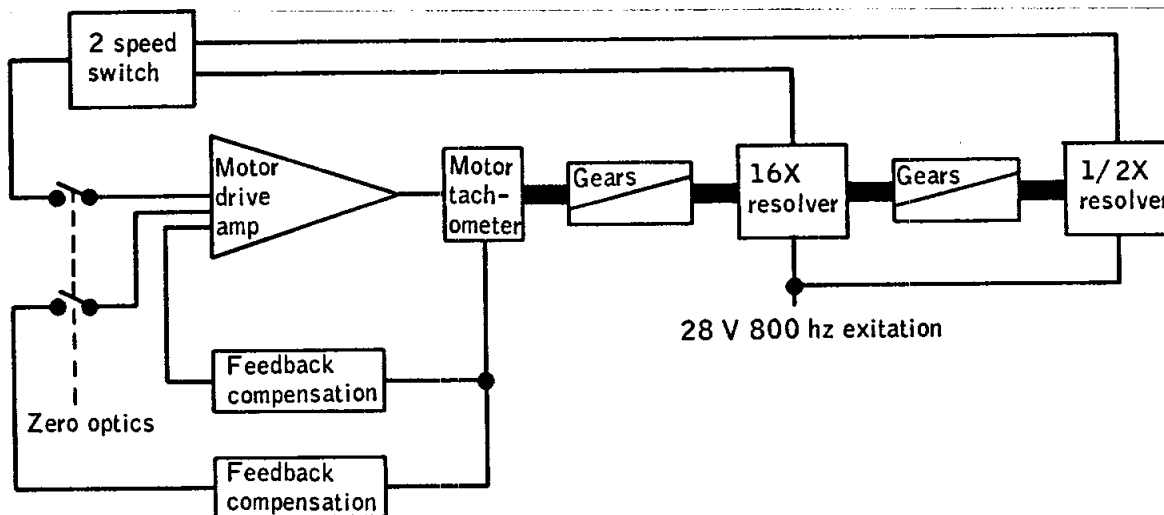
Figure 14-11.- Zero optics mode circuitry.

A number of components in the optics drive servomechanism (fig. 14-11) are used only in the zero optics mode. The optical unit and the power-and-servo assembly were removed from the spacecraft, and the servo assembly was subjected to thorough testing. The flight symptoms, however, could not be reproduced. Because of extensive sea-water corrosion, the optical unit could not be tested, but an analysis and testing of a similar unit demonstrated the cause of the zero optics anomaly to be within the power-and-servo assembly. The flight assembly was installed in a working system and has operated properly under a variety of thermal conditions. The modules associated with the optics servo were also thermally cycled in an oven, operated in a vacuum, and subjected to acceptance test vibration levels with no degradation of their performance. The modules were depotted and examined, but no cause of the anomaly could be isolated.

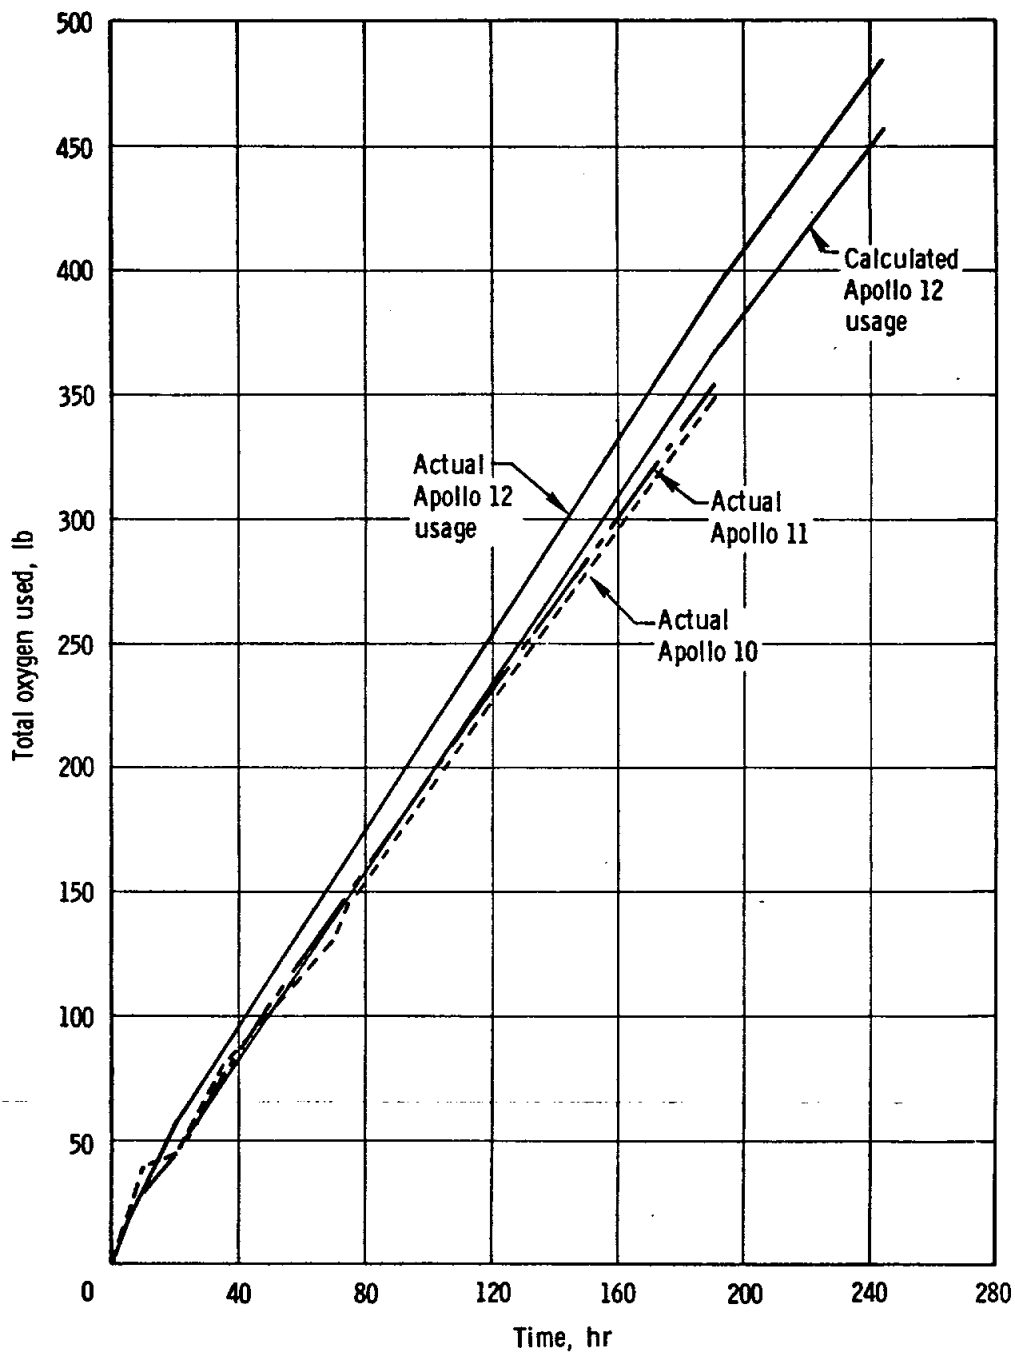
At the end of the mission there was a discrepancy of approximately 27 pounds of oxygen between the measured total cryogenic oxygen usage and the calculated combined environmental control system and fuel cell oxygen usage, as shown in figure 14-9.

Figure 14-9. - Comparison of oxygen consumption for Apollo 10, 11, and 12.

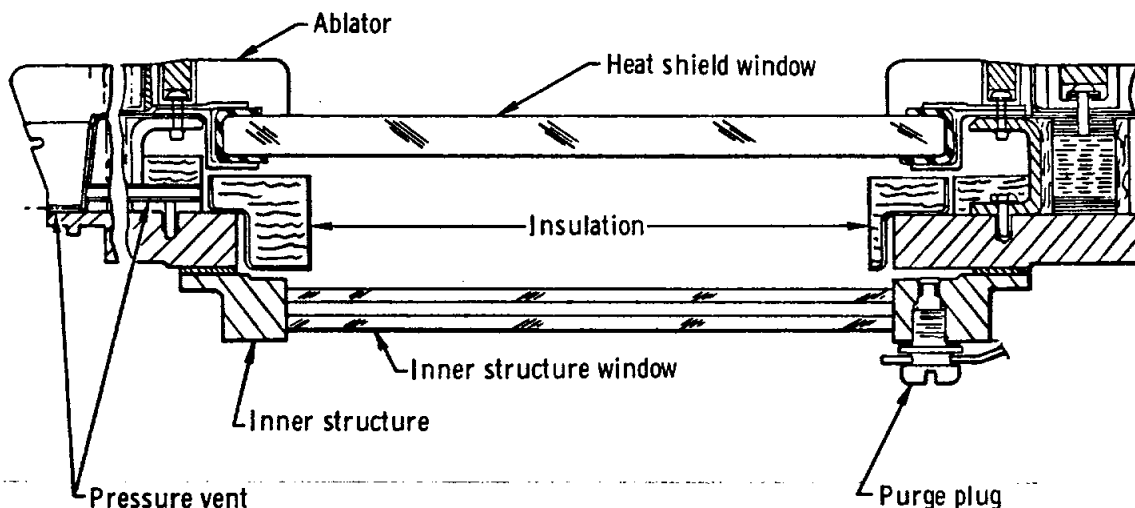
Contamination was also noted on the inside surface of the heat-shield panes on the left-hand side and hatch windows. The contamination, which disappeared on the left-hand side window after the first day, probably resulted from water entrapped between the heat shield and pressure structure in the general area of this window. The contamination on the inside surface of the hatch heat shield window remained throughout the flight and varied in size with the thermal cycles of the spacecraft. This contamination could have resulted from either entrapped moisture in the hatch area between the heat shield and the pressure structure or from outgassing of sealant materials in this area (fig. 14-14). Such outgassing has been minimal in the past three flights because the curing processes were changed to alleviate this problem. However, a chemical analysis of the contamination on the inside surface of the hatch window has shown the concentration of silicone oils to be higher than expected. These oils are the outgassed products from the material used to seal the thermal blankets near the window.

Figure 14-14. - Cross section of hatch window.

For Apollo 13 and subsequent spacecraft, seals will be added to the boost protective cover to prevent leakage of rain water. Prior to flight, the hatch window cavity will be purged with a 35/65-percent mixture of dry nitrogen and oxygen to remove entrapped moisture. To further alleviate the outgassing of silicone oils, the insulation material will be removed from between the outer and inner hatch windows on future spacecraft.

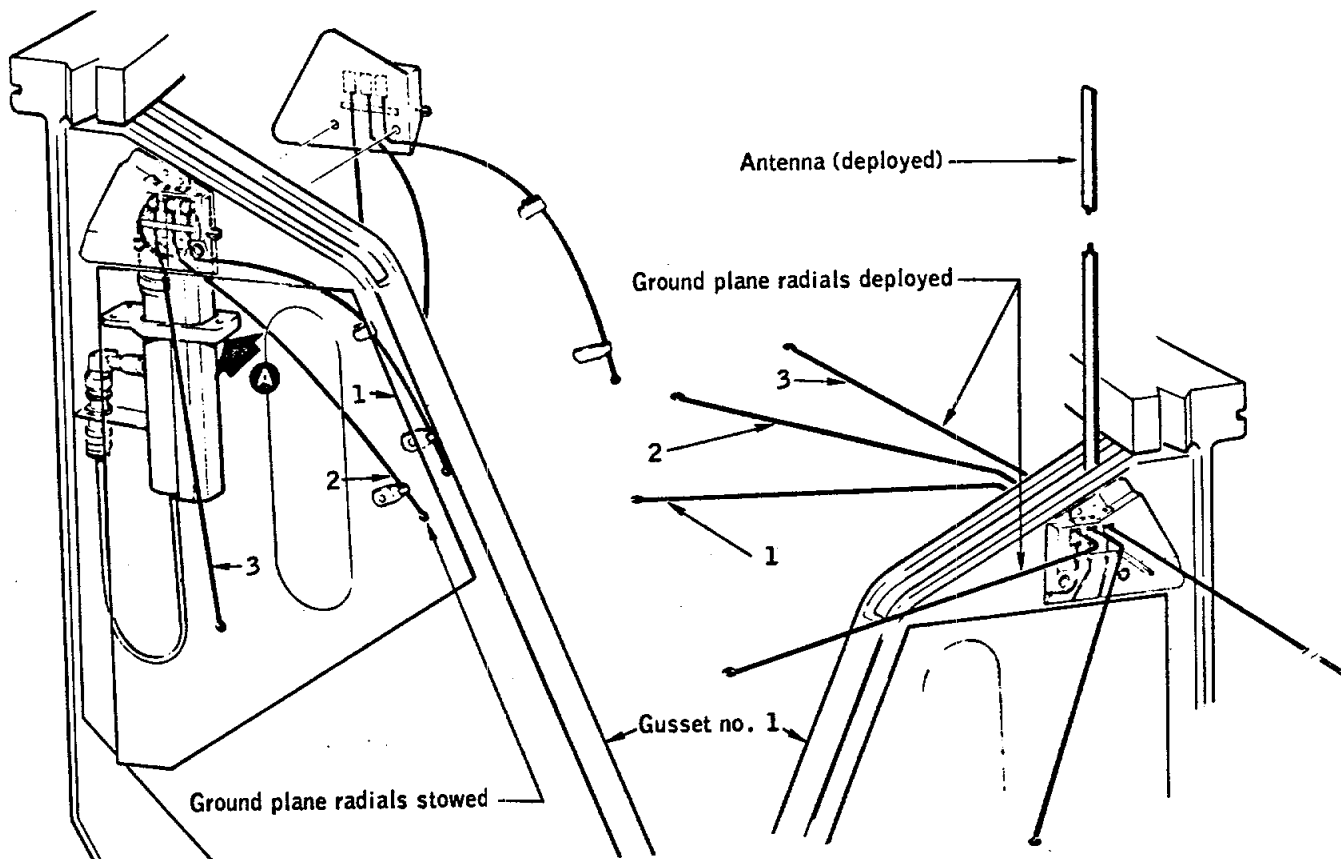
During the command module descent on the main parachutes, ground plane radials 1 and 3 of VHF recovery antenna 2 (fig. 14-15) did not properly deploy. However, voice communications with the recovery forces while using this antenna were not significantly affected. Postflight examination of the antenna revealed that the cloth flap which normally covers the radials to prevent entanglement with the parachutes could be made to stick to the gusset by an adhesive substance which was inadvertently present on both the flap and the gusset. The radials would not deploy when the flap had stuck to the gusset; however, radial 1 would not always deploy, even when the flap was not stuck. A slight binding at the spring end or at the retaining clip has been experienced on radial 1.

Figure 14-15.- VHF recovery antenna configuration.

For Apollo 13 and subsequent missions, recovery antenna 2 will be used for recovery beacon transmissions instead of voice. However, even

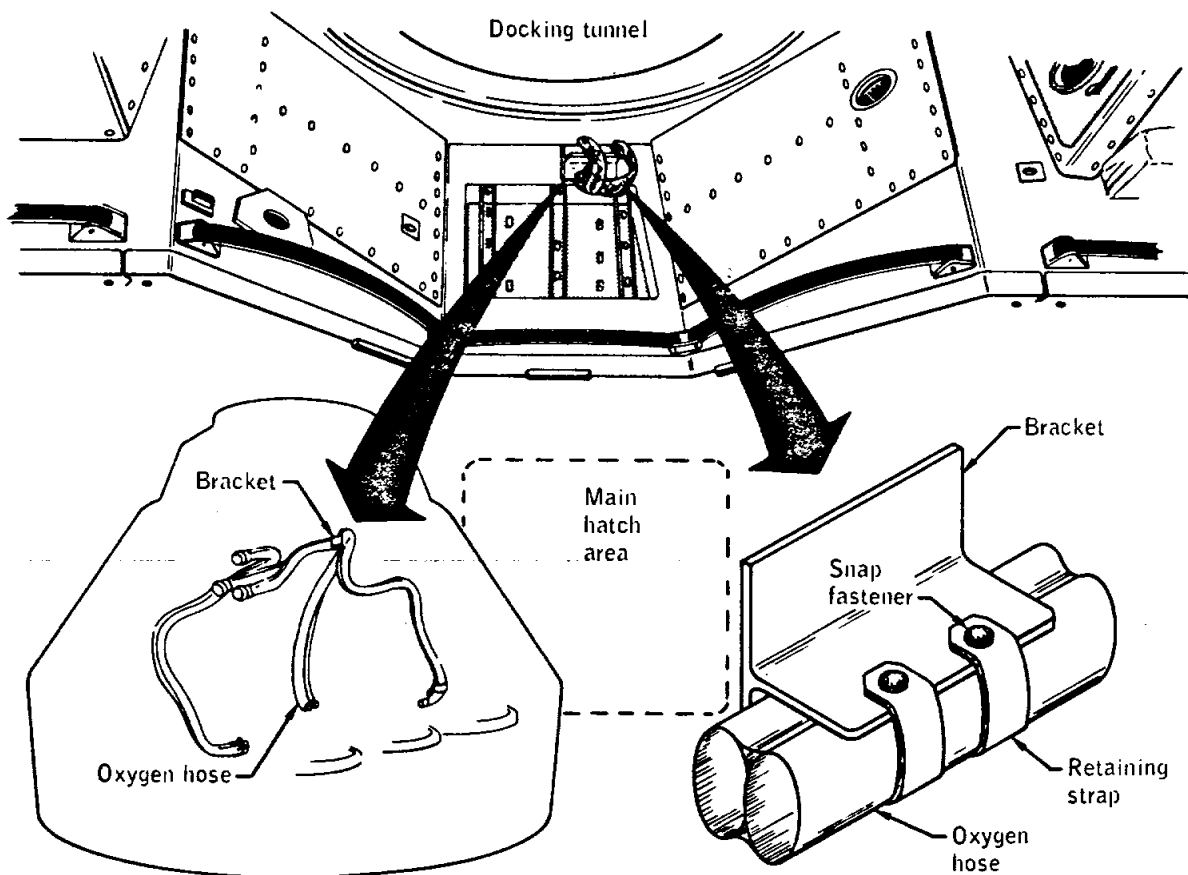
At earth landing, an aluminum retention bracket for the oxygen hoses pulled loose from the main display panel (fig. 14-17). The bracket is bonded to the panel and supports four oxygen hoses, which are attached to the bracket by Beta cloth straps that snap to the panel.

Figure 14-17.- Oxygen hose retention bracket.

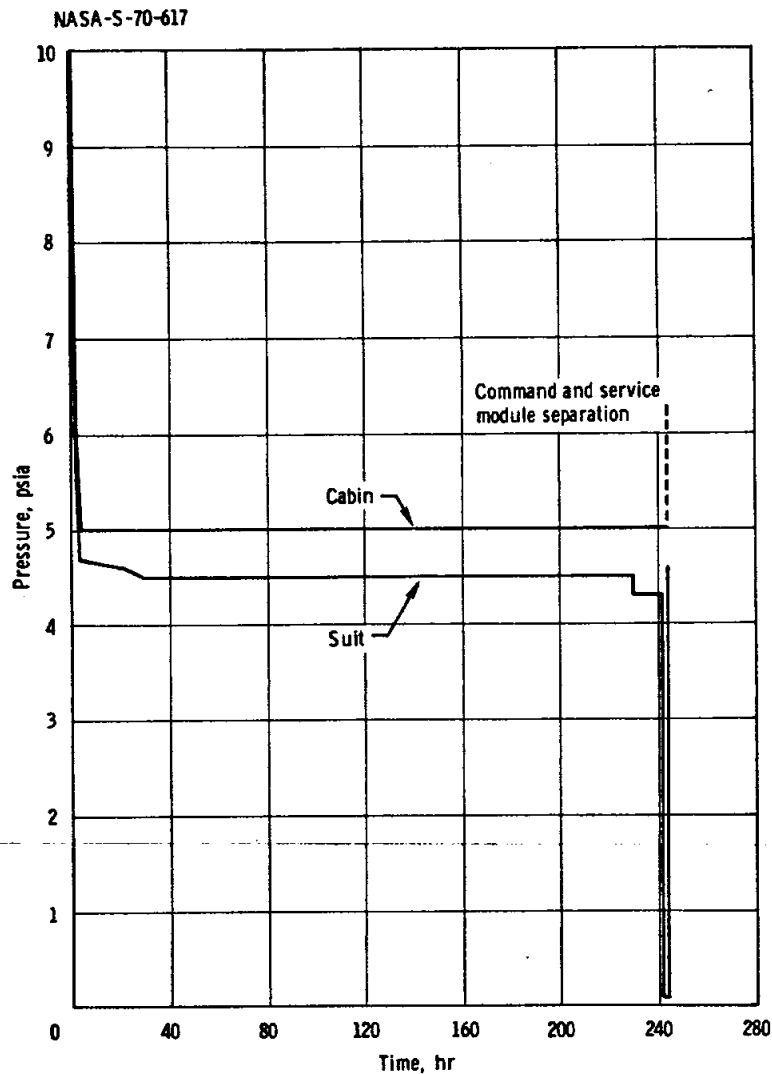
The suit pressure transducer operated properly throughout the pre-launch and launch activities. When the helmets and gloves were removed after launch, the transducer indicated 0.2-psid less than cabin pressure and at approximately 22 hours the differential was 0.4 psid. A 0.4- to 0.6-psid disparity existed between the indicated suit loop and cabin pressures until the final hours of the mission (fig. 14-22).

Figure 14-22. - Suit and cabin pressure history

At 241:41, the suit pressure transducer reading dropped to 0.1 psia, while cabin pressure was stable at 5.0 psia. About 3 hours later, at command module/service module separation, the transducer recovered to 4.6 psia. The transducer indicated a 0.4- to 0.5-psid discrepancy throughout entry. Postflight tests of the installed transducer repeated the flight anomaly. However, during subsequent tests of the removed transducer, the unit operated normally. The transducer was then returned to the manufacturer's facility, where flushing and disassembly revealed internal contamination from metallic nickel-plating particles. These particles could have caused an irregular transducer output by physically interfering with the Bourdon tube movement or by changing the inductance field of the unit. After the transducer was cleaned and reassembled, testing produced satisfactory operation. The noted contamination apparently resulted from either improper cleaning procedures or from self-generated particles within the unit.

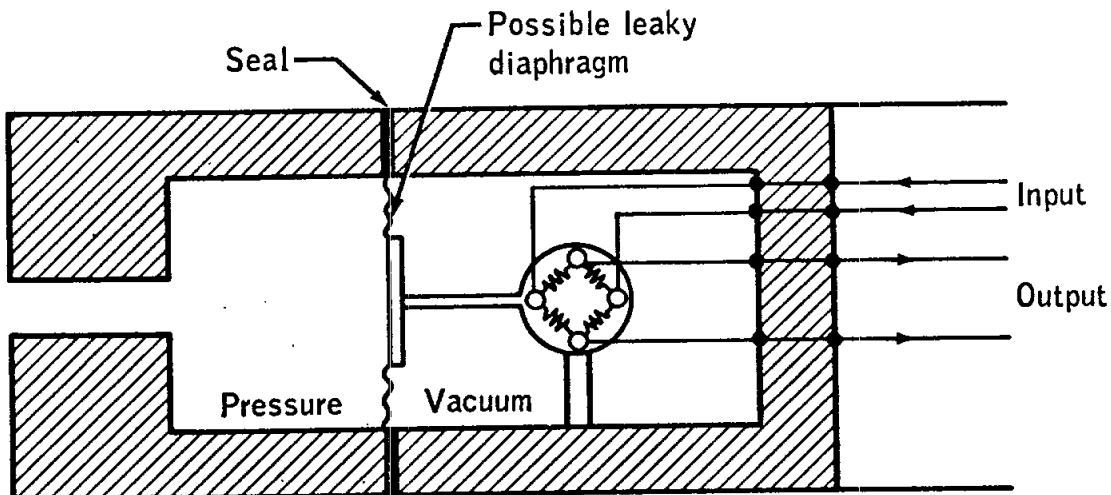
The apparent pressure drop has been attributed to a pressure transducer failure, with the most probable failure mode being a small leak through or around the stainless steel diaphragm in the transducer (fig. 14-25). Such a leak would allow hydrogen to enter the vacuum reference chamber of the transducer, thus destroying the normal pressure differential across the diaphragm. This reduction would result in the indicated pressure decay observed during the flight. A similar transducer failure occurred during a production fuel cell pre-test checkout.

Figure 14-25.- Fuel cell 3 transducer schematic.

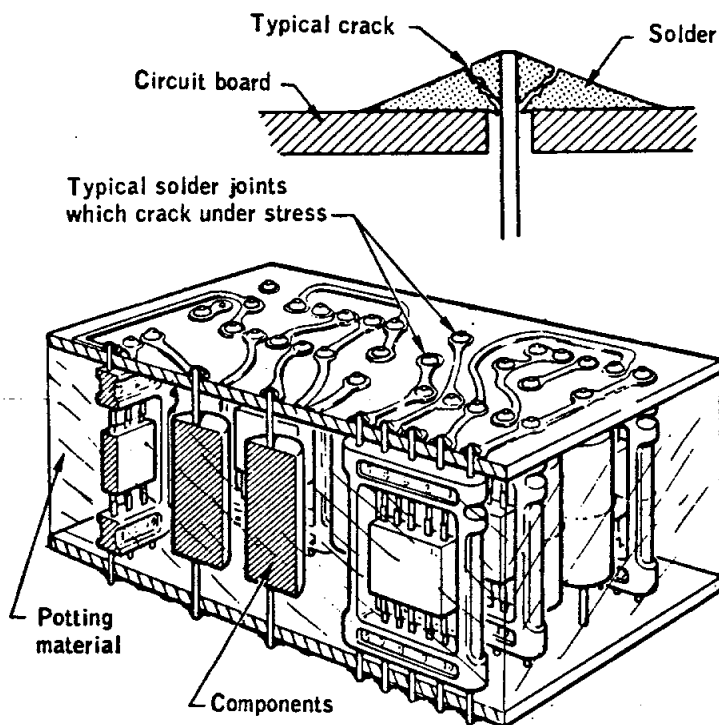
Based on previous mission clock failures, the most probable cause for this anomaly is a cracked solder joint in the cordwood construction. As seen in figure 14-26, electrical components (resistors, capacitors, diodes, etc.) are soldered between two circuit boards, and the void between the boards is filled with potting compound. The differential expansion between the potting compound and the component leads can cause solder joint cracks.

Figure 14-26.- Mission timer construction.

New mission timers, which will be mechanically and electrically interchangeable with present clocks, are being developed for Apollo 13 and subsequent spacecraft. The new clock design eliminates the cordwood construction and is less susceptible to electromagnetic interference.

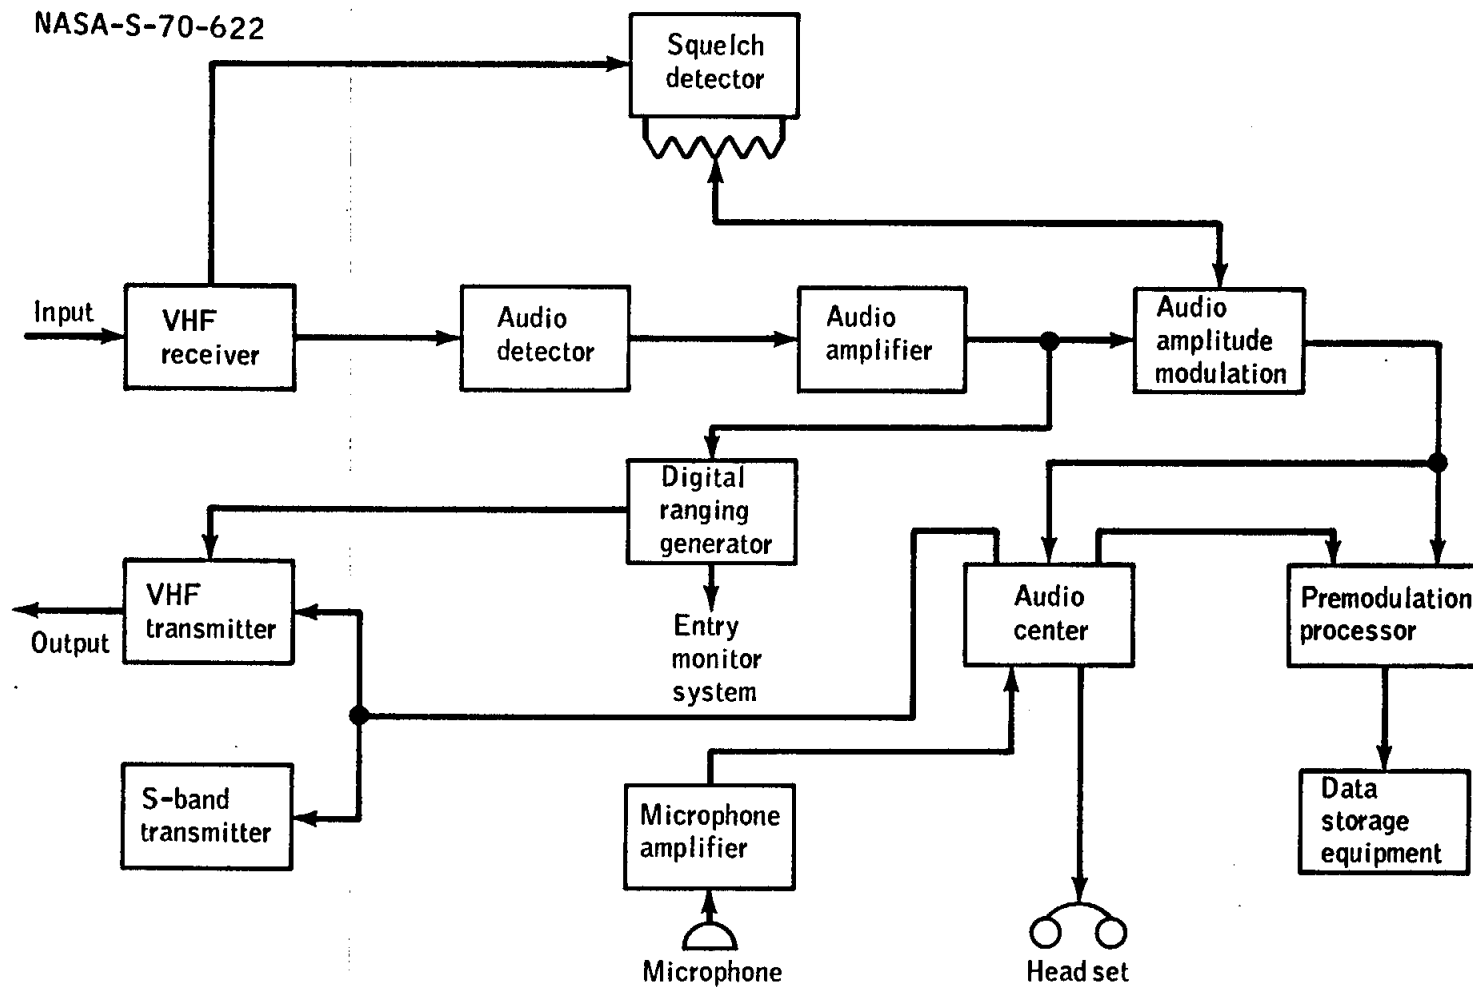
During ascent and rendezvous, there was a VHF communications problem between the command module and the lunar module. During this time period, there appeared to be only one problem associated with VHF voice but there were actually two separate problems. Figure 14-27 shows the VHF system as it was configured in the command module during these phases.

Figure 14-27.- Command module VHF communications configuration.

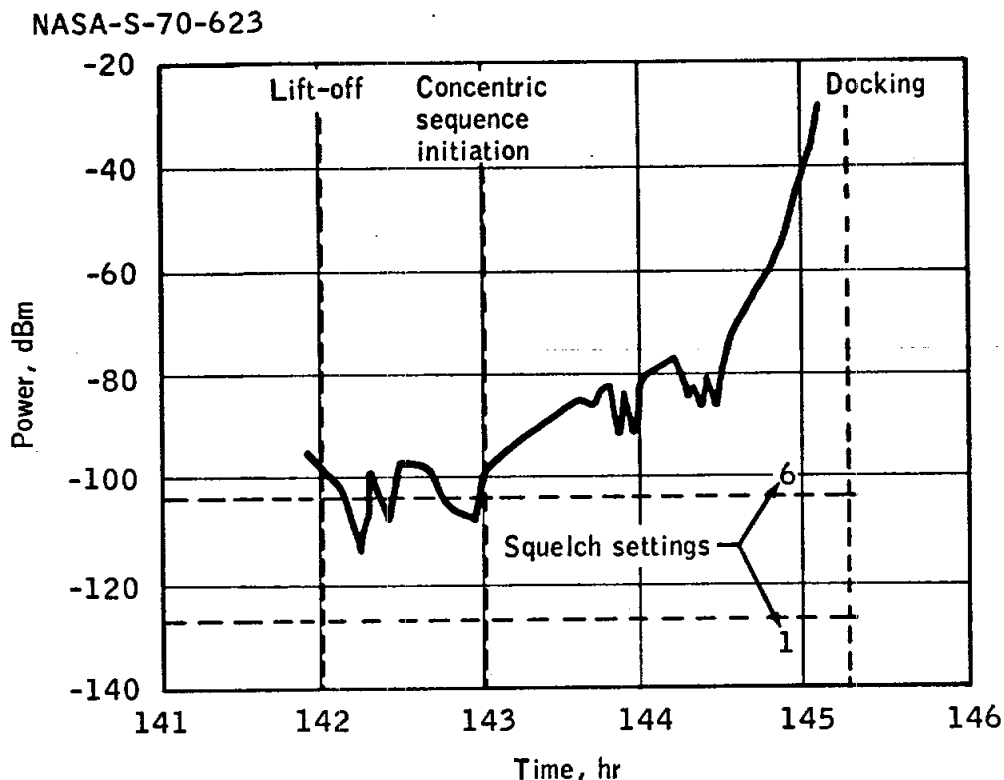
Figure 14-28.- Spacecraft received power.

During the time period from 142:43:00 to approximately 142:53:00, the signal strength was strong enough to maintain the squelch circuit open, as verified by flight data. During the concentric sequence initiation maneuver, the squelch was noted as dropping in and out. According to predictions, the selection of either the left or the right command module antenna did not significantly affect voice communications. During this time, the received signal strength (fig. 14-28) was approximately minus 105 dBm while using the command module right antenna and lunar module forward antenna. This figure also shows the signal strength to be minus 102 dBm or less while using the command module left antenna and lunar module forward antenna according to the flight plan. From previous tests, the squelch thumbwheel, when set at approximately 6, requires from minus 100 to 105 dBm to unsquelch the audio signal.

During the preflight checkout period, the backup crew is required to set the squelch thumbwheel to the squelch trip point and then add one increment of the thumbwheel. Since the received VHF signal is strong during this time period, there is no requirement to operate the receiver unsquelched because excessive noise would enter the system.

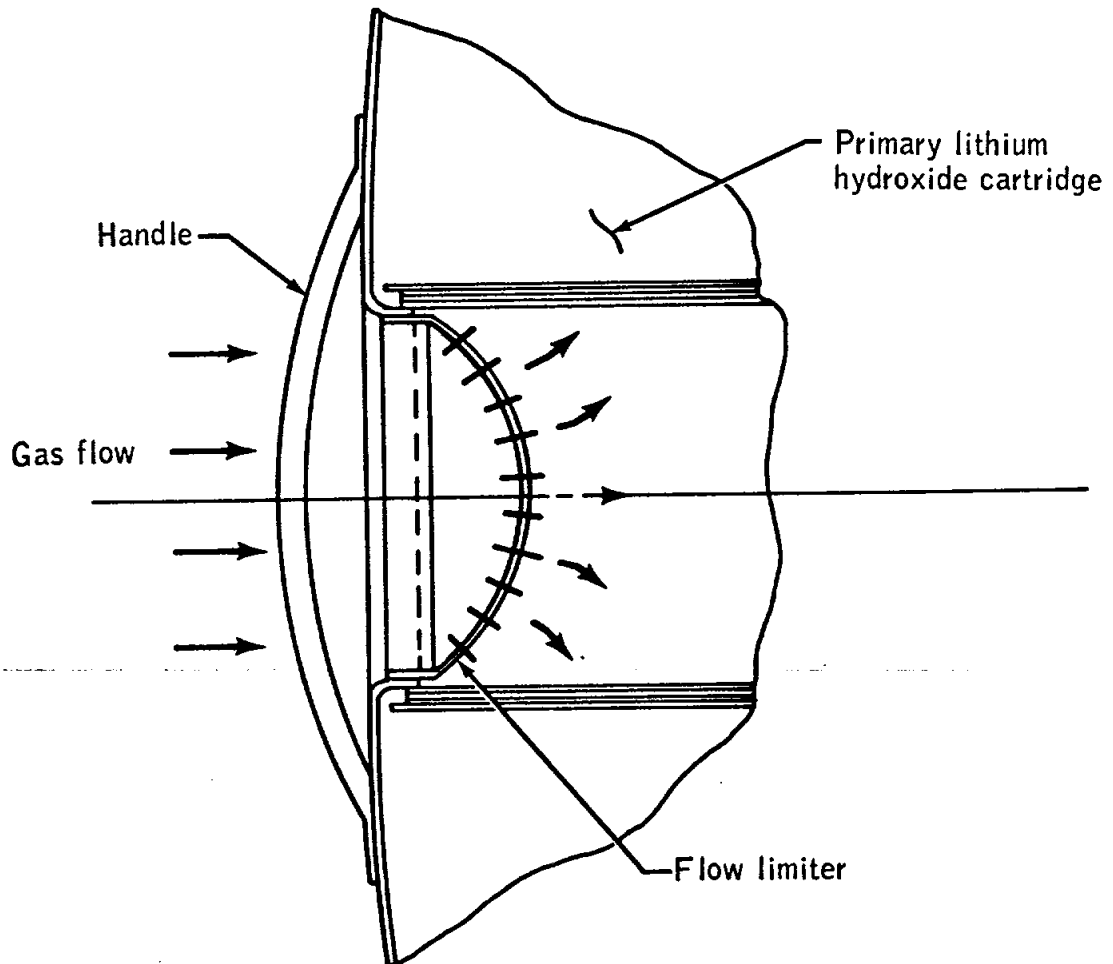
Figure 14-32.- Suit circuit flow limiter.

The water separator speed indication was above the upper limit (in excess of 3600 revolutions per minute) for about 50 percent of the mission. Since the water separator is a gas-driven centrifugal pump, this high speed indicates a higher than normal gas flow through the separator. Tests have shown that, at separator speeds in excess of 3700 revolutions per minute, water splashing occurs at the pitot tube (fig. 14-31) allowing water to bypass the separator.

For Apollo 13 and subsequent missions, a flow limiter (fig. 14-32) will be added to the primary lithium hydroxide canister to reduce suit-loop gas flow and consequently limit the separator speed to within the no-splash range. The flow limiter provides restriction of flow equivalent to the secondary canister. If necessary, this added resistance can be removed in flight.

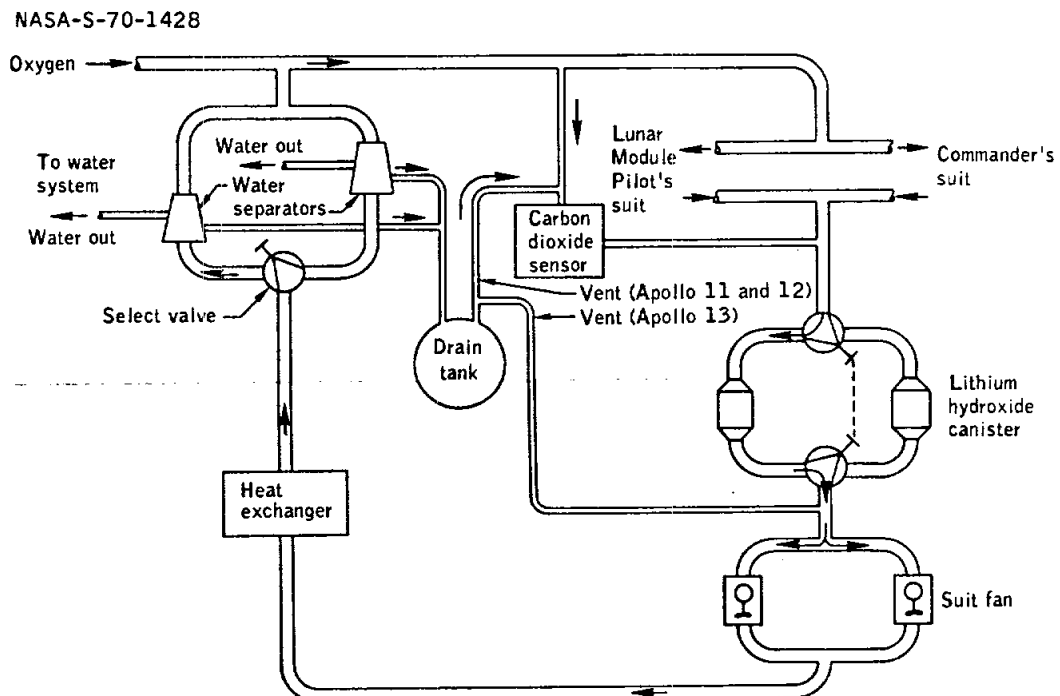
Figure 14-33.- Simplified suit loop schematic.

The carbon dioxide sensor is sensitive to free water, and the malfunction was probably caused either by water from the water separator sump tank entering the sensor or by water bypassing the water separator and entering the sensor. The water separator sump tank vent line joins the carbon dioxide sensor inlet sense line (fig. 14-33). This vent line has been rerouted for Apollo 13 and subsequent vehicles.

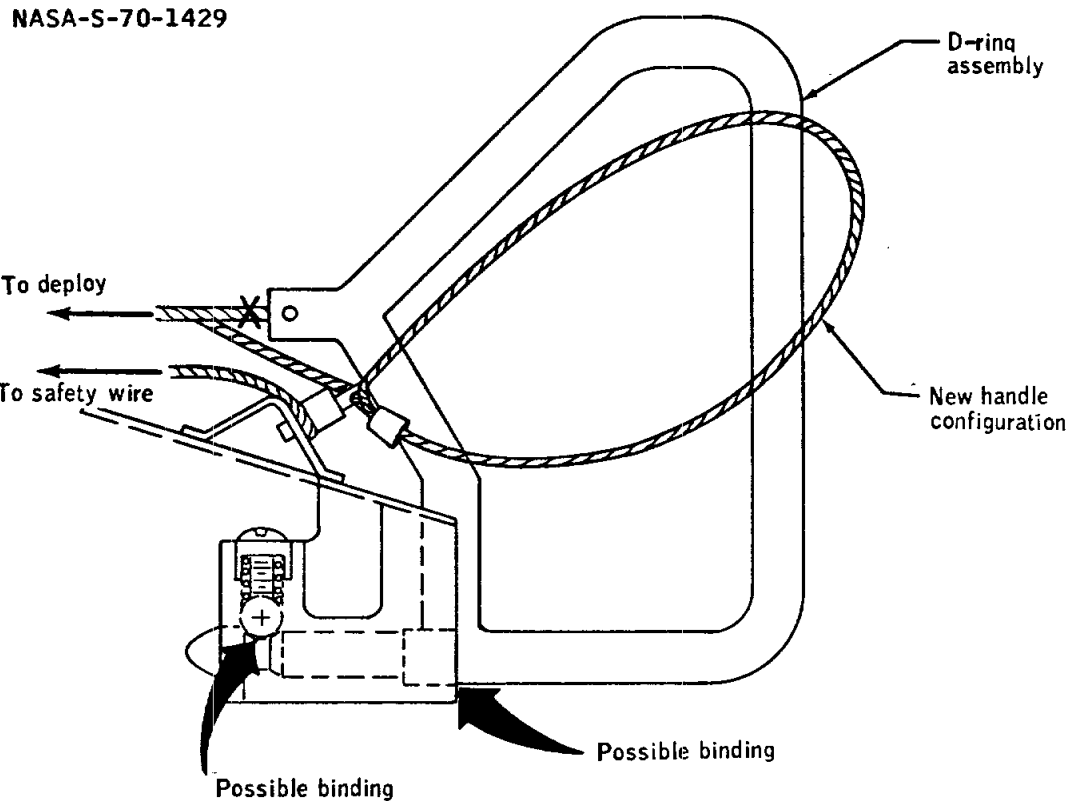
Figure 14-34.- Deployment handle (D-ring) on the modular equipment storage assembly.

During the initial egress, the modularized equipment stowage assembly was to be deployed by pulling a special D-ring handle. Although the Commander was unable to release the handle from the support bracket, it could be rotated in its bracket. The equipment compartment was subsequently deployed by pulling on the bellcrank cable, which attaches to the center of the D-ring handle. A retention pin at the bottom of the D-ring handle plugs into a socket in the retaining bracket (fig. 14-34). This socket contains a ball detent mechanism which holds the D-ring to the bracket. Apparently, either there was binding in the ball detent or the crewman pulled on the D-ring handle at such an angle that a lateral load was applied to the retention pin, causing it to bind in the retention socket.

For Apollo 13 and subsequent, the D-ring will be deleted and a loop will be clamped to the end of the deployment cable. The loop will be retained using the same type of pin presently installed to retain the safety wire (fig. 14-34).
