MSC-01855

APOLLO 12 MISSION REPORT

HOUSTON, TEXAS
MARCH 1970

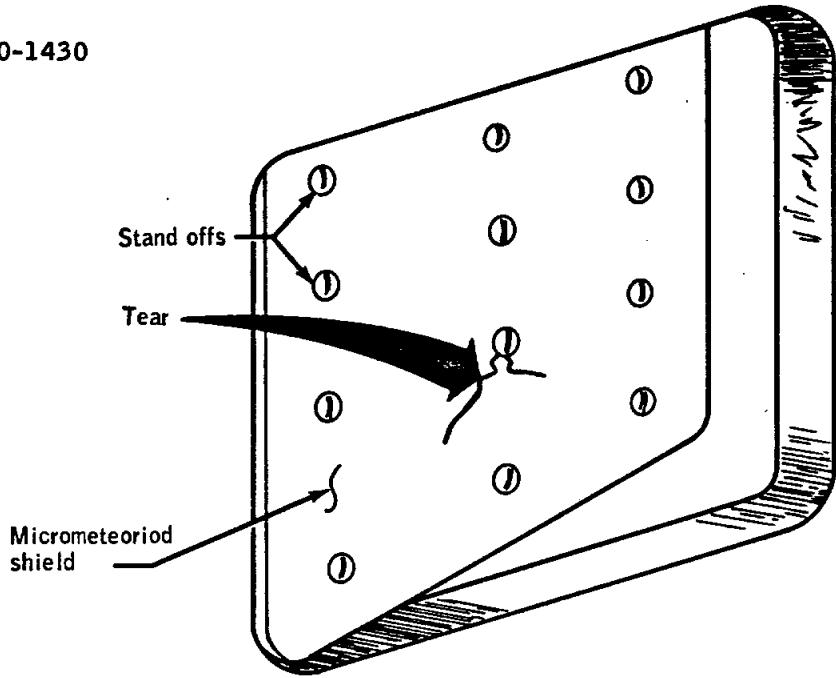
Figure 14-35.- Tear in forward hatch outer skin.

During egress, the Commander's portable life support system came in contact with and tore the hatch micrometeoroid shield (fig. 14-35). Such a tear could represent a potential hazard to the suit. For Apollo 13 and subsequent, the thermal shield thickness will generally be increased from 0.004 to 0.010 inch. At the standoff, however, the shield thickness will be increased from 0.020 to 0.040 inch. In addition, the diameter of the shield mounting holes will be increased from 0.375 to 0.5 inch (fig. 14-36). These modifications should strengthen the shield sufficiently to prevent tearing in any future contacts by the egressing crewmen.

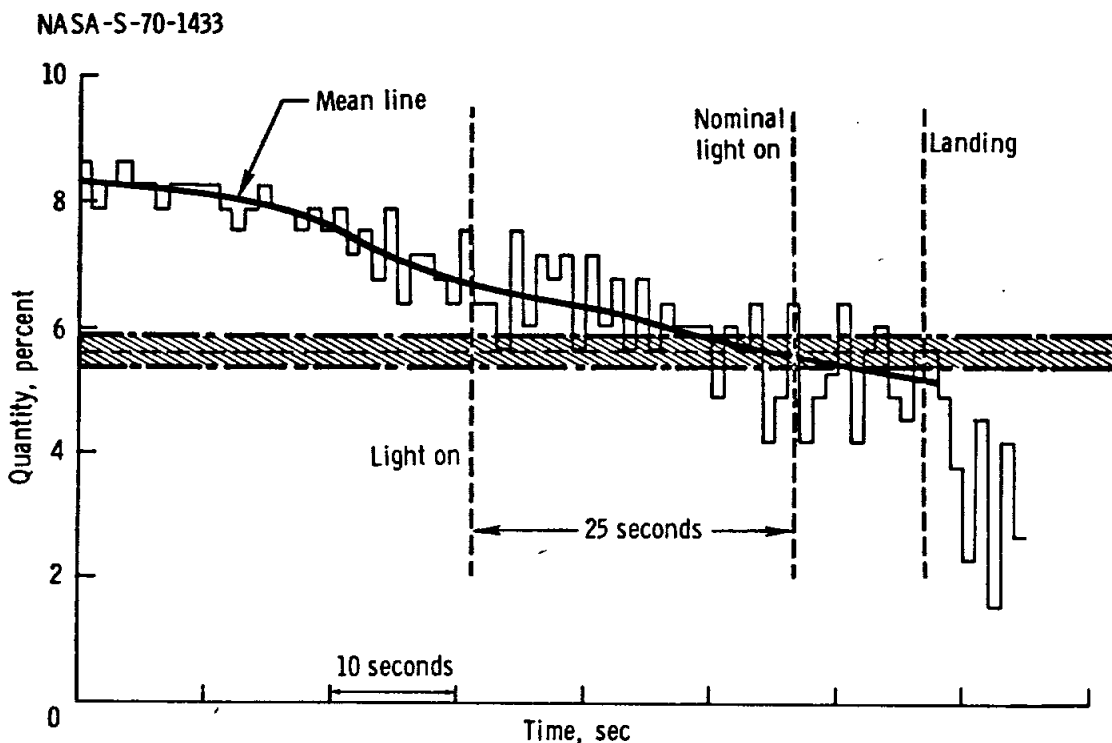
Figure 14-38. - Descent propellant quantity just prior to landing.

At low-level light activation, the gaging system indicated that fuel tank 2 had a mean propellant quantity of 6.7 percent. In addition, it had about a 2.3-percent peak-to-peak oscillation (fig. 14-38), probably caused by propellant slosh, which continued for some time after landing. The other three tank readings experienced similar oscillations, although at a slightly higher mean quantity level. One of the four low-level point sensors, probably fuel tank 2, uncovered momentarily because of propellant slosh, causing the low-level light to latch on.

The quantity warning light should illuminate when the lowest indicated propellant level remaining in any tank reaches a value of $5.6 \pm 1/4$ percent. Since the light came on when the averaged quantity measurement indicated 6.7 percent with an oscillation of ± 1.1 percent, the

lowest excursion of the quantity reading was 5.6 percent and the display operated properly. The averaged propellant quantity reached 5.6 percent about 25 seconds later.

For Apollo 13, the quantity measurements for the four descent propellant tanks have been increased in sampling rate from 1 to 100 samples per seconds. These data will be averaged automatically and used to determine the low-level point from which the remaining firing time can be calculated. The 100 samples per second rate will provide data that will permit an understanding of the particular dynamics of the fluid in the tanks.

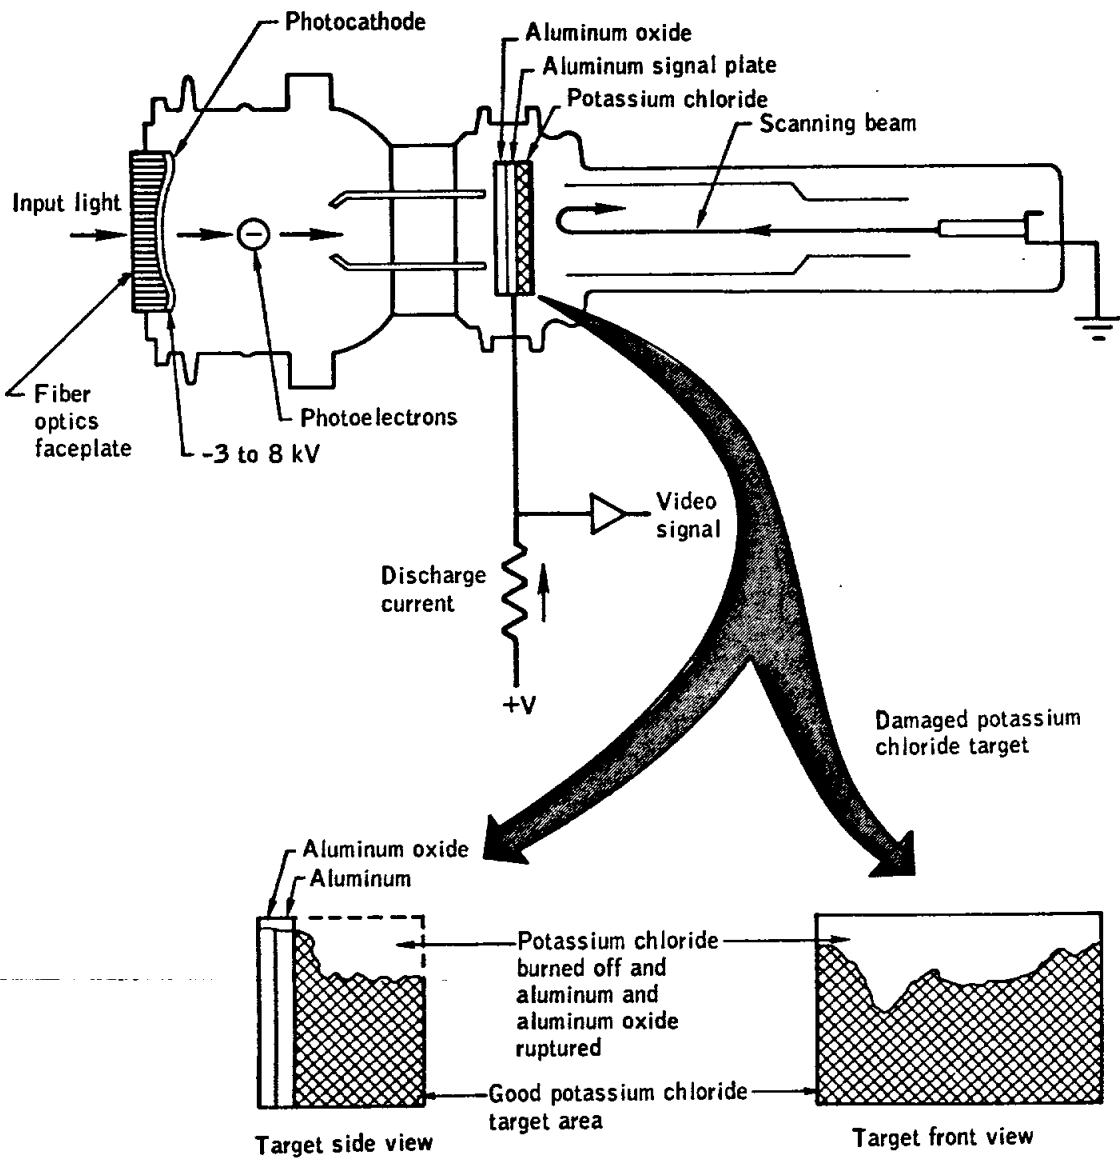
Figure 14-39.- Secondary electron conductivity tube in the color television.

Ground tests using an Apollo-type image sensor (secondary electron conducting vidicon tube) exposed the camera system to extreme light levels. The resulting image on a monitor was very similar to that seen after the flight camera failure.

After decontamination and cleaning, the flight camera was inspected and power was applied. The image, as viewed on a monitor, was the same as that last seen from the lunar surface. The automatic light-level control circuit was disabled by cutting one wire. The camera then reproduced good scene detail in that area of the picture which had previously been black, verifying that the black area of the target was undamaged, as shown in figure 14-39. This finding also proved that the combination of normal automatic light control action and a damaged image-tube target caused the loss of picture. In the process of moving the camera on the lunar surface, a portion of the target in the secondary-electron conductivity vidicon must have received a high solar input, either directly from the sun or from some highly reflective surface. That portion of the target was destroyed, as was evidenced by the white appearance of the upper part of the picture.

Training and operational procedures, including the use of a lens cap, are being changed to reduce the possibility of exposing the image sensor to extreme light levels. In addition, design changes are being considered to include automatic protection, such as the use of an image sensor which is less susceptible to damage from intense light levels.

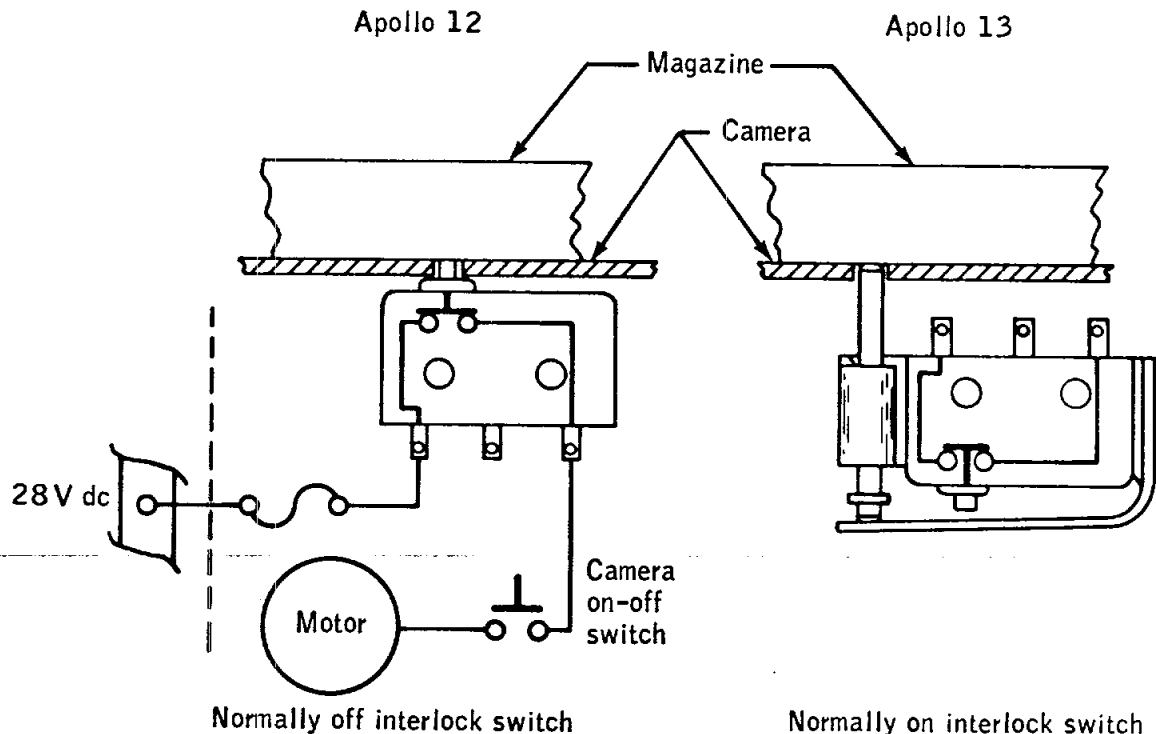
Figure 14-40.- Sequence camera interlock switch modification.

Although postflight tests showed the 16-mm camera and magazine to be in satisfactory operating condition, the characteristic sensitivity of the magazine interlock microswitch installation is such that the operating limits of the switch could cause intermittent actuation. The intermittent operation was duplicated on the flight and similar equipment by the application of pressure to the end of the magazine. The problem will be resolved by changing the interlock switch (fig. 14-40) to a configuration that is much less sensitive to variation in switch settings.

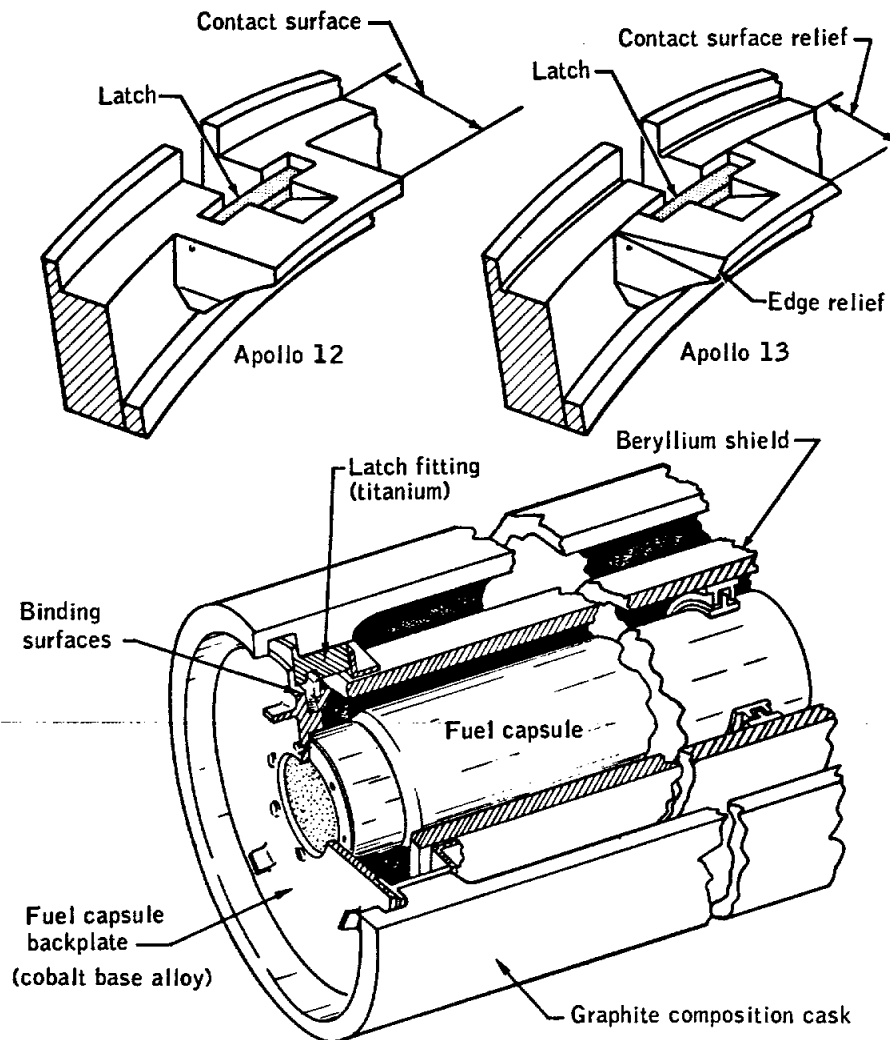
Figure 14-41.- Radioisotope fuel capsule configuration.

Thermal tests and analyses show that dimensional tolerances can diminish with temperature and result in binding between the latch fitting (C-ring) on the cask and the contact surface of the backplate on the fuel capsule (fig. 14-41). The longitudinal contact distance for these two surfaces is approximately 0.6 inch, and extraction was easily accomplished once this distance was negotiated.

As a result of the dimensional checks, the thermal tests, and analyses performed with both the qualification and Apollo 13 flight hardware, the contact surfaces of the fuel capsule backplates are being reworked as indicated in the figure. The outside diameter of the 0.10-inch long contact surface, while remaining within design limits, may be reduced as much as 0.005 inch for ease of capsule extraction. All existing capsule backplates will be reworked in this manner.

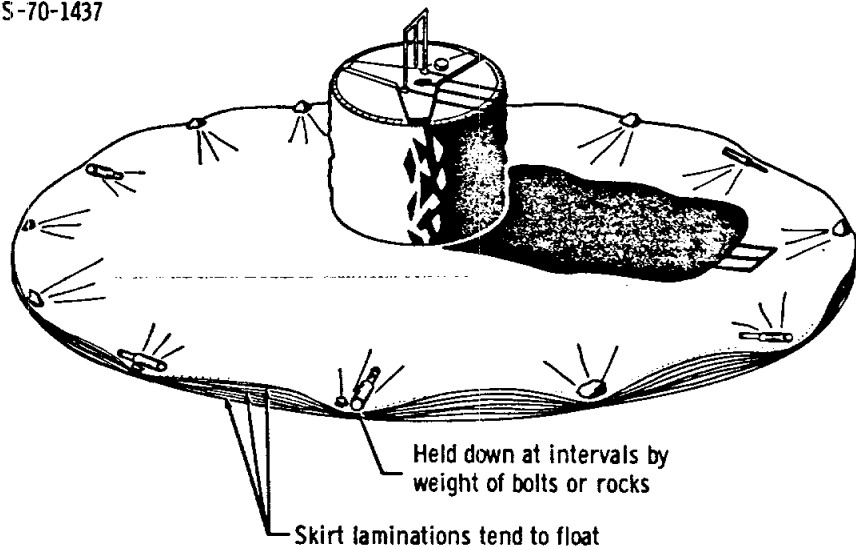
Figure 14-42. - Passive seismic experiment deployed.

The thermal shroud tended to delaminate and rise up off the lunar surface. This condition had been anticipated, and lunar soil was placed on the periphery of the shroud to hold it down. When this operation proved difficult, tie-down bolts, which had been removed from the pallet during deployment of the experiments package, were placed on the shroud with satisfactory results (fig. 14-42).

For Apollo 13 and subsequent spacecraft, the shroud laminations will be spot-sewed together at intervals around the periphery, a weight will be sewed to each of the six attach-pullout points on the shroud, and a 5-foot diameter Teflon blanket will be added for thermal control to decrease solar degradation.

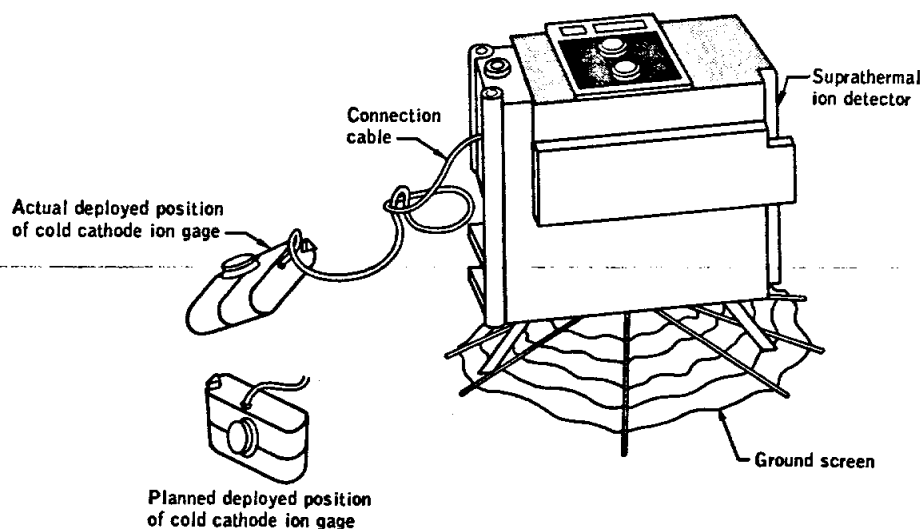
Figure 14-43.- Cold cathode gage deployed.

The cold cathode ion gage would not remain upright when deployed. Its final position was on its back with the sensor aperture at an angle of approximately 60 degrees from the horizontal but was satisfactory (fig. 14-43).

The cable connecting the cold cathode ion gage with the suprathermal ion detector was quite stiff. The combination of the spring effect in the cable, the reduced weight of the cold cathode ion gage under lunar gravity, and the softness of the lunar surface was apparently sufficient to cause the equipment instability during deployment. Final positioning of the equipment requires that the sensor aperture does not point directly at the surface nor directly at other experiment package components. The final positioning fulfilled this requirement.

The combination of the suprathreshold ion detector with the cold cathode ion gage will not be included for Apollo 13. For Apollo 14 this equipment will be flown, and the wires of the connecting cable will be tied at 6-inch intervals instead of being wrapped with heavy Mylar tape. This modification not only reduces cable stiffness by 70 percent, which decreases the spring effect, but also decreases cable bulkiness to permit easier stowage.

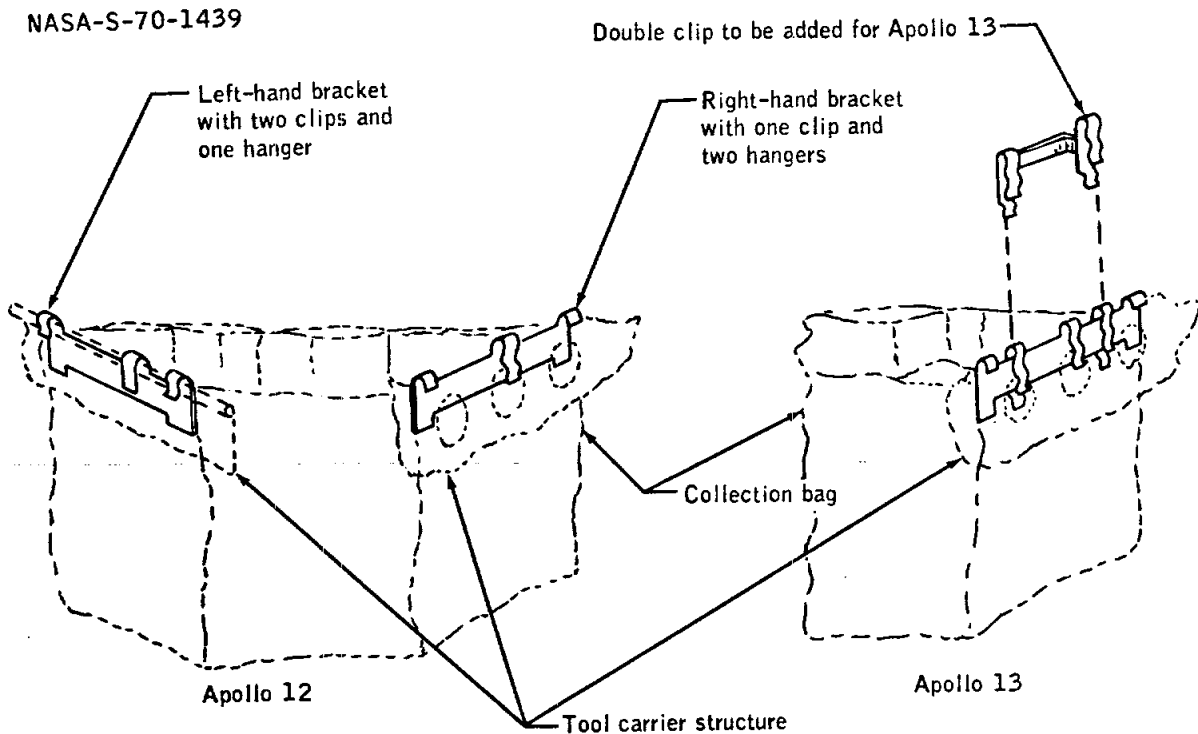
Figure 14-44.- Tool carrier collection bag retention.

At the beginning of extravehicular activity, the empty tool carrier collection bag tended to rise out of the tool carrier until some lunar surface soil was put in to hold it down. The bag is attached to the carrier structure by three aluminum spring clips (fig. 14-44). The weight of the loaded bag is shared by these clips and three hangers. The retention force is limited so that the loaded bag may be easily lifted out of the carrier.

The retention characteristics of the left side, with two spring clips over the 0.37-inch diameter rolled bead of the carrier structure, is satisfactory. However, the single spring clip over the 0.18-inch lip of the carrier on the right side did not provide sufficient positive retention. A separate double spring clip, which reaches over both the bag hanger and tool carrier structure, will be added for Apollo 13 to provide the necessary retention force as shown in the figure.

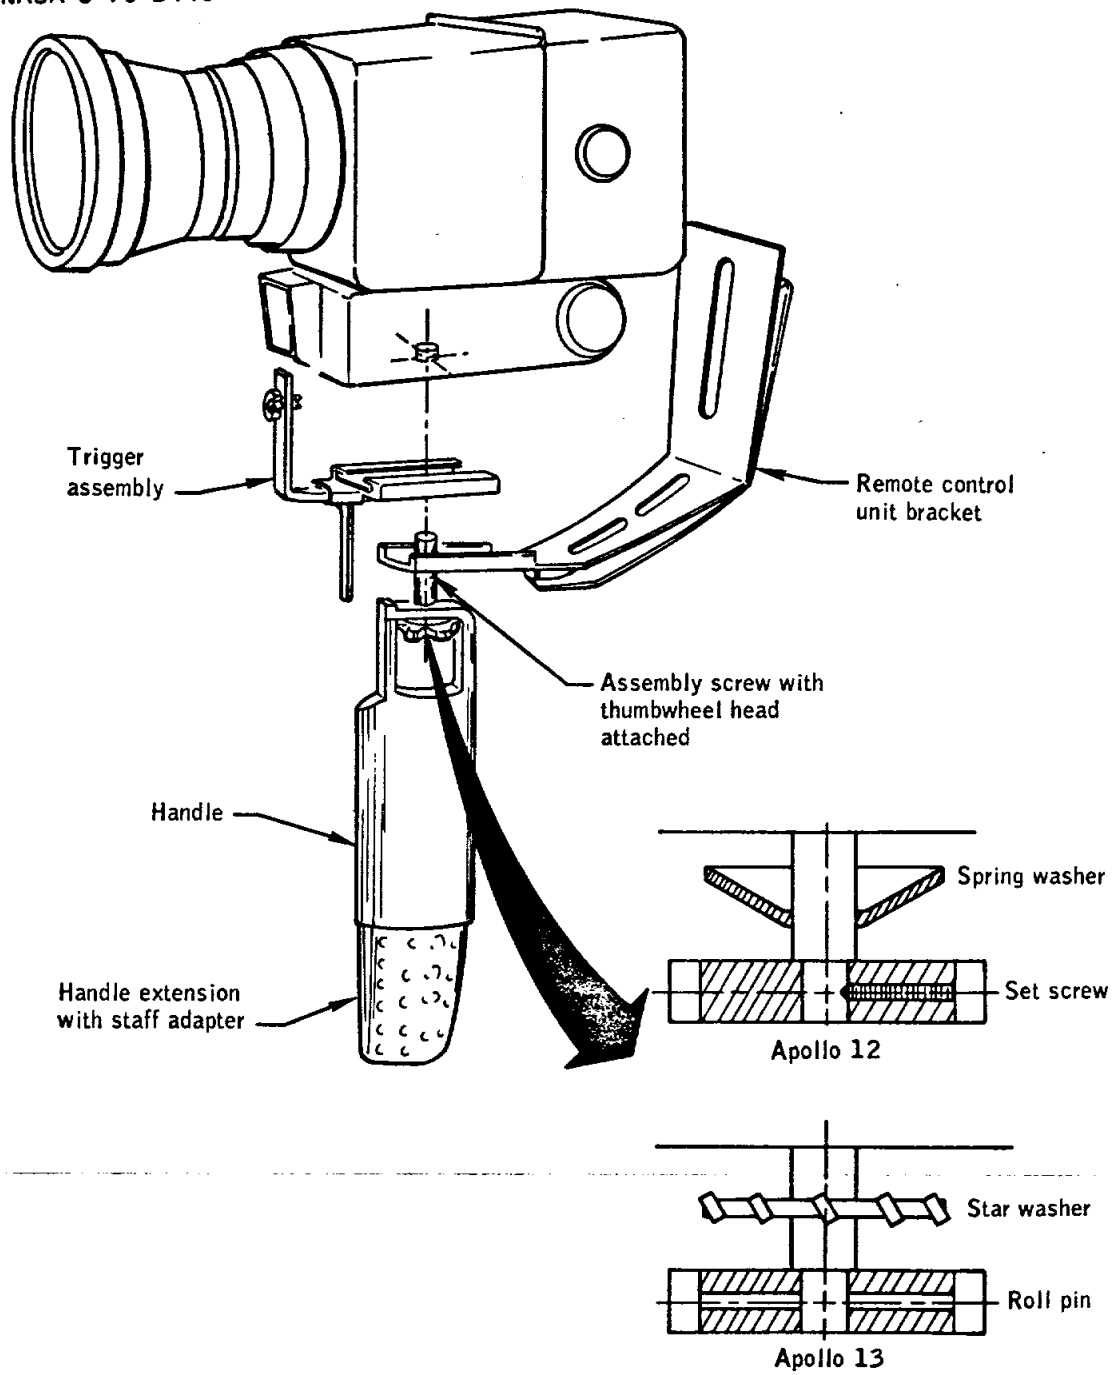
Figure 14-45.- 70-mm camera handle assembly.

During the second extravehicular period, the Commander's camera did not advance and count every time the trigger was squeezed. Shortly afterwards, when both the camera assemblies were being removed from the remote control units in order to exchange them, both assemblies were loose, although they had been well tightened before egress. In the process of retightening on the lunar surface, the thumbwheel fell off the Lunar Module Pilot's camera assembly, making reassembly impossible (fig. 14-45). The empty camera and faulty assembly were then discarded. The Commander's camera assembly was retightened and performed satisfactorily during the remainder of the extravehicular activity.

The intermittency experienced by the Commander in the shutter, counter, and film advance actions was the result of excessive trigger play caused by the loose assembly. The loss of the thumbwheel experienced by the Lunar Module Pilot was apparently the result of the improper installation of the thumbwheel setscrew.

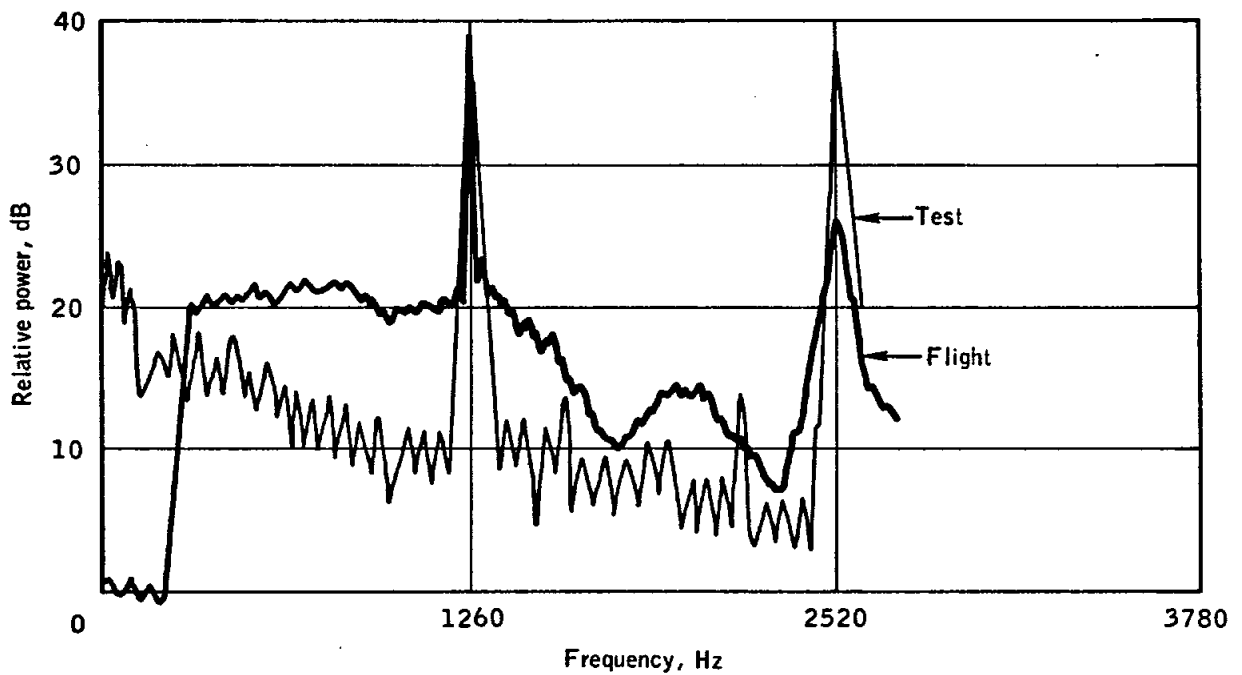
Figure 14-46.- Tone power spectral density.

A subsequent analysis of the telemetry data transmitted from the extravehicular mobility unit did not show any degradation of data quality as a result of the noise. Power spectral density plots, however, revealed a fundamental frequency of approximately 1260 hertz and a harmonic frequency of 2520 hertz. Postflight interference tests of an equivalent extravehicular mobility unit revealed the same 1260-hertz tone on the battery-bus leads and shield which originated from the fan-motor ripple current. This condition is normal and has been noted during qualification testing of the extravehicular mobility unit. Figure 14-46 illustrates the tone interference generated by the fan motor. However, during these initial tests, the noise interference could not be made to enter the audio system such that the audio tone heard in flight was simulated.

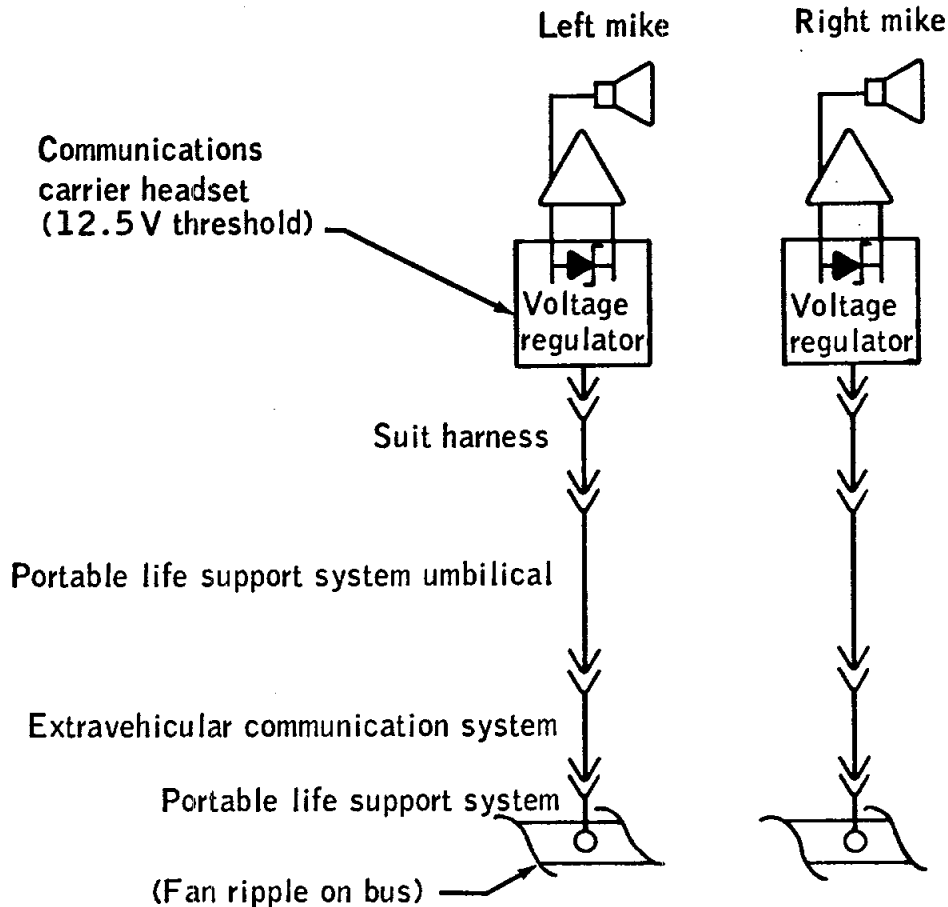
Figure 14-47.- Communications carrier headset power path.

could not be correlated to the tone phenomena, the random impulse noise heard inflight could be related to the intermittent microphone because a failure analysis has revealed an intermittent open-circuit condition in the primary winding of the amplifier transformer. Additional tests showed no further malfunctions in the communications carriers or harnesses.
