APOLLO 10 MISSION REPORT

MANNED SPACECRAFT CENTER

AUGUST 1969

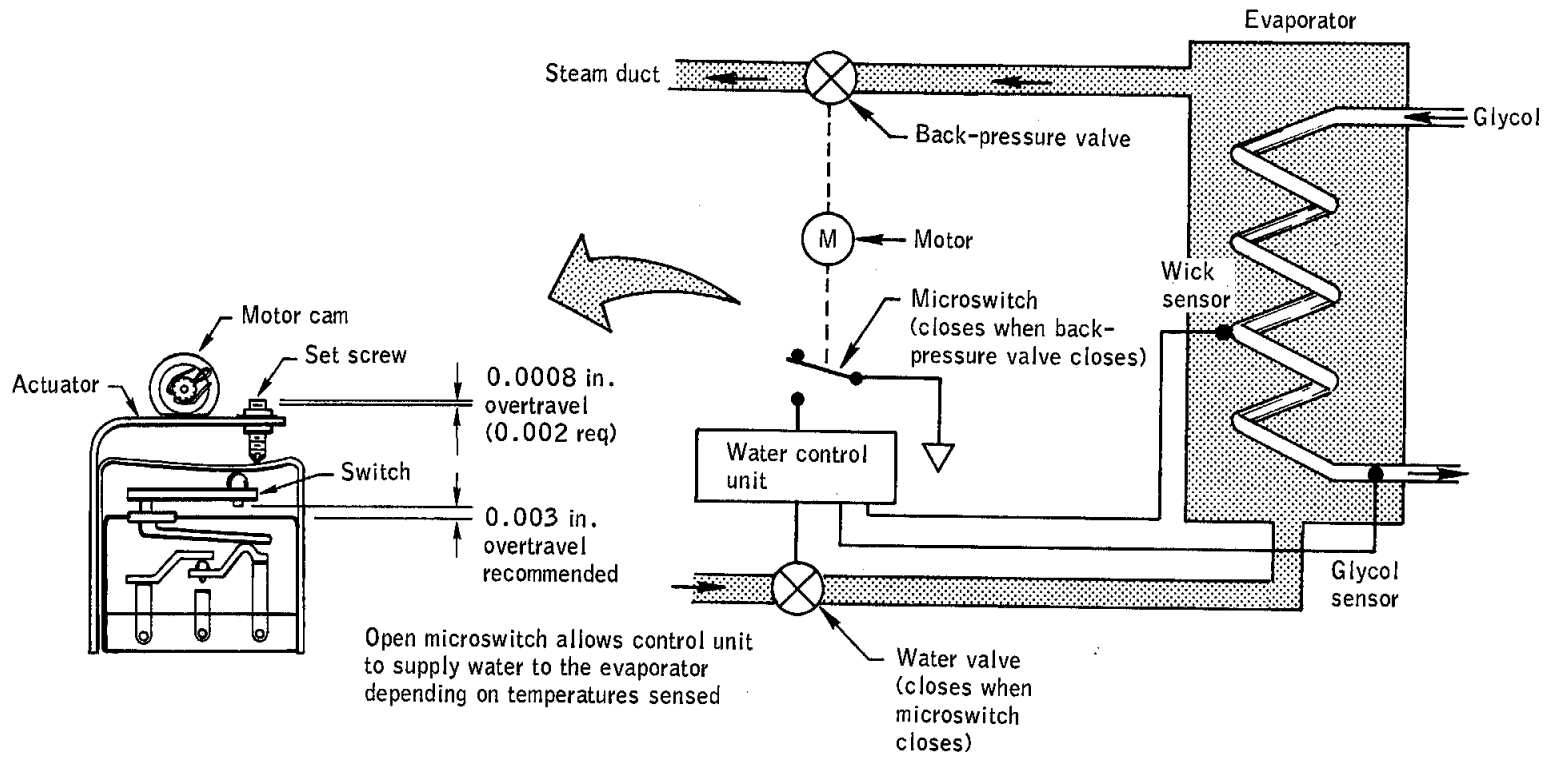
Figure 15-2.- Water control circuit.

After the mission, the spacecraft wiring and control circuits were checked. Continuity and resistance measurements were normal. Further tests of the system duplicated the inflight condition and revealed that the water control circuit operated intermittently. When a microswitch in this circuit opens, the water section of the environmental temperature control unit is activated and begins to supply water to the evaporator on demand (fig. 15-2).

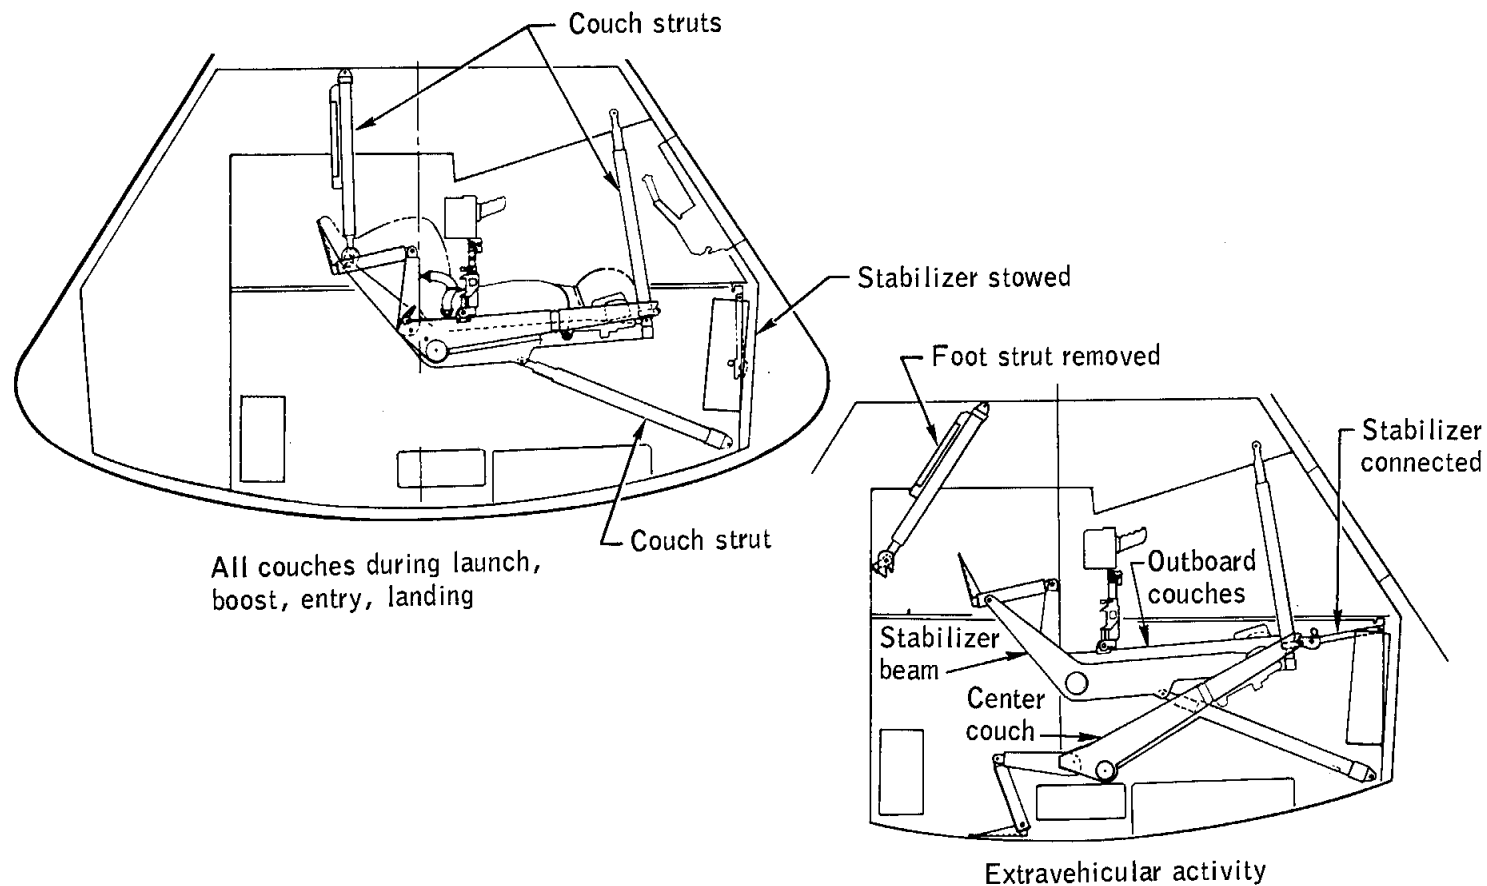
Figure 15-3.- Stabilizer usage.

The stabilizer, which maintains couch positioning when the foot strut of the center couch is removed, was connected during the launch (fig. 15-3). The stabilizer should have been in the stowed position to allow stroking of the couch struts for an abort landing. The crew properly stowed the stabilizer prior to entry.

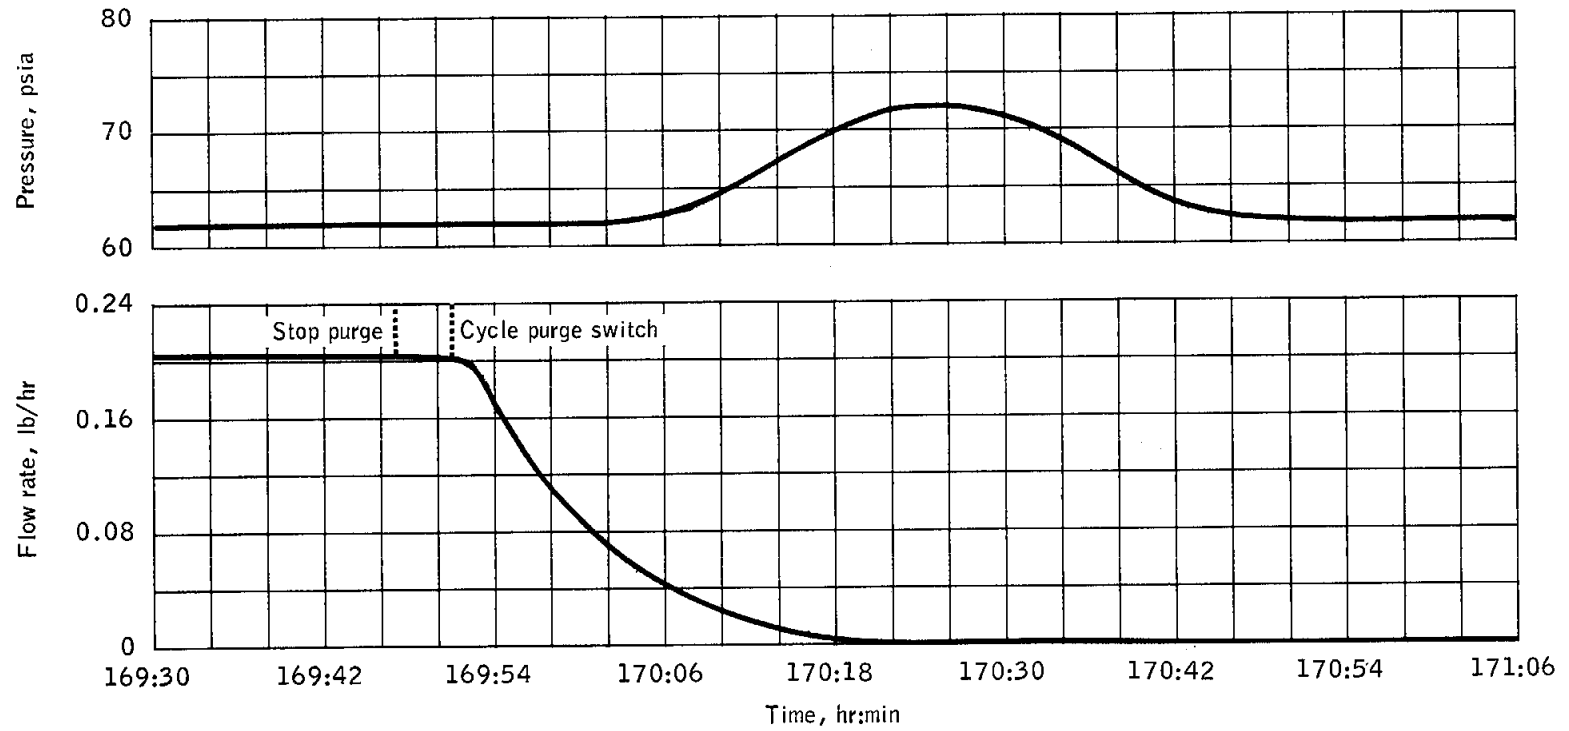
Figure 15-5.- Flow rate and pressure after purge.

At 166 hours 49 minutes, the skin temperature of fuel cell 1 was 420° F, and a continuous hydrogen purge was initiated to reduce the concentration of water in the electrolyte. Three hours later, the fuel cell was sufficiently dry and hot, the purge was terminated, and the heater for the hydrogen vent line was turned off. However, hydrogen flow to the fuel cell decayed very slowly (fig. 15-5). Normally, flow decays to zero in less than 1 minute. The purge valve was reopened, and the flow rate increased to the upper limit, indicating that the purge valve was functioning. The valve was closed again but the flow decrease was still very slow. As the flow rate was approaching zero after about 30 minutes, the regulated hydrogen pressure for the fuel cell began to increase, reaching a maximum of 72 psia before slowly decaying to the normal 62 psia.

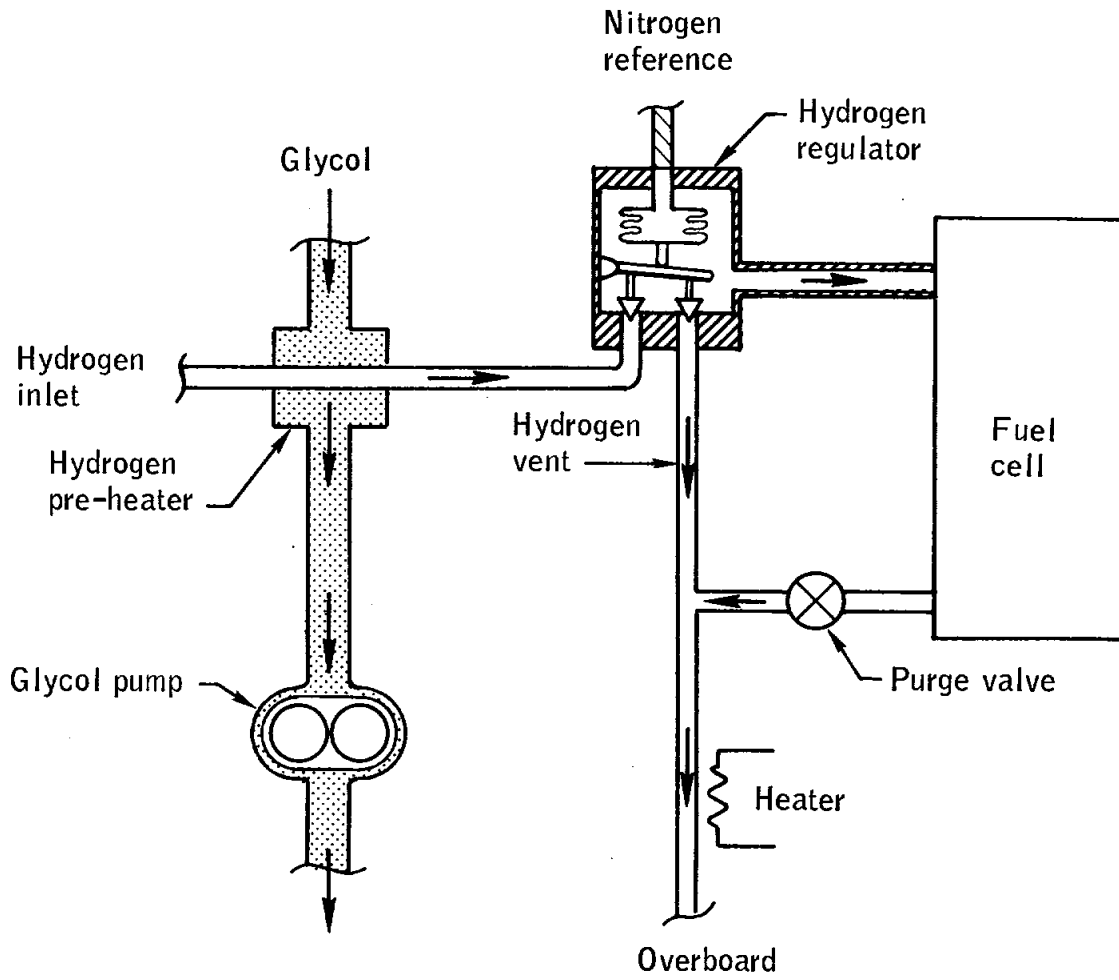
Figure 15-6.- Fuel cell hydrogen system.

As shown in figure 15-6, the regulator operation depends on a regulated nitrogen reference pressure. The nitrogen pressure did not change during the hydrogen pressure excursion, nor did the regulated oxygen pressure, eliminating the possibility of a reference pressure change.

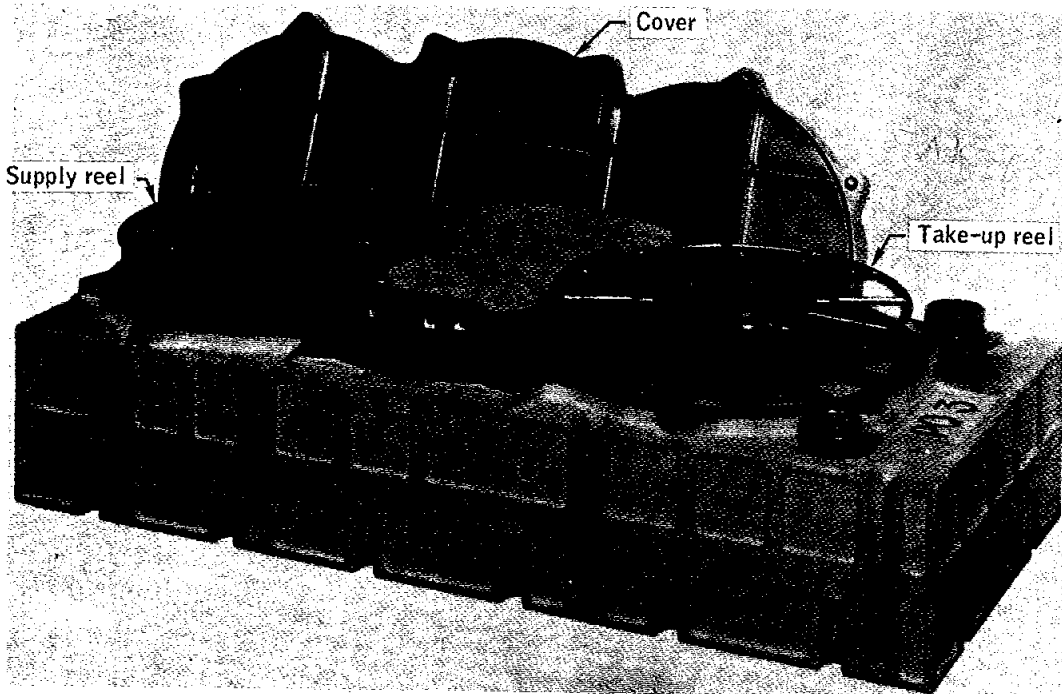
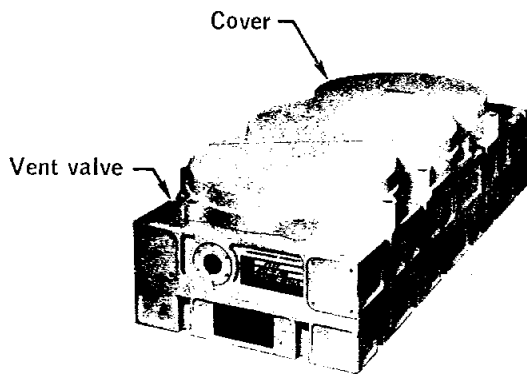
Figure 15-10.- Data storage equipment.

Clearance between cover and reel hubs is 0.058 to 0.053 in.

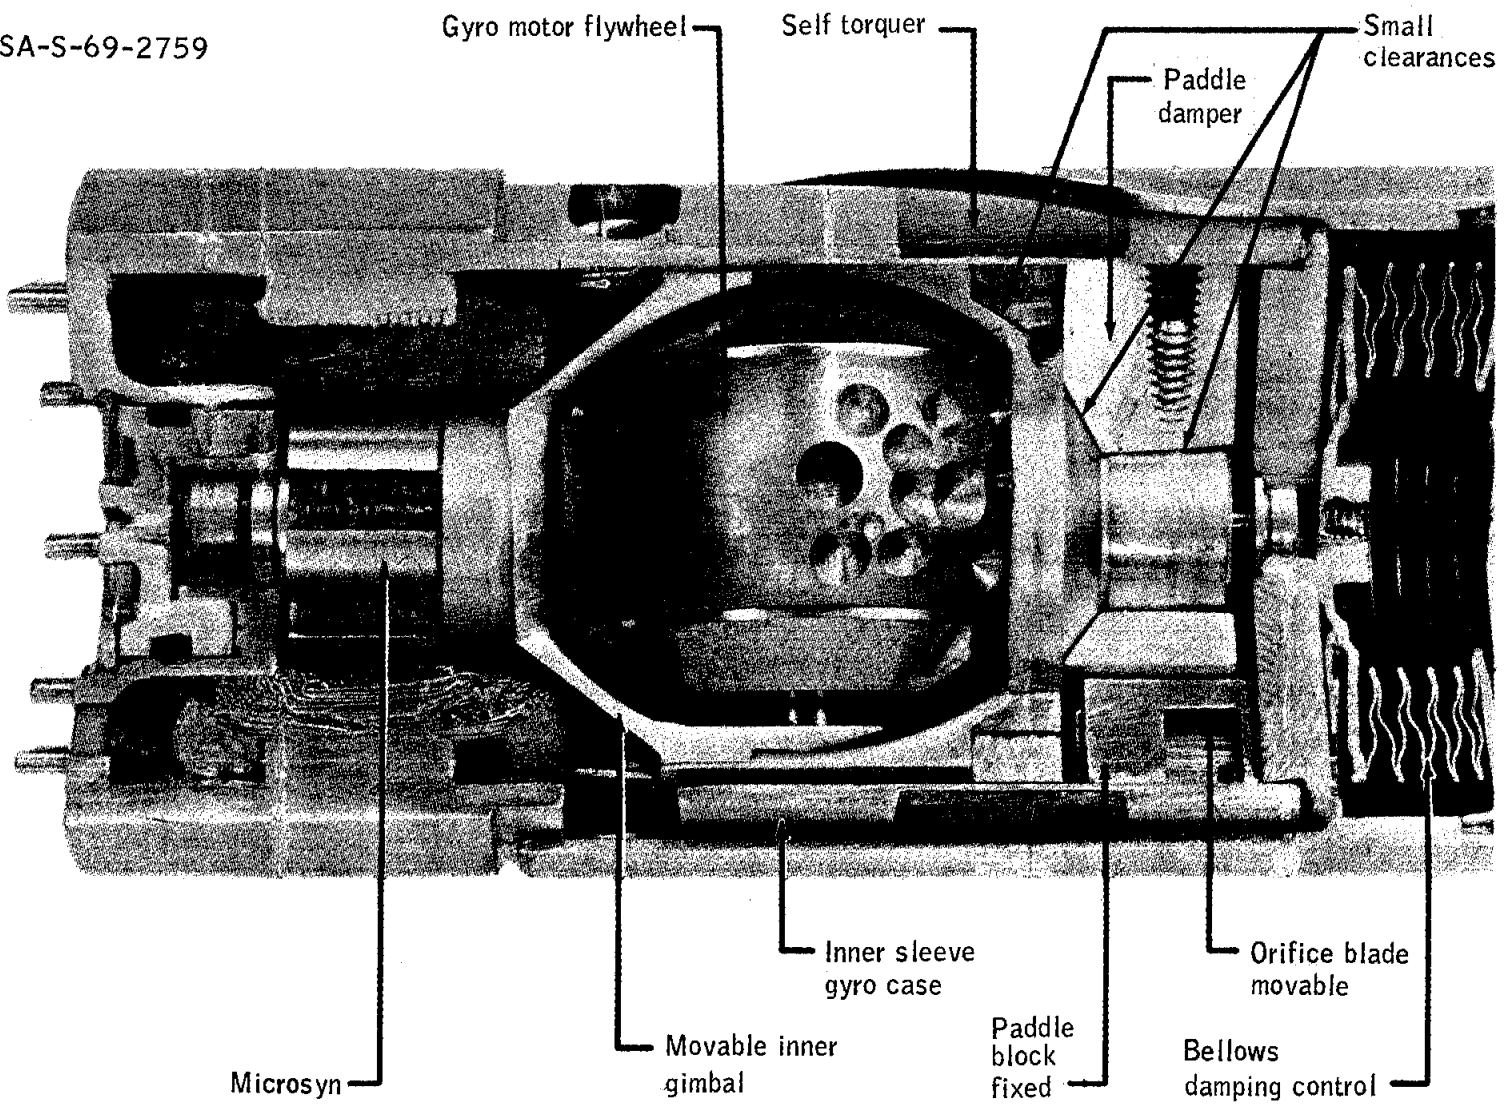
Figure 15-31.- Cross sectional view of rate gyro.

The rate gyro is a spring-restrained, single-degree-of-freedom unit with the spring force being supplied by a torsion bar (fig. 15-31). The wheel assembly is partially floated in a silicon damping fluid. Damping is supplied by a paddle wheel which pumps fluid through a temperature-controlled orifice. Three gyros are mounted orthogonally in a rigid block and placed in the spacecraft such that each gyro input axis is parallel to a spacecraft axis.

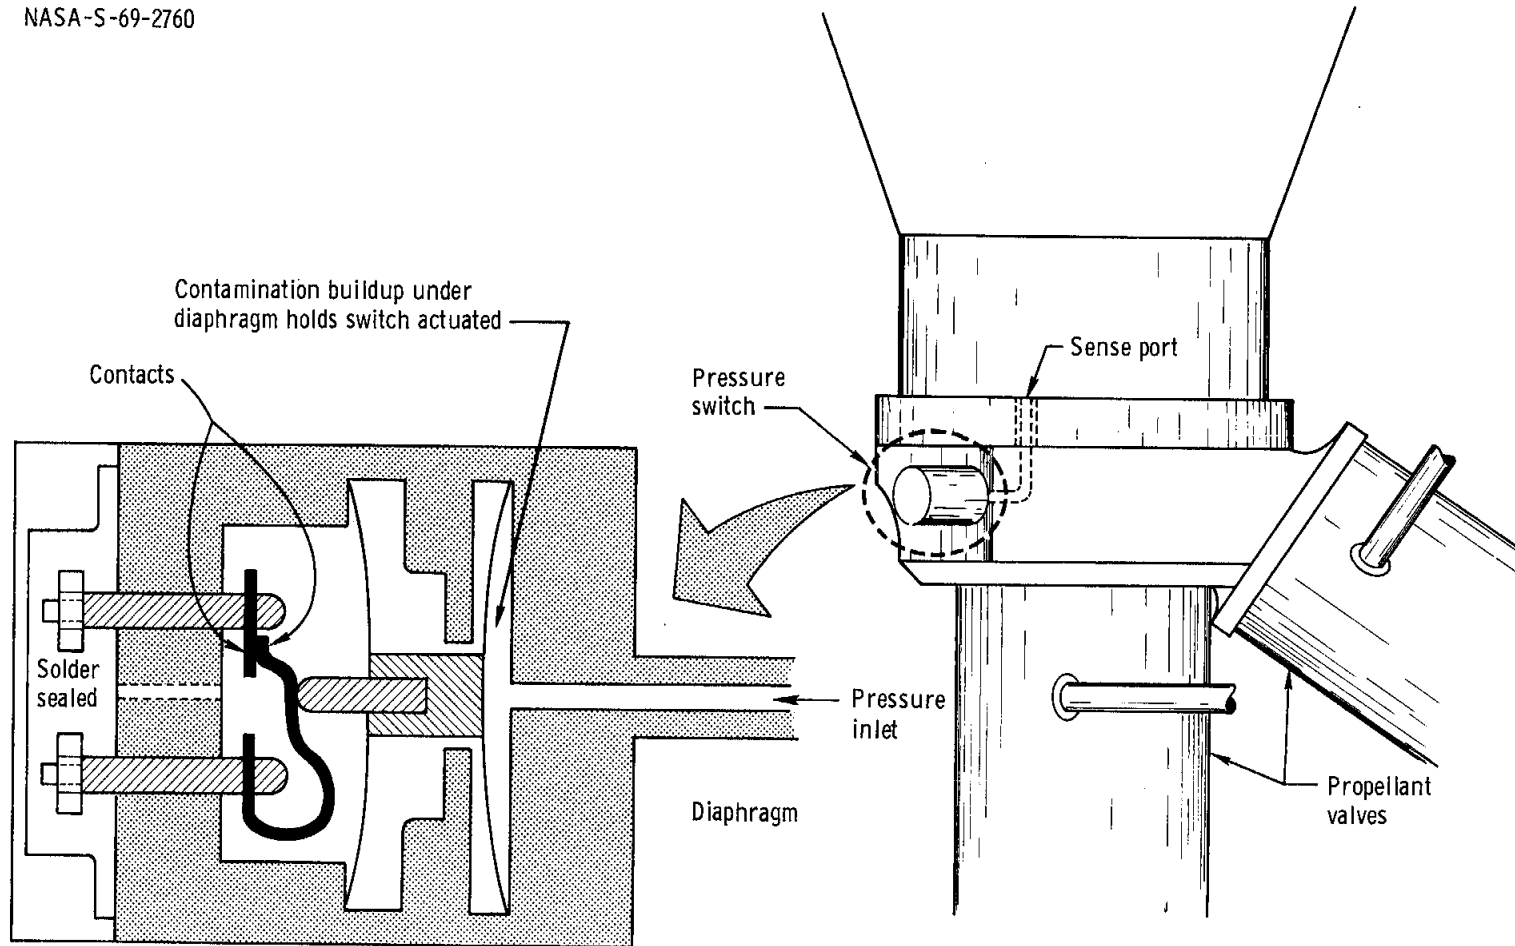
Figure 15-32. - Lunar module reaction control system thrust chamber switch.

The failure mode for these five switches is believed to be the same as that of one LM-3 unit and several others during ground testing. Particulate contamination and/or propellant residue is forced under the switch diaphragm by chamber pressure and holds the diaphragm deflected and the electrical contacts closed (fig. 15-32). The small stroke of the diaphragm (0.007 inch) and the low diaphragm restoring force generated by the return spring make the switch extremely susceptible to failure by contamination.

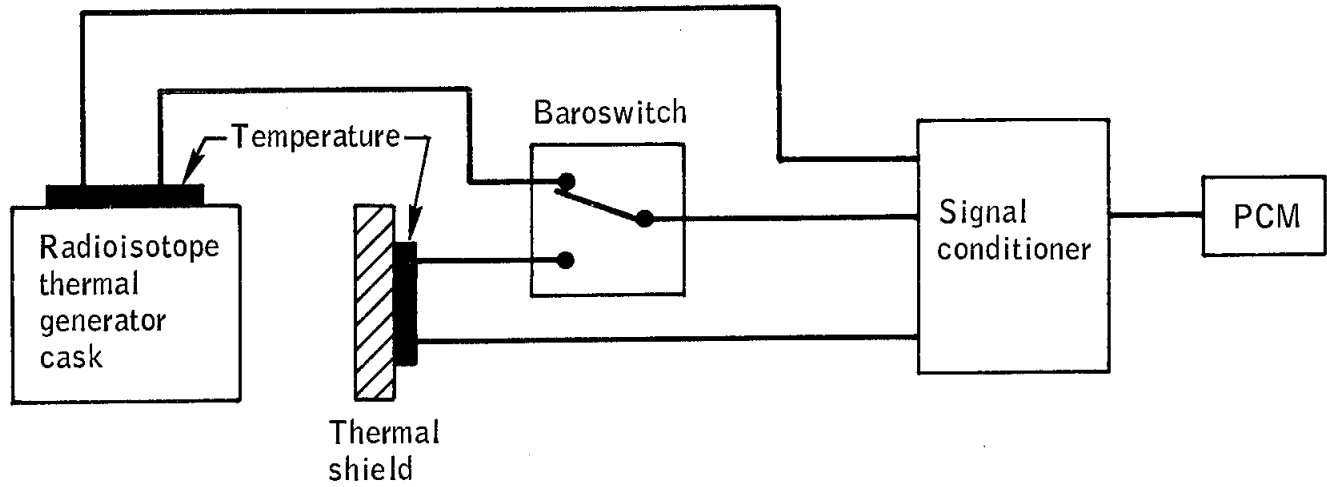
Figure 15-33.- Cask temperature.

Cask thermal shield temperature.- The temperature measurement of the thermal shield for the radioisotope thermal generator cask read upper limit throughout the lunar module portion of the flight. The telemetry is switched to this measurement from cask temperature by a baroswitch at 10 000 foot altitude (fig. 15-33).

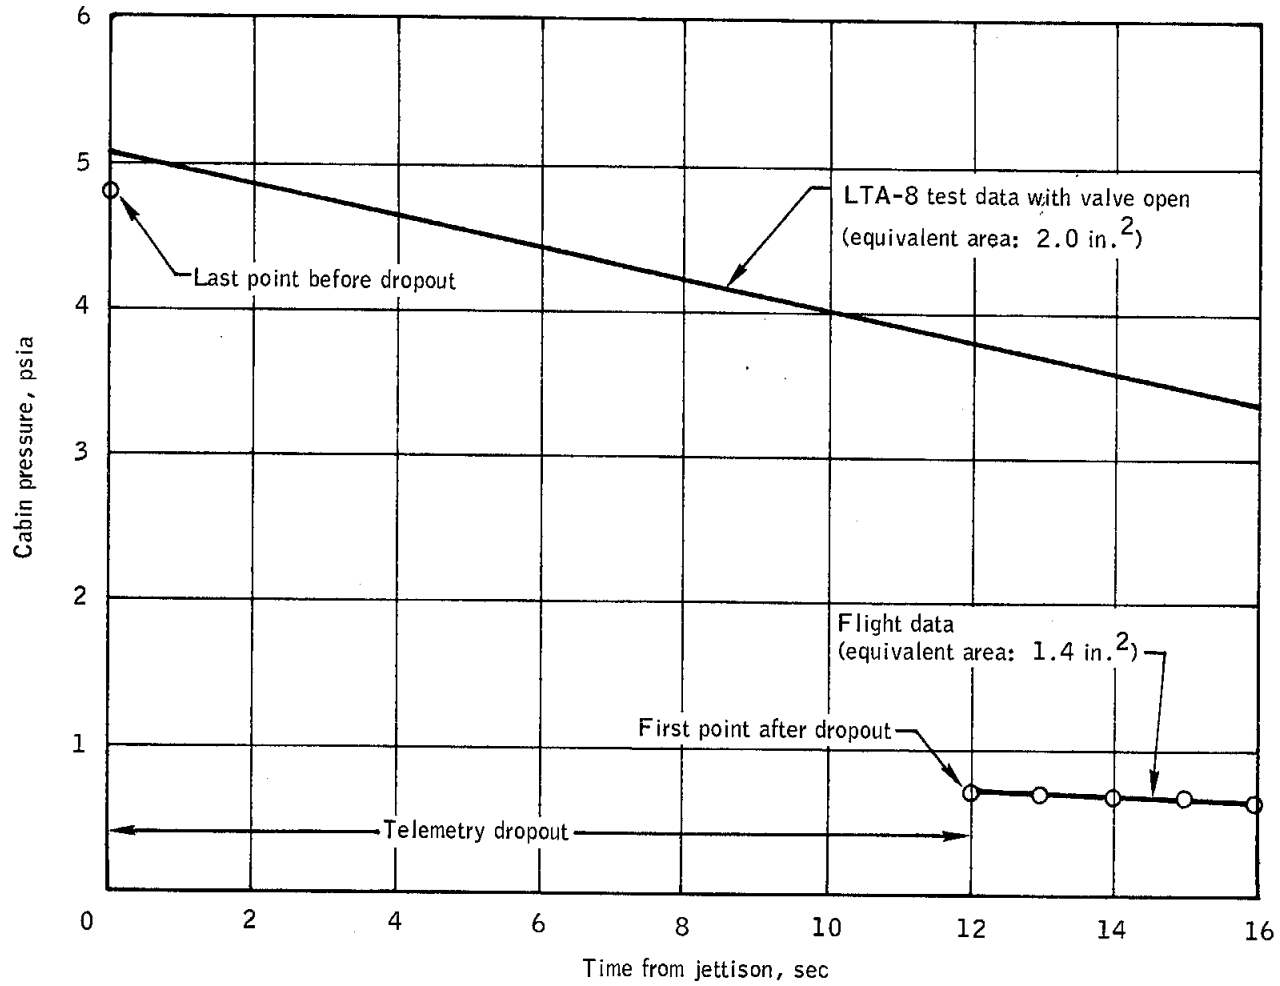
Figure 15-34.- Measured cabin pressure during jettison.

During the ascent stage separation from the command module, the lunar module cabin pressure dropped rapidly, as measured by three separate transducers. Telemetry data were lost for 12 seconds beginning at the initiation of separation. As shown in figure 15-34, the cabin pressure was 4.86 psia at the initiation of separation and 0.70 psia at the end of the telemetry dropout and continued to decay slowly.

In summary, the analyses indicate that the loading on the lunar module hatch at separation exceeded the capability of the latch. The hatch then opened and closed resulting in a cabin pressure decay as shown in figure 15-34 and separation distance and relative accelerations as shown in figures 15-35 and 15-36.

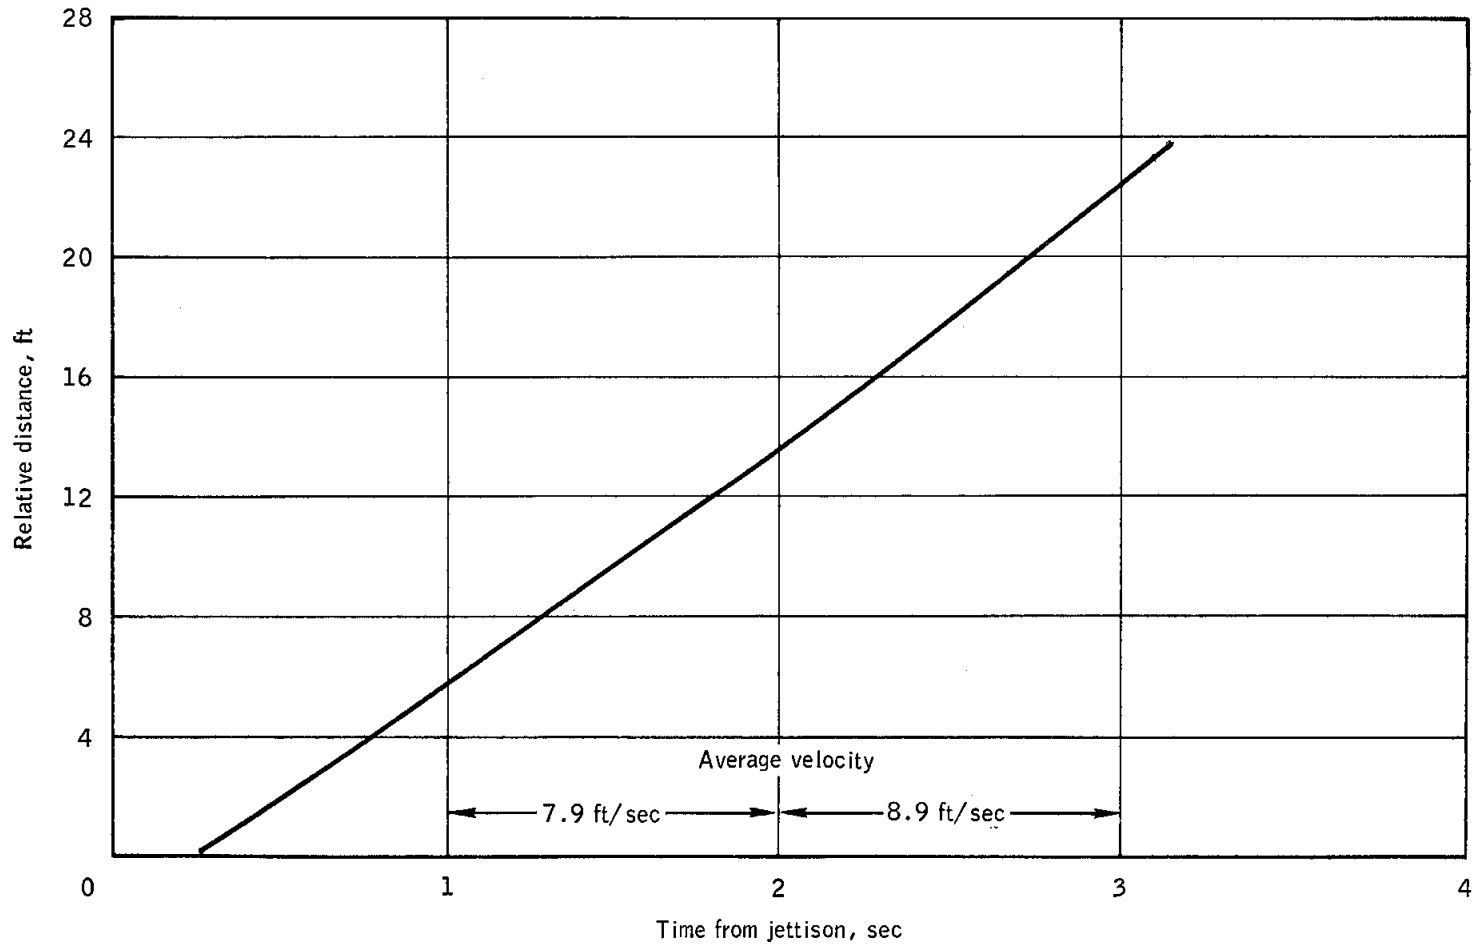
Figure 15-35.- Relative separation distance.

The film was used for determining a history of relative separation distance between the command module and the lunar module (fig. 15-35). A time history of relative acceleration, or the required pressure force, was then estimated from the data, as shown in fig. 15-36. The maximum acceleration of 50 ft/sec/sec shown is considerably in excess of the acceleration caused by separation pyrotechnic effects. However, the acceleration history shown in figure 15-36 can be obtained by dumping the cabin pressure in the first 0.3 second of separation. A 4-psi drop in cabin pressure in 0.3 second requires a constant venting area of 290 square inches. The impulse from dumping cabin pressure through the hatch is consistent with the direction and magnitude of the lunar module velocity change (5 ft/sec in minus X direction) noted from the flight data. Further, the upper hatch is the only item on top of the lunar module that could open and close, allowing the cabin to vent while satisfying the pressure history. The hatch has a maximum area of 838 square inches, which is more than enough to vent the cabin from 4.8 to less than 1.0 psia in 0.3 second.

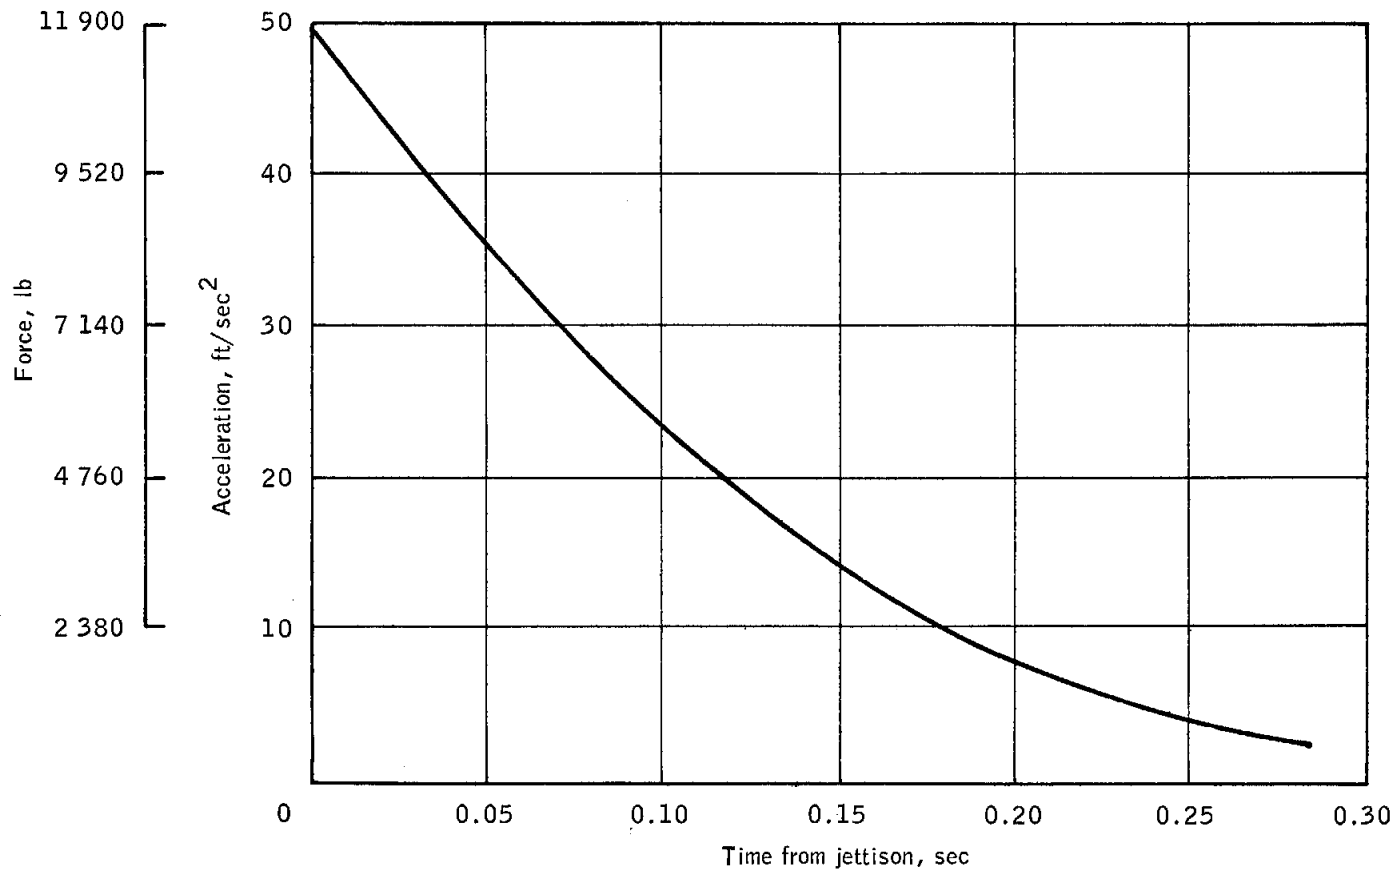
Figure 15-36.- Lunar module/command module relative acceleration after staging.

it completely. The remaining gap of about 1.4 square inches allowed a slight pressure decrease, as indicated by cabin pressure data. Figure 15-37 presents a history of hatch area that allows the cabin pressure to decrease rapidly and also yields an acceleration time history which agrees with figure 15-36.

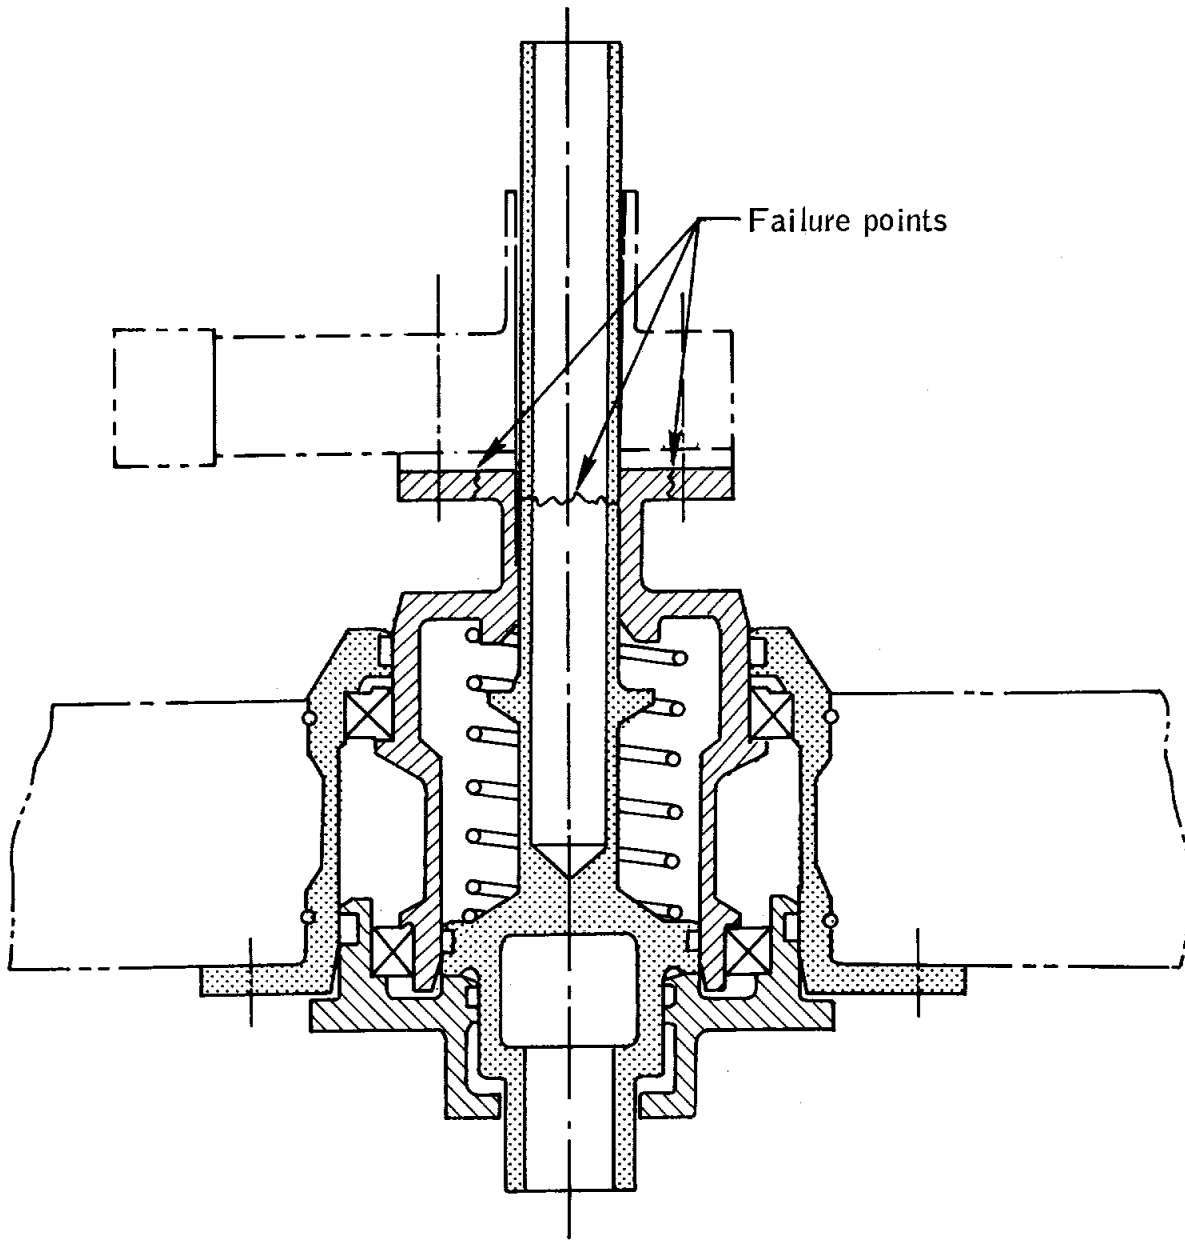
Figure 15-38.- Lunar module hatch latch.

The hatch and latch assembly was statically pressure-tested to failure. At a differential pressure of 4.1 psi, the latch failed as indicated in figure 15-38.

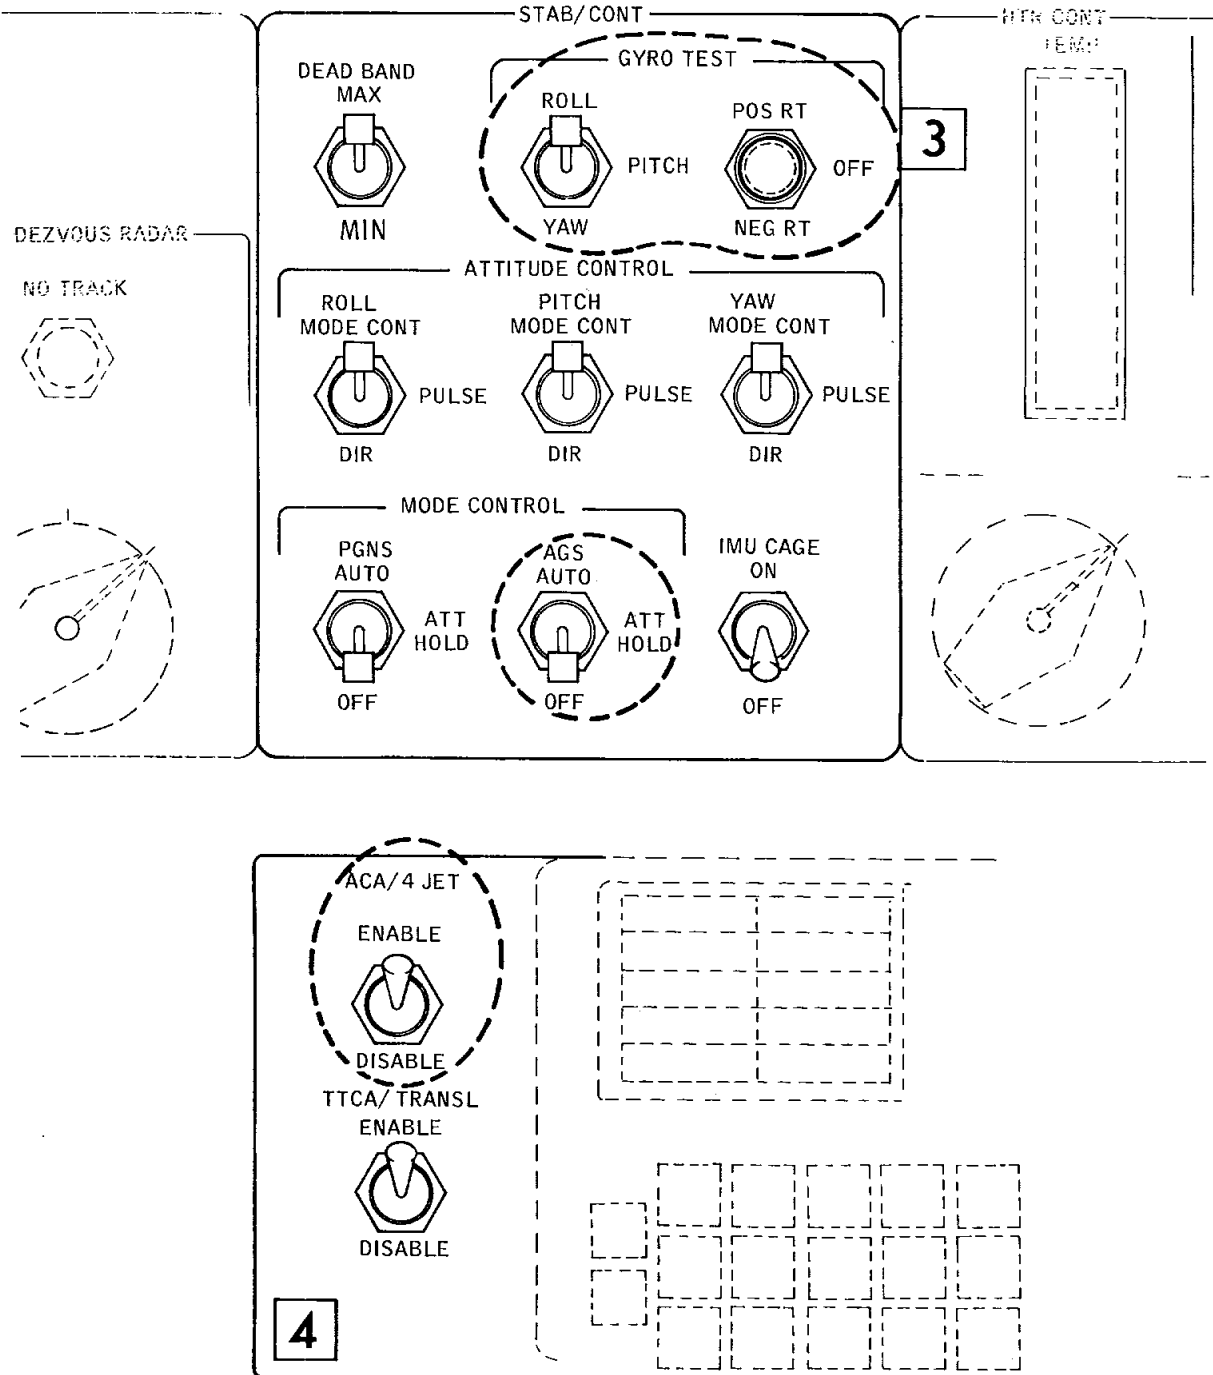
Figure 15-41. - Lunar module guidance switch locations.

The attitude control switches on panels 3 and 4 are shown in figure 15-41, and a simplified functional switching diagram is shown in figure 15-42. Approximately 4 minutes before staging, with the guidance select switch in AGS and the attitude control switches in PULSE, the crew verified that the abort guidance mode control switch was in ATT HOLD since the intent was to perform staging in AGS ATT HOLD. After some discussion, they selected MAX deadband to save propellant.

Switches.- Functions in each of the anomalous areas are controlled by switches (see fig. 15-41).

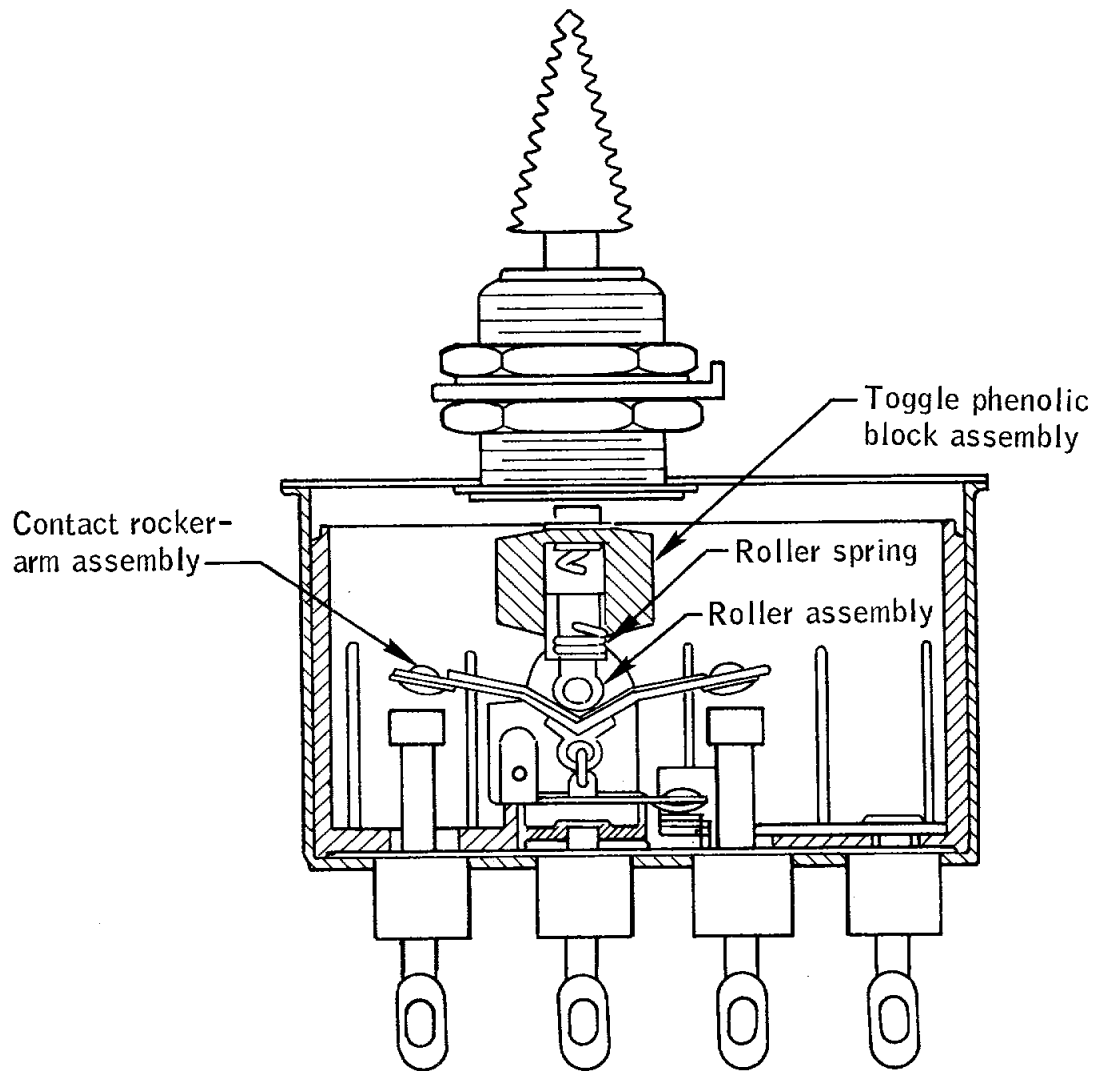
Figure 15-43.- Abort guidance mode control switch.

The abort guidance system mode control switch, on panel 3, was used several times before and after staging with no evidence of abnormality. To produce the flight results requires the contacts to transfer on at least two of the three poles of this switch. No known failure modes in the switch would produce this type of failure. Two failure modes postulated would allow the contact rocker arms to become free-floating. However, testing under a simulated flight environment has shown that because of frictional forces at the contact arm pivot point, the free-floating contacts will not transfer (see fig. 15-43). The observed anomaly would have required the simultaneous motions of two rocker arms.

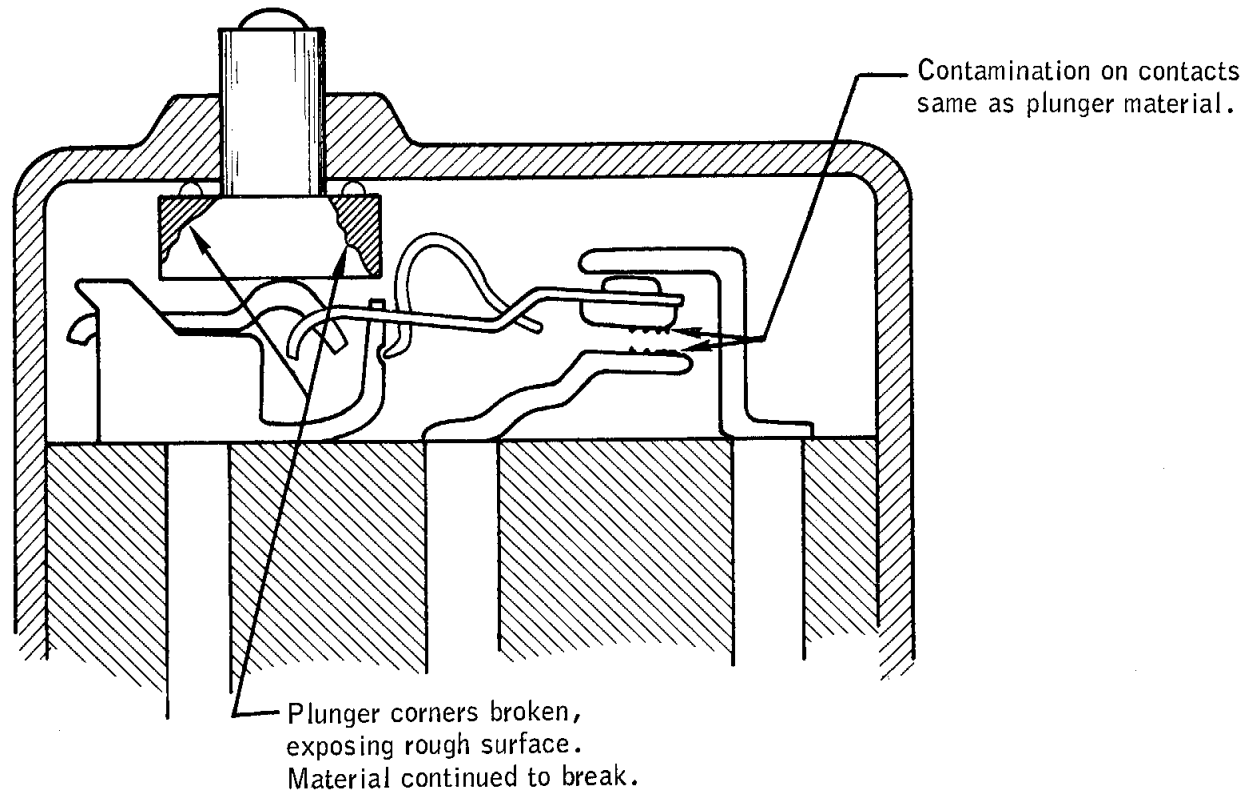
Figure 15-47.- Magazine interlock switch.

At approximately 173 hours, during transearth coast, the command module 16-mm camera ceased to operate in the pulse mode because the magazine interlock microswitch failed. The switch was not a high reliability item and failed because of internal contamination and a faulty plunger (fig. 15-47).
